**NOTICE:** Defect Information Report, in accordance with 49 CFR §573.6, concerning certain MGM Type 24 J-Series Piston Parking Brake Actuators shipped to Meritor and installed on axles manufactured between November 23, 2010 and October 22, 2012,.

# MGM Brake Chamber Inspection and Replacement

Vehicles Equipped with MGM Type 24 J-Series Piston Parking Brake Actuators, and Meritor DiscPlus™ EX225 Air Disc Brakes or Q Plus™ Cam Brakes/Rear Axles Only

This technical bulletin provides procedures for inspecting and replacing MGM Type 24 J-Series parking brake chambers that have date codes between November 23, 2010, and March 31, 2012.

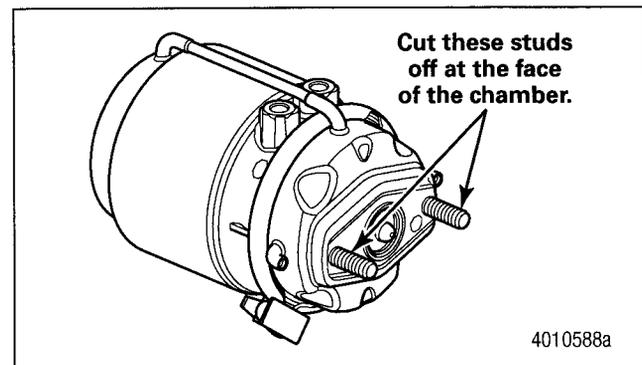
Figure 2

You must disable a chamber that requires replacement by using a cutting tool, such as a die grinder with a cutting wheel, to remove both brake chamber mounting studs at the face of the brake chamber. Figure 2.

OnTrac will require confirmation that the chamber has been disabled before a warranty claim is approved.

Once the brake chamber mounting studs are removed, dispose of the chamber according to the chamber manufacturer's guidelines.

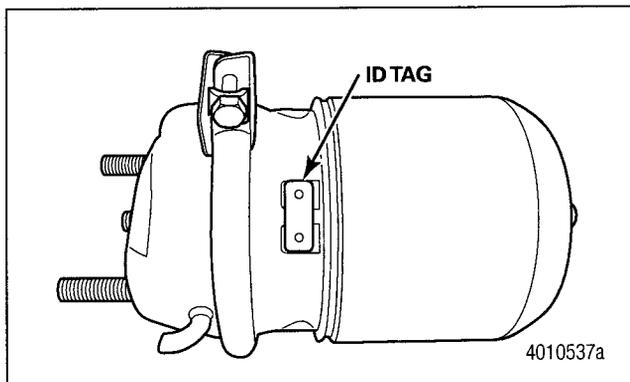
1. Wear safe eye protection. Park the vehicle on a level surface. Block the wheels to prevent the vehicle from moving.
2. Locate the identification tag on the brake chamber. Figure 3.

3. Check the identification tag for a date code falling on or between the date range of November 23, 2010 and March 31, 2012. As an example, the date code shown in Figure 3 (C051911 centered in ID tag) means "built on May 19, 2011". In this example, the chamber requires replacement. Figure 4.
  - **If the date code on the brake chamber identification tag is on or between the date range of November 23, 2010 and March 31, 2012:** Replace the brake chamber using the disc or drum brake procedures in this technical bulletin.
  - **If the date code on the brake chamber identification tag is not within the date range:** The chamber does not require replacement. Continue checking the rest of the brake chamber identification tags on the vehicle.

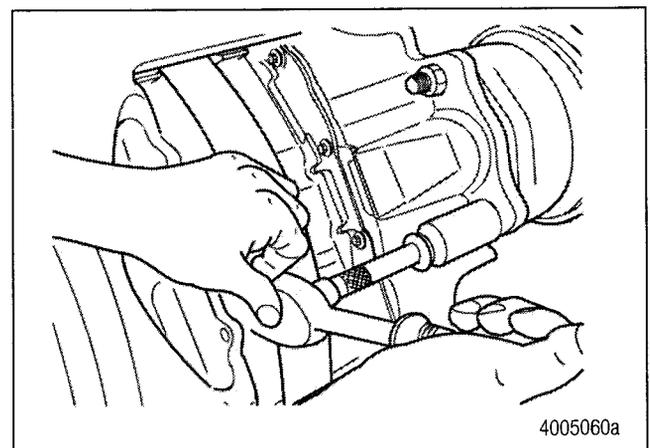
Figure 5

1. Raise the axle of the wheel end you are servicing. Support it with safety stands.
2. Remove the tire and wheel assembly according to the manufacturer's instructions.
3. Follow the brake chamber manufacturer's instructions to completely release the brake. This may require manually caging the park brake spring assembly using the manual caging screw.
4. In order to prevent debris from entering the caliper assembly, use a vacuum brush or damp cloth to remove any dirt from the brake assembly.
5. Disconnect the air lines connected to the brake chamber ports according to the vehicle manufacturer's instructions.
6. Use the correct wrench to remove the air chamber nuts and washers. Figure 5.

- Remove the air chamber assembly from the brake caliper.

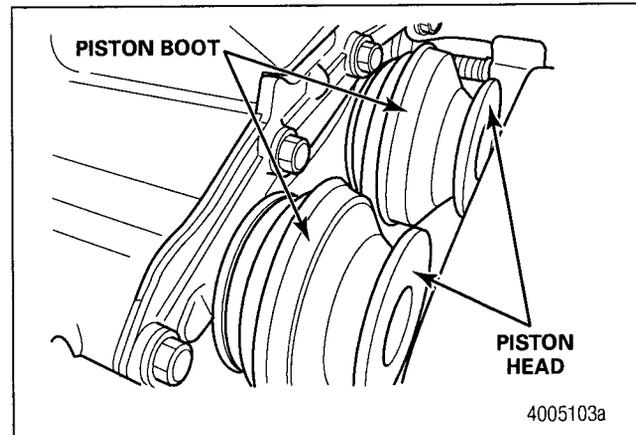
Figure 6

- Burnt or melted caliper piston boots. Figure 6.
- Cracks in the rotor that extend 25% into the thickness of the outer edge of the rotor. Figure 7.
- Heavy Heat Checking — Heavy heat checking is surface cracks that have width and depth. Replace the rotor if the heat checks have a width greater than 0.02-inch (0.5 mm), depth greater than 0.04-inch (1 mm) and extend across the surface more than 75% in the radial direction. Figure 8.

- Brake pads deteriorated from a severe overheating condition. Figure 9 and Figure 10.
- If you find heavy heat checking on the rotor, cracks in the rotor, deteriorated brake pads, or burnt or melted caliper piston boots:** Component replacement may be required. Contact the OnTrac Customer Service Center using the instructions at the beginning of this bulletin before the removal and replacement of any suspect overheated brake component. OnTrac will advise you as to additional functional checks and parts replacement that may be required.

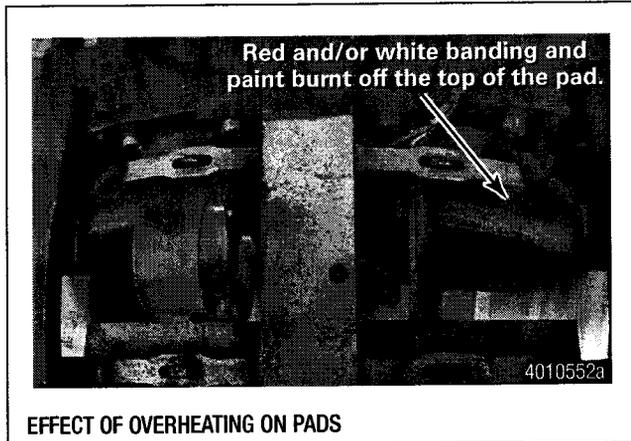
Figure 9

EFFECT OF OVERHEATING ON PADS

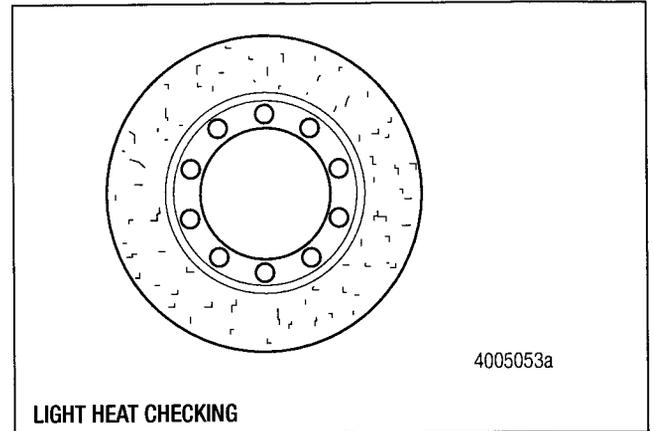
Figure 12

- Light Heat Checking** — Cracks on the surface of the rotor that result from light heat checking are small and fine and do not require rotor replacement. Figure 11 and Figure 12.

LIGHT HEAT CHECKING

- If the brake rotor shows light heat checking or blue marks or bands:** The brake rotor will not require replacement.

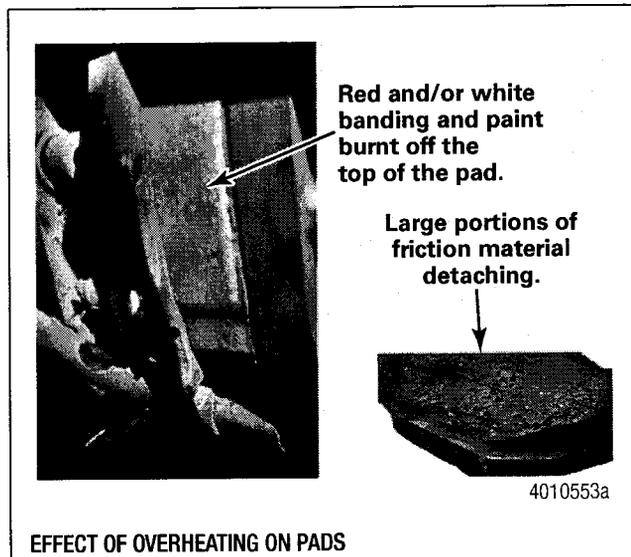
Figure 10

EFFECT OF OVERHEATING ON PADS

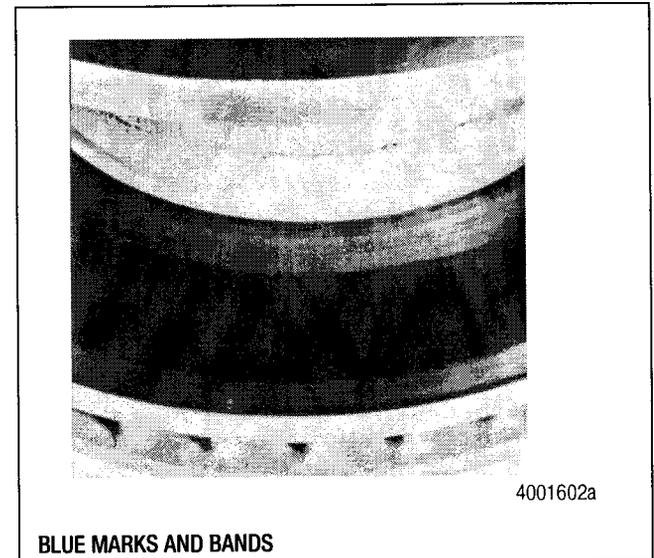
Figure 13

**Blue Marks or Bands** — Blue marks or bands indicate that the rotor was very hot. This does not require rotor replacement. If blue marks or bands are consistently found during scheduled maintenance inspections, it is recommended the brake system be inspected for correct operation and balance. Figure 13.

BLUE MARKS AND BANDS

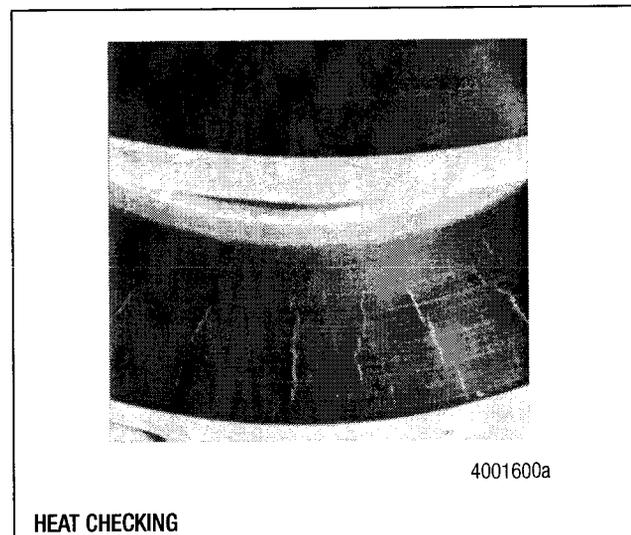
Figure 11

HEAT CHECKING

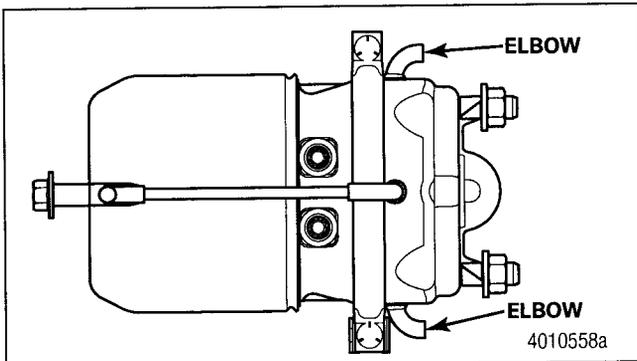
Figure 14

For brake chambers equipped with elbows, the brake chamber must be oriented in such a way that any two elbows will easily allow water and contaminants to drain from the brake chamber. Figure 14.

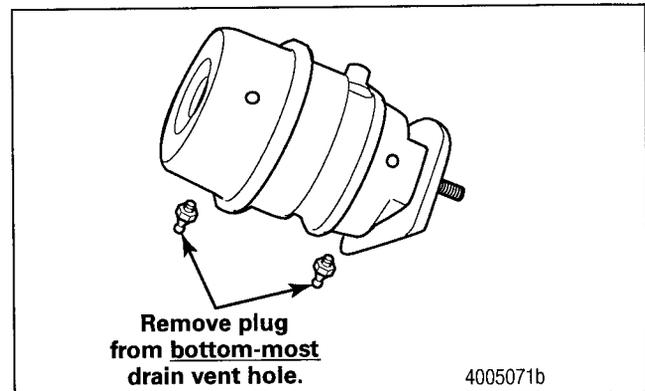
Figure 15

8. If removable breather plugs are supplied with the brake chamber, locate the bottom-most breather plug and remove it from the chamber. Figure 15.

If the brake chamber is supplied with removable breather plugs and the bottom-most breather plugs are not removed, the caliper may become contaminated which can cause damage to the internal parts of the caliper. The brakes can seize resulting in serious personal injury and damage to components.

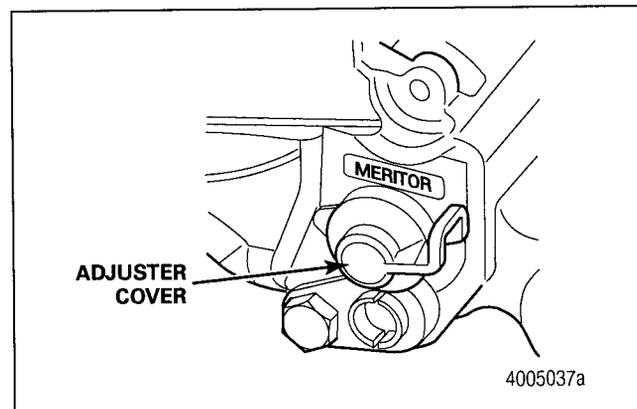
Figure 16

- A. Remove the adjuster cover. Figure 16.

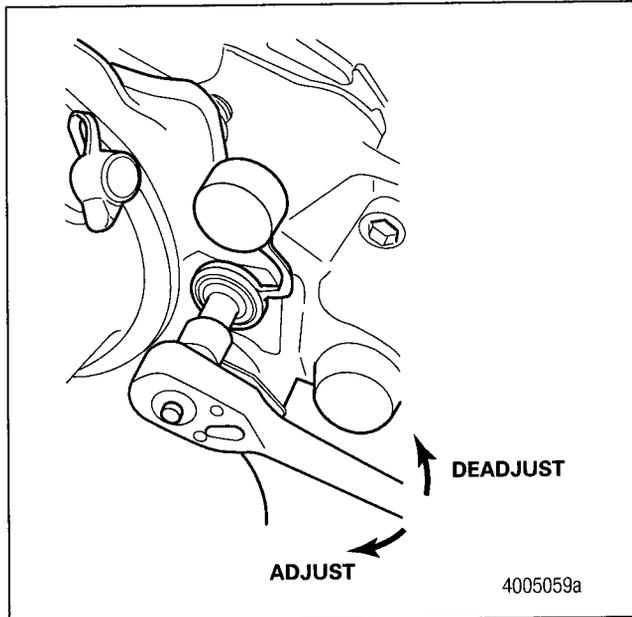
**Figure 17**

- B. Use a 10 mm wrench to rotate the manual adjuster stem **CLOCKWISE** so that the brake pad-to-rotor clearance is ZERO. Figure 17.

C. Deadadjust the manual adjuster stem one half turn COUNTERCLOCKWISE to set the initial running clearance. Reinstall the adjuster cover. Figure 17.

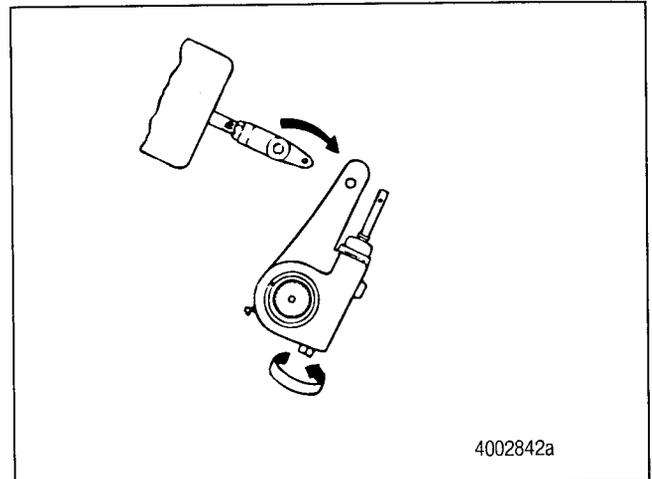
**Figure 18**

3. Follow the brake chamber manufacturer's instructions to completely release the brake. This may require manually caging the park brake spring assembly using the manual caging screw.
4. Disconnect the air lines that are connected to the brake chamber according to manufacturer's instructions.
5. Remove the clevis pin(s) from the clevis on the automatic slack adjuster and rotate the slack adjuster away from the clevis. Figure 18.

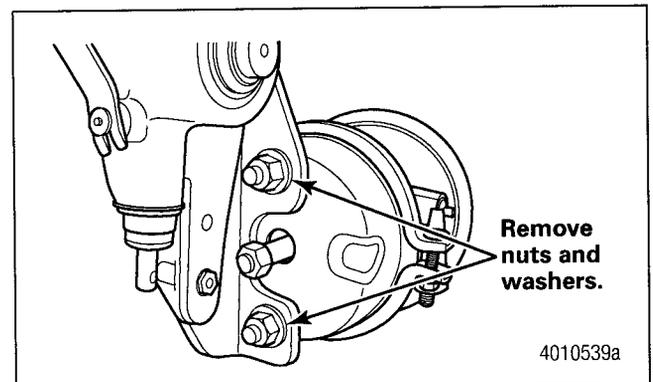
**Figure 19**

6. Use the correct wrench to remove the air chamber nuts and washers. Figure 19.

7. Remove the air chamber assembly from the brake chamber bracket assembly.

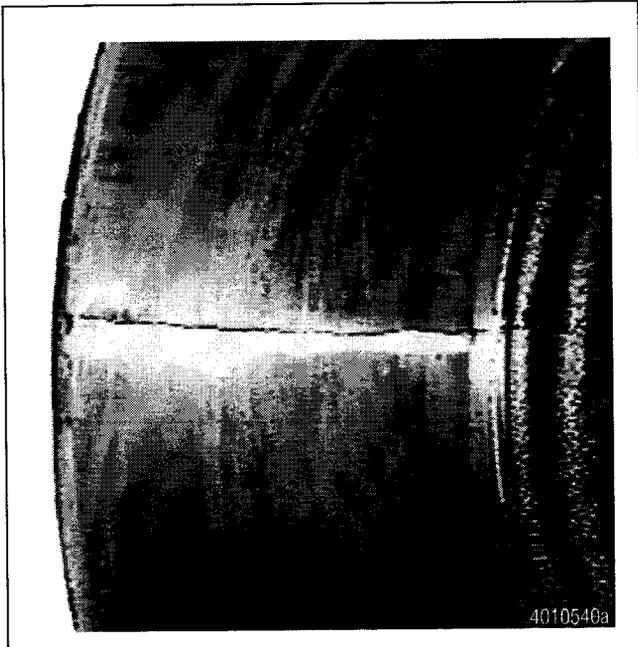
Figure 20

1. Inspect the brake according to the instructions in Maintenance Manual 4.
2. Inspect the brake assembly for the following conditions.
  - Cracks in the brake drum. Figure 20.
  - Heavy heat crazing that covers over 75% of the brake shoe width. Figure 21.
  - Brake linings deteriorated from a severe overheating condition.
  - **If the brake assembly shows any signs of overheating as described above:** Contact the OnTrac Customer Service Center following the instructions in the beginning of this bulletin before the removal and replacement of any suspect overheated brake component.
