13E-033
(6 pages)

**Safety Defect and Noncompliance Report for Motor Vehicle Equipment
PART 573 Defect and Noncompliance Report [49 CFR Part 573]**

This report serves as Kuryakyn Holdings, LLC's notification to the U.S. Department of Transportation, National Highway Traffic Safety Administration that a "defect related to motor vehicle safety" exists in certain on road motorcycle backrests. Reporting party decided that this "defect" existed in this equipment on the above noted date of submission.

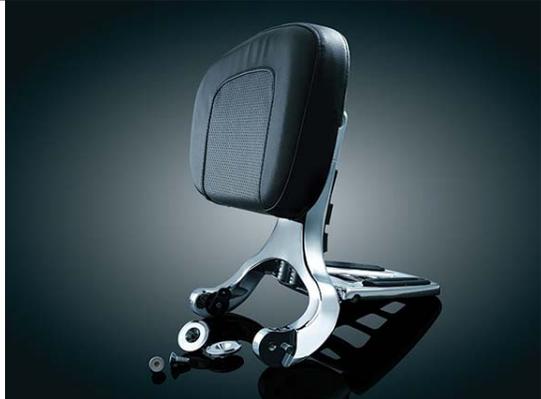
Type of equipment (e.g., tire, child restraint, headlamp): Multi-purpose driver & passenger backrest	
Part/Model number: 1660 (chrome finish)	
Size and function (where applicable): Only one size; Multi-purpose driver & passenger backrest	
Inclusive dates of manufacture (month and year): 3/2012 to 5/2013

Other information necessary to describe this equipment: (see photo below) chrome finish	
Total number of these items of equipment: In reporting party's inventory waiting for retrofit: 1010	
Sold to USA customers/retailers: 300 (subject to this recall) Sold in Canada: 43 Sold outside North America: 176

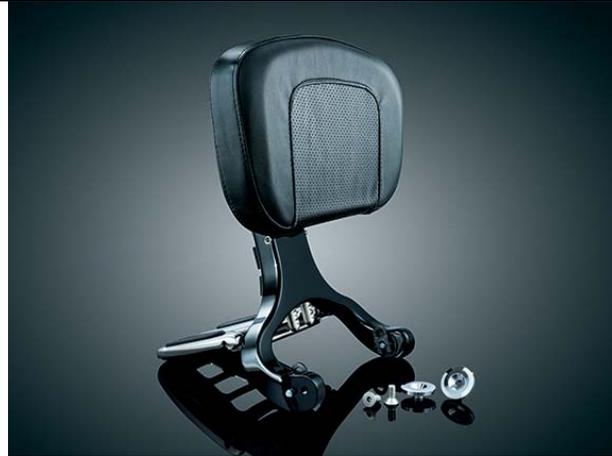
Type of equipment (e.g., tire, child restraint, headlamp): Multi-purpose driver & passenger backrest	
Part/Model number: 1661 (black and chrome finish)	
Size and function (where applicable):

Only one size; Multi-purpose driver & passenger backrest

Other information necessary to describe this equipment: (see photo below)

black and chrome finish

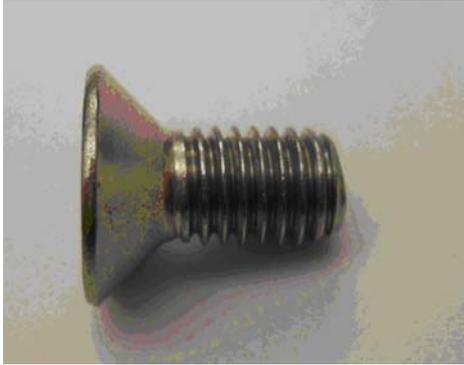
If not tightened pursuant to existing instructions during installation, the backrest pivot screws [P/N 201660; 5/16 in. (thread OD)-18 (threads per inch) x ¾ in. (overall length)] socket flat head cap screw, 18-8 (grade stainless steel per ANSI B18.3); pictured below]

may come loose from -rotation by friction applied to the pivot joint when changing the backrest from the driver to passenger position or back again. Once the fastener is loose, it is suspected that the screw may vibrate out due to normal vibrations encountered during normal motorcycle operation because the screws do not have a secondary retaining method to combat the vibration loosening.

The supplied instruction sheets did not have a torque specification for the tightening of the pivot screws and the pivot screws did not require consumers to use a thread lock compound to prevent vibration loosening.

If the screws vibrate out during use, it is possible for the backrest to separate from the mounting brackets at the pivot locations, which could result in possible loss of control or injury.

The original supplied pivot screws are 3/4" long with no thread lock adhesive and have no installation torque specified in the installation instructions. If the screws are not sufficiently tightened during installation or get loosen through any method after installation, the screws are subject to additional loosening or possibly falling out of the holes due to vibration encountered during normal use or by just repeatedly adjusting the seat. After tightening, the screws with no thread lock can be loosened by applying a reverse torque equivalent to the tightening torque plus minor frictional forces of the screw threads and under surface of the screw head. After breakaway has been achieved, the turn out torque is essentially 0 ft-lbs.

We are proposing to send replacement screws to customers that are 7/8" long with 3M 2353B thread lock adhesive (see attached specification sheet; Exhibit 3) applied to prevent possible loosening or loss due to pivot moments or vibrations encountered during normal use. We will also be specifying an installation torque requirement of 15 ft-lbs in the installation instructions. If the replacement screws with thread adhesive get loose through any method after the installation torque has been applied and the adhesive has cured, the thread adhesive provides a significant frictional resistance that will prevent additional loosening due to vibrations encountered during normal use. After tightening the screws with thread lock adhesive can be loosened by applying a reverse torque equivalent to the tightening torque plus 4-5 ft-lbs. With the proposed installation torque of 15 ft-lbs, the breakaway torque is 19-20 ft-lbs. After the breakaway has been achieved, the turn out torque is 8-10 ft-lbs. with the thread lock adhesive.

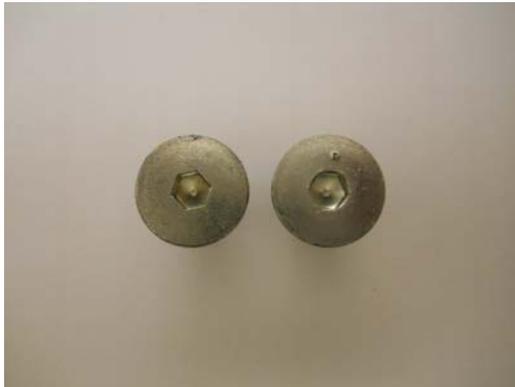
We propose putting a center punch mark on the face of the replacement screws. (Please see photos below comparing center punched bolt with existing non center punched recalled bolts; the center punched bolt is on the right)
