INSTRUCTIONS TO PERFORM CAMPAIGN 129

This campaign affects 2011 model year E30W Winnebago® Vista® and Itasca® Sunstar®.

These motor homes were manufactured June 30, 2010 through June 16, 2011.

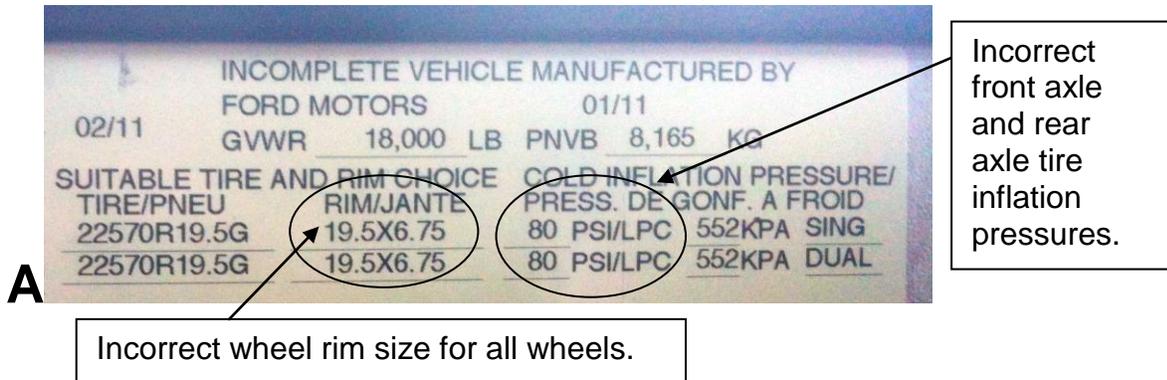
The affected vehicles were produced with a Vehicle Certification Label that incorrectly states the tire inflation pressures and wheel size. Incorrect labels will be replaced with correct ones.

The incorrect labels identify the front axle and rear axle tire inflation pressures as 80 PSI and wheel rim size as 19.5x6.75. See Photo A. The correct front axle tire inflation pressure is 95 PSI and rear axle rear axle tire inflation pressure is 100 PSI. The correct wheel rim size is 19.5x6.00 for all wheels. See Photo B.

1. Cover the existing Vehicle Certification Label below the driver's window with the corrected label included with this campaign as shown in Photo C.

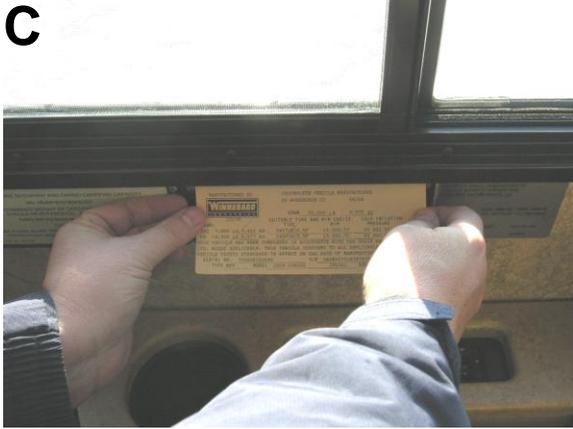
Install Label

Vehicle Certification Labels are located both below the driver's window and inside the Owner InfoCase.
