Campaign Service BULLETIN

BULLETIN NUMBER:
CB08-J-001C

SUPPLY PUMP CONNECTING PIPE FUEL LEAK SAFETY RECALL CAMPAIGN 08V-251

- 2006-2007 Isuzu N-Series
 - 2006-2007 GMC W-Series
 - 2006-2007 Chevrolet W-Series
- Equipped with 5.2L Diesel Engine and a Production Date Between June 2006 and March 2007

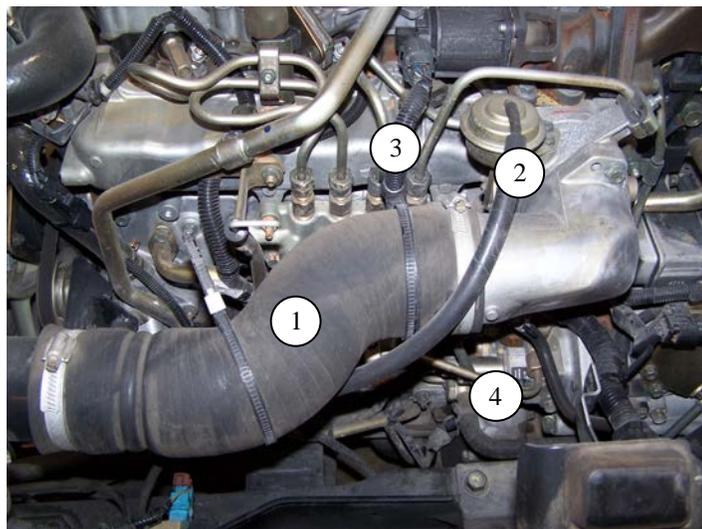
Figure 1

1. Tilt up the cab. Insert the lock pin. (**For Crew Cab Model** - Remove the driver's seat cushion and inspection panel to access the engine compartment.)
2. Remove the intake duct for access. See figure 1.

Legend:

1. Intake Hose

- 2. Throttle Valve Vacuum Hose
- 3. EGR Valve Harness
- 4. Supply Pump

- 4. If no leak is found, go to step 5. If a leak is found, replace the supply pump as outlined in the appropriate service manual. After replacing the supply pump go to “Applying the Campaign Label”.
- 5. Disconnect the Throttle Valve vacuum hose. See figure 1.
- 6. Remove shield mounting bolts and lower the shield for required clearance. See figure 3. (Three mounting bolts)

10. **For Crew Cab Model** - install the driver side inner fender panel.
11. Connect the Fuel Rail Pressure (FRP) Regulator connector.
12. Install shield.
13. Connect Throttle Valve Vacuum hose.
14. Install intake duct. Be sure to secure EGR valve harness and Throttle Valve vacuum hose into retaining clips. See figure 1.
15. Remove the lock pin and lower the cab. (**For Crew Cab Model** - Install inspection panel and secure the driver's seat cushion)

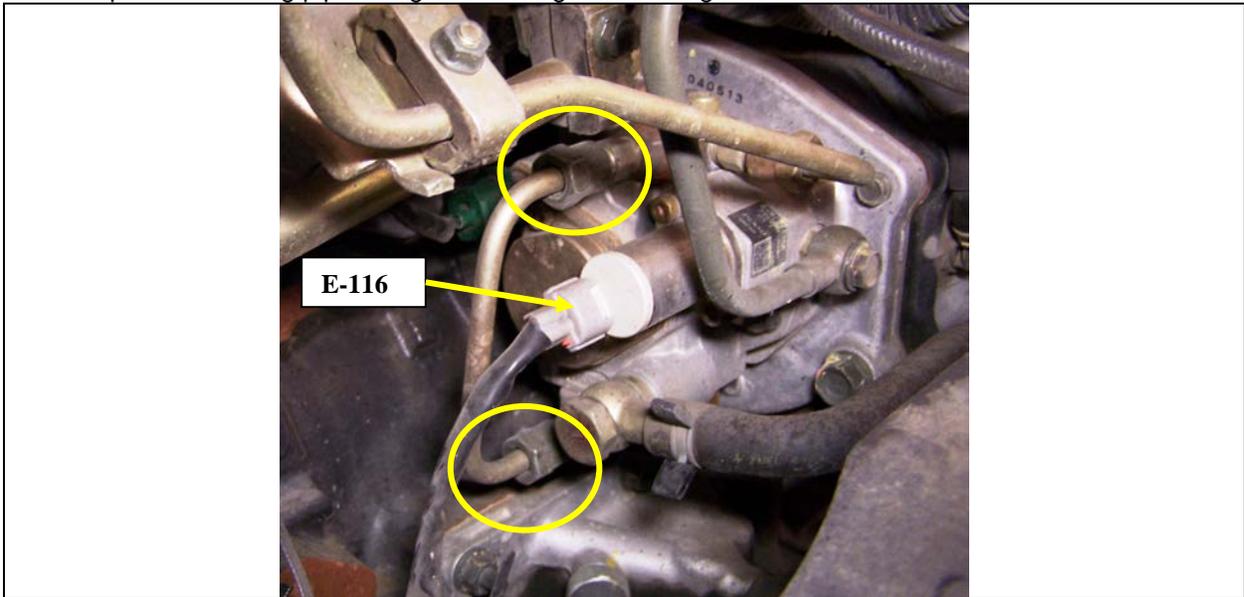
Figure 2

3. Inspect connecting pipe fittings for leaking fuel. See figure 2

- 7. Disconnect the Fuel Rail Pressure (FRP) Regulator connector E-116. See figure 2.
- 8. **For Crew Cab Model** - Remove the driver side inner fender panel. See figure 4.
- 9. Using the special tool 3300FN pipe socket (SnapOn FRXM 17 or an equivalent), tighten both connecting pipe fittings to 22 lb-ft (30Nm). The torque wrench operation angle should not be greater than 30 degrees. If the operation angle of the special tool is too wide, the tool may interfere with and scratch the pipe. To prevent accidental scratches, apply vinyl tape to the tool. Repeat tightening, alternating sides, until reaching the specified torque.

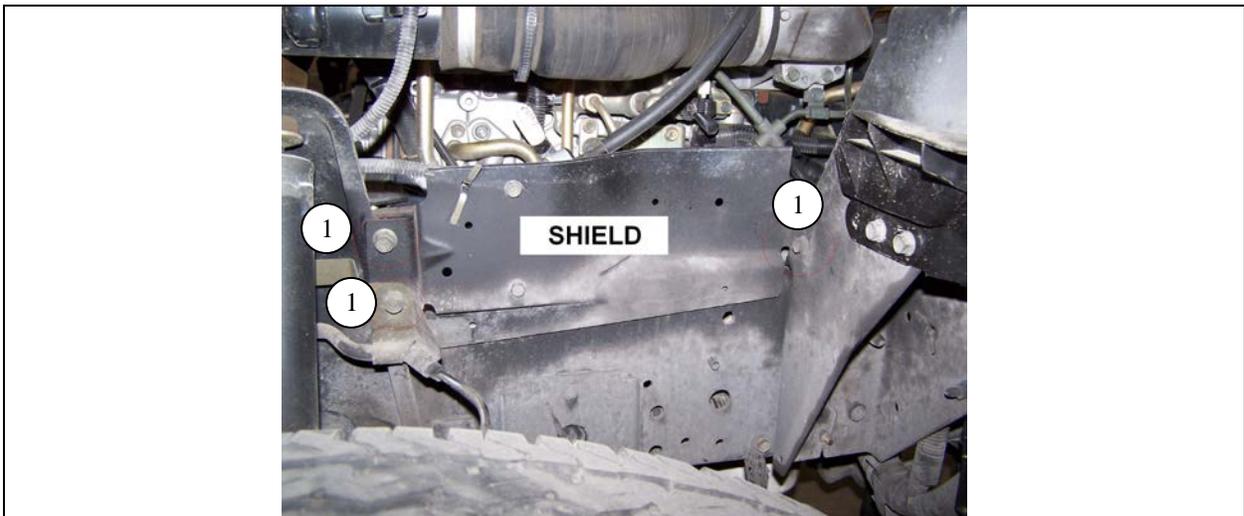
Figure3

Legend:

- 1. 1. Mounting Bolt
