Safety Defect and Noncompliance Report Guide for Vehicles

PART 573 Defect and Noncompliance Report

This report serves as Terex Corporation's notification to the U.S. Department of Transportation, National Highway Traffic Safety Administration that a defect related to motor vehicle safety exists in certain Front Discharge Concrete Trucks. Terex Corporation decided that this defect existed in these vehicles October 2<sup>nd</sup>, 2013.

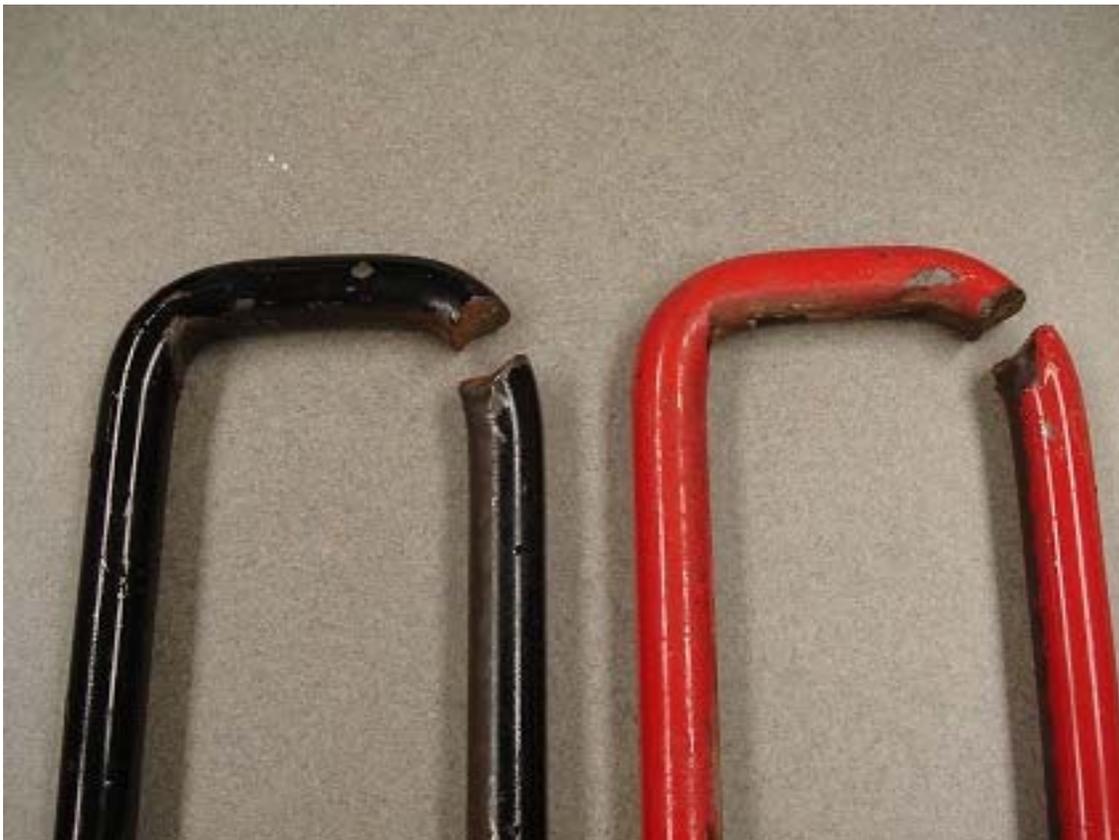
The u-bolt that attaches the front axle to the leaf spring can fracture in the upper radius of the bolt.

1. There is a high stress concentration area on the inner radius of the u-bolt. The mating top plate also has a sharp edge that is in contact with the area of high stress concentration on the u-bolt. Under load, the compounding stress concentrations can cause a fracture to originate in this area.
2. It was found that the assembly procedure for the u-bolts allowed for over-tightening to occur. This over-tightening, coupled with the stress concentrations from Item 1, could cause complete fracture at the point of assembly, or delayed fracture during service.

The remedy was to go back to a variation of a previous design that uses straight studs that do not have the stress concentrations inherent to the u-bolts. The previous straight stud design has been in service for decades without known incident.

The remedy assembly contains four straight double ended studs with a flat top plate with four holes in place of two u-bolts and a notched top plate per side.
