Sure Power Battery Equalizer **RECALL**

Models Affected: 2004 Ultra LMB (L3RE), 2003-2006 Ultra LF (L4RE), 2004-2007 Express (M4RE)

RECALL CAMPAIGN R13WN

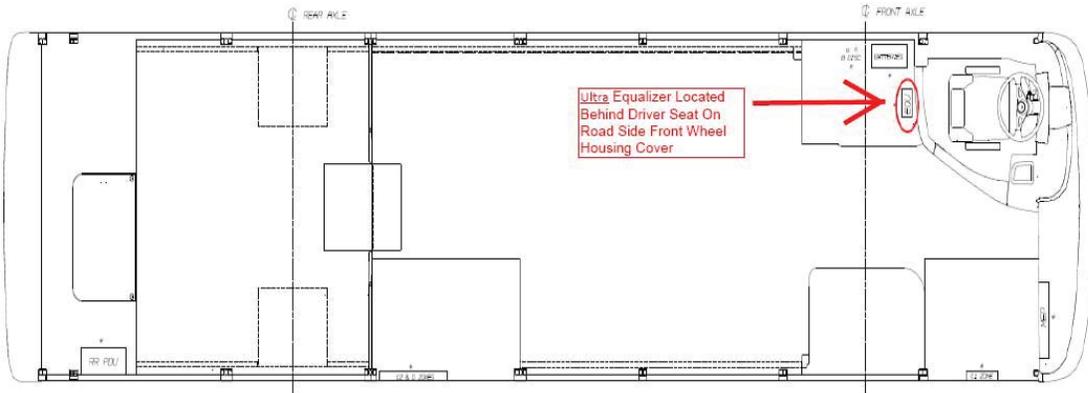
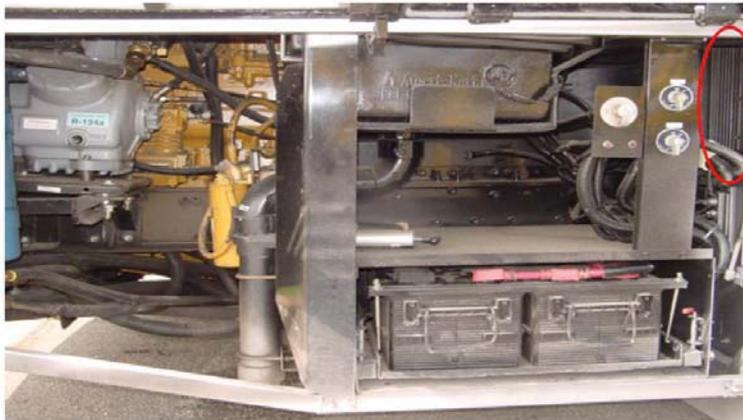
There is only one label location on the product as shown in the picture below, with the serial number in the white section on the end opposite the terminals:

3. Locate the Sure Power battery equalizer. See detail views on page 2 for location by product type.
4. The battery equalizer must be inspected and the serial number, date inspected and body number or vehicle identification number recorded on the attached Recall R13WN Inspection Reply Sheet.
