# SAFETY RECALL ALERT

**Bulletin:** SRA-M13-05  
**Date:** December 5, 2013  
**Action Required?** **YES**

**Subject:** Safety Recall, SC0373, L9 Seat Belt Buckles (Revised to correct part numbers on pg 2)

# L9 SEAT BELT BUCKLE INSPECTION GUIDE

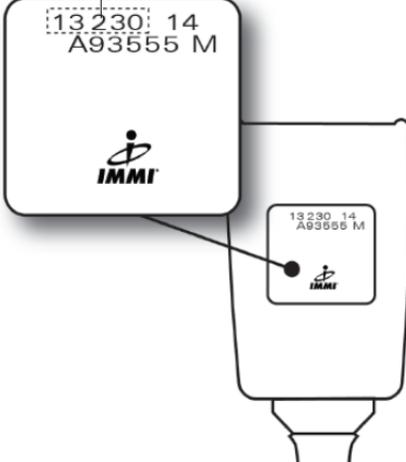
**SALTILLO MEXICO**

Suspect code range is  
**13220 through 13256**

YEAR	DAY
13	230

- 5) If your buckle code is within either of the ranges above, replace your buckle with the substitute buckle.
- 6) If your code does **NOT** fall within either range, you do **NOT** need to replace your buckle.

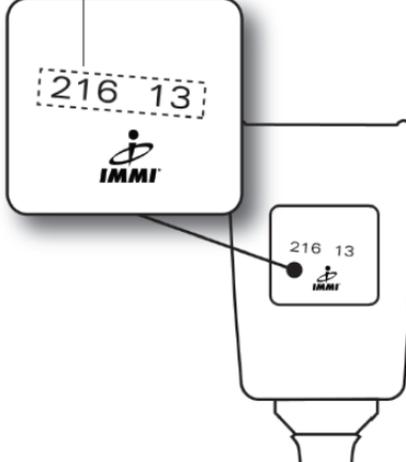
**WESTFIELD, IN US**

Suspect code range is  
**214 13 through 256 13**

DAY	YEAR
216	13
