VILLA INTERNATIONAL  
RECALL REPAIR 14E-015

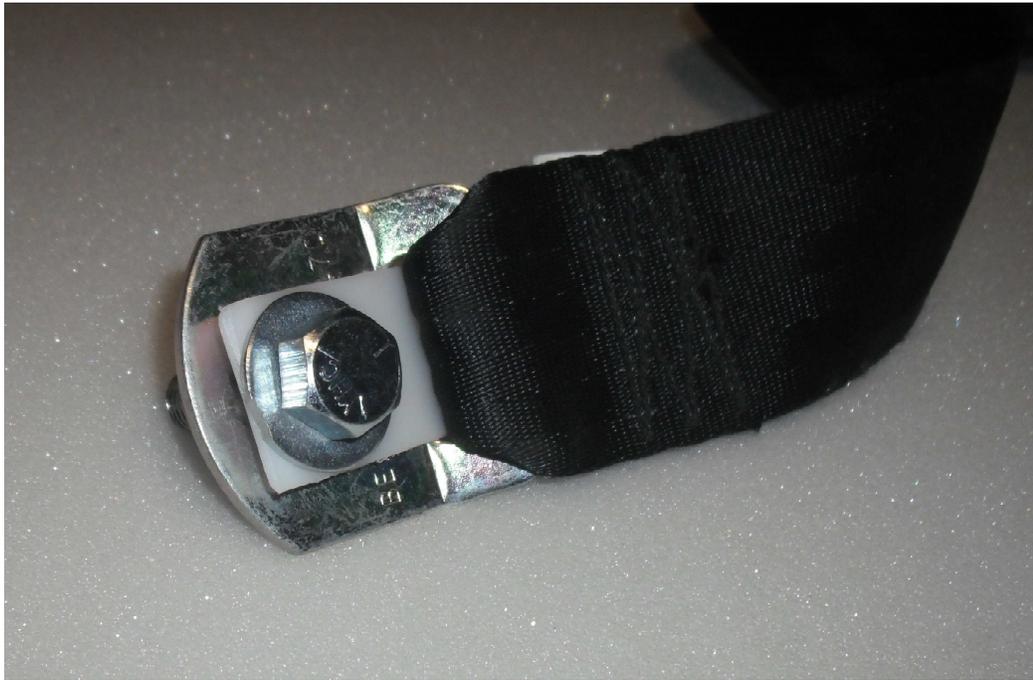
BELT GUARD INSTALLATION  
INTO SEAT BELT BRACKET

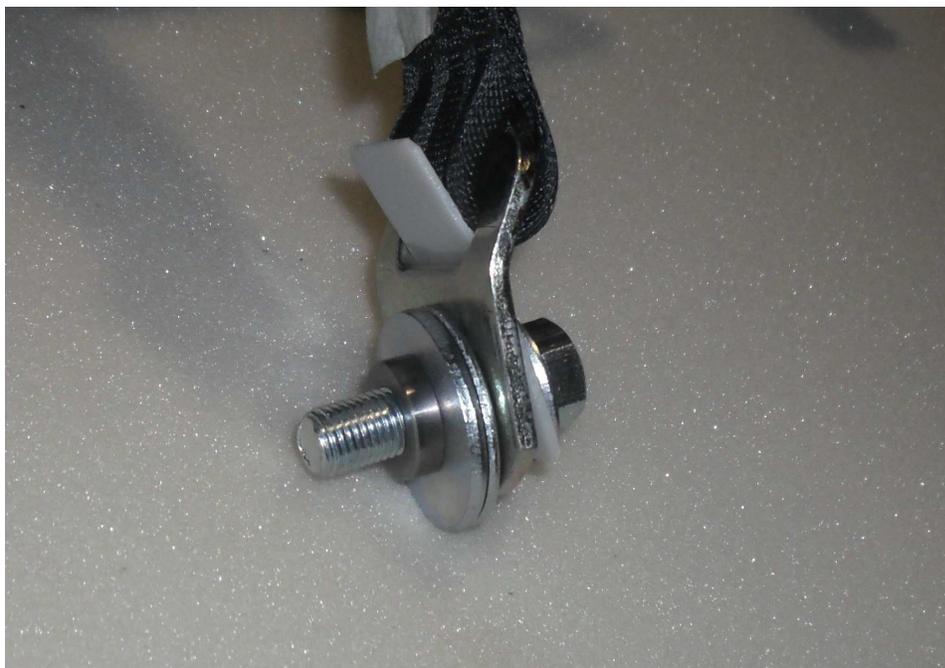
REPAIR FASTENERS & SEAT BELT BRACKET LOCATION  
FROM KIT 14E-015

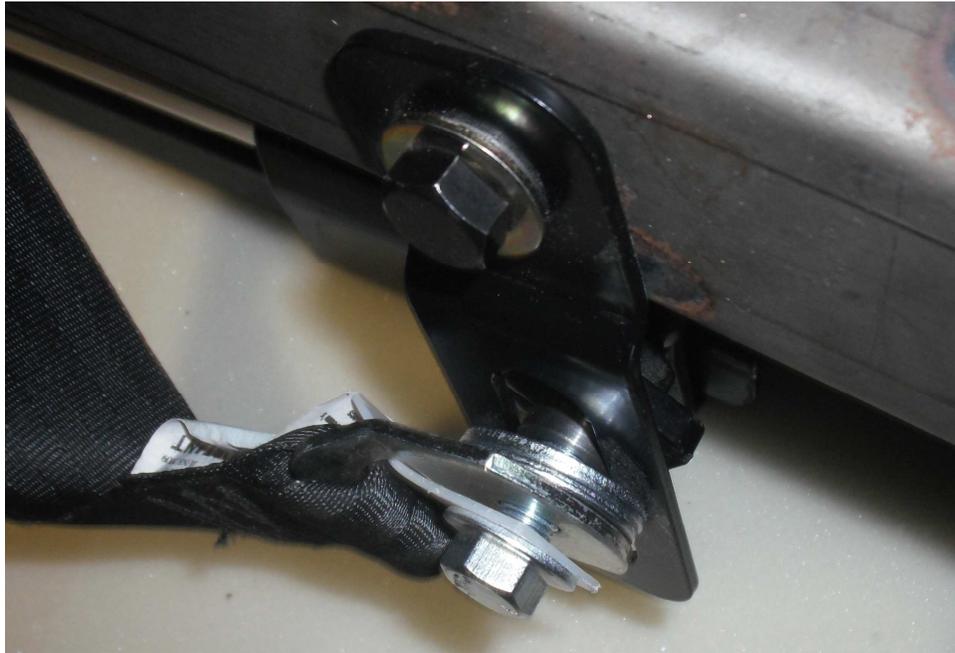
**FASTENERS & BELT BRACKET ASSEMBLY INTO ISS LINK**

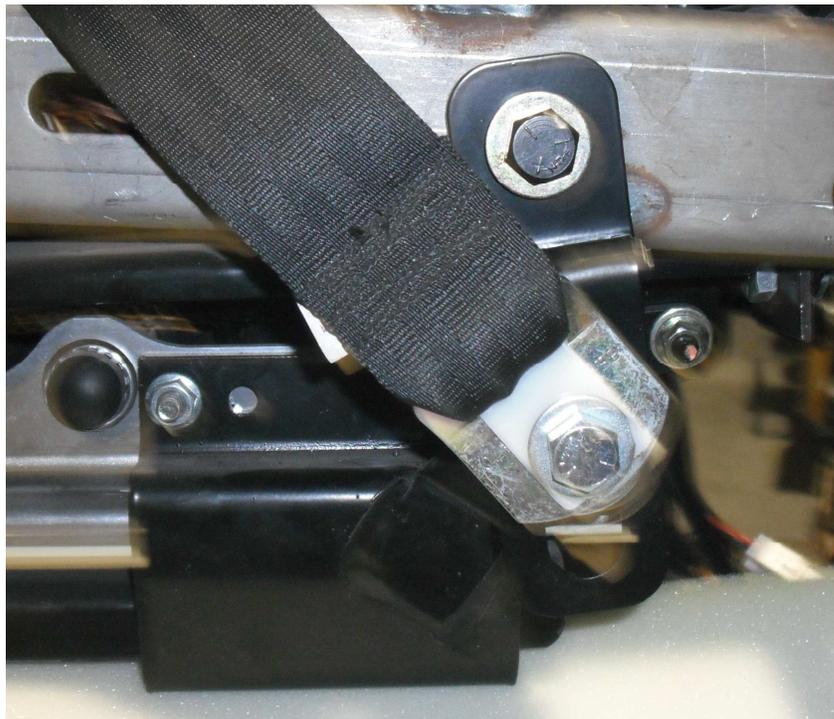
**COMPLETED REPAIR  
TIGHTEN BOLT TO 20 ft-lb**
