TECHNICAL INSTRUCTIONS
FOR
SPECIAL SERVICE CAMPAIGN E0R
2nd ROW PASSENGER SEAT FRAME LATCH INSPECTION
CERTAIN
2014 MODEL YEAR HIGHLANDER

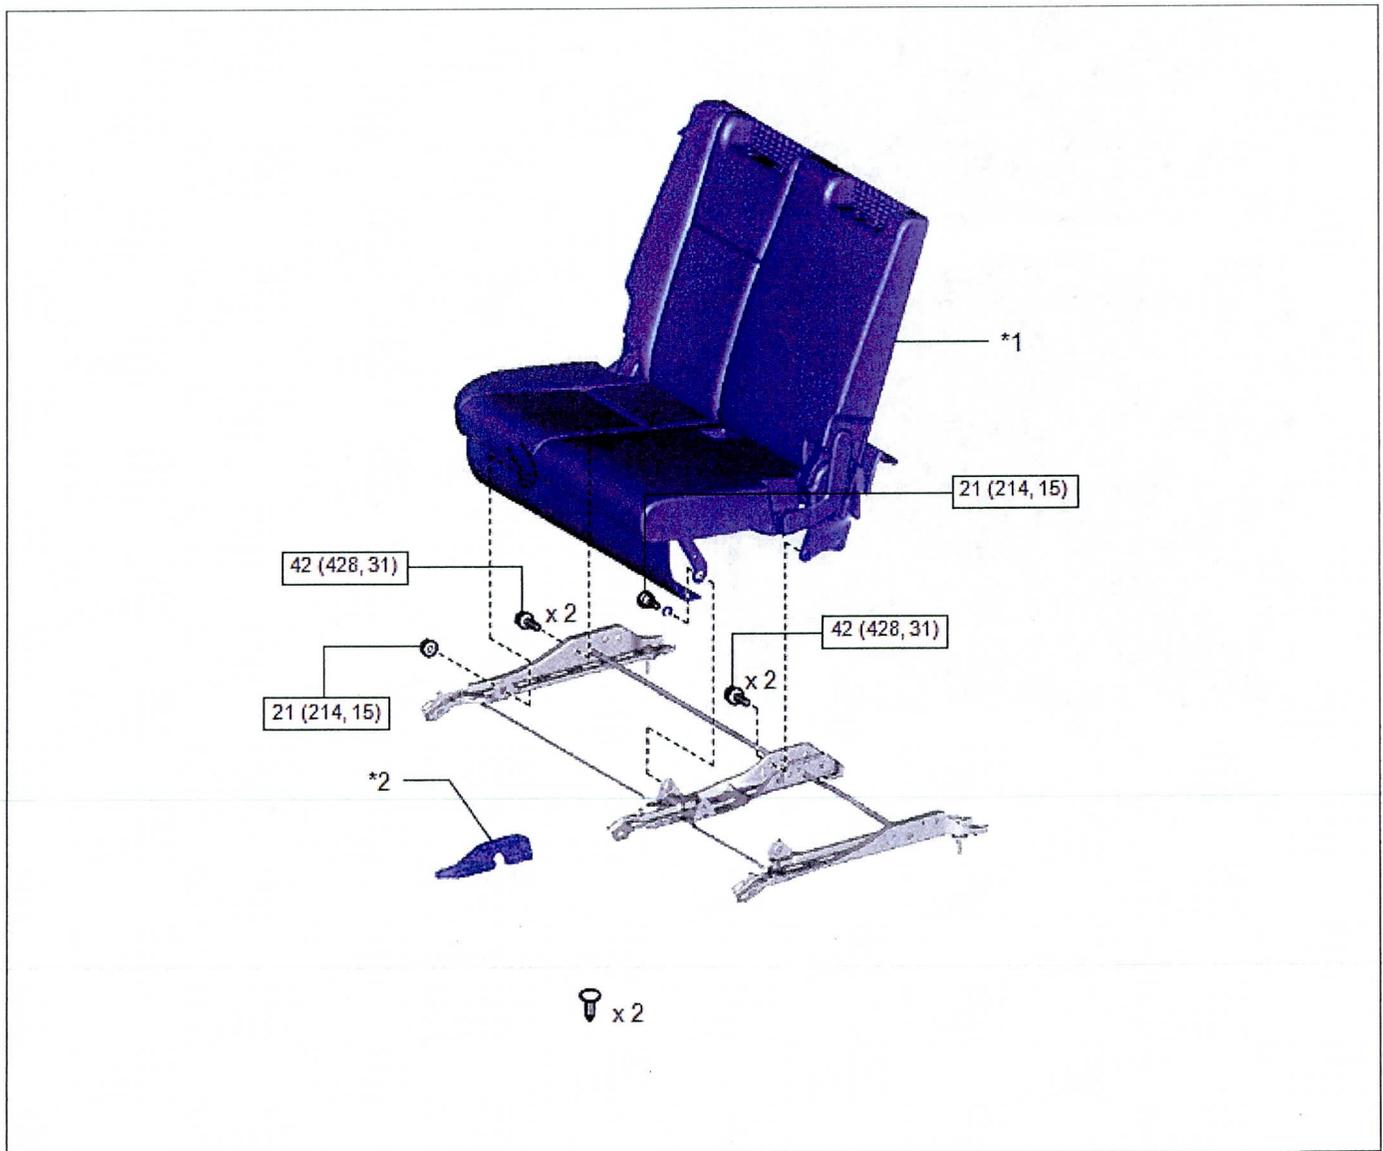
In certain 2014 Model Year Highlanders, equipped with a 60/40 split second row seating configuration, the passenger side second row seat may not fully lock into the inboard seat track when the seat is adjusted forward to the first, second, or third adjusting positions. A seat in this condition does not conform to FMVSS No. 207 "Seating Systems". Under some conditions, this could increase the risk of injury to occupants in the event of a crash.

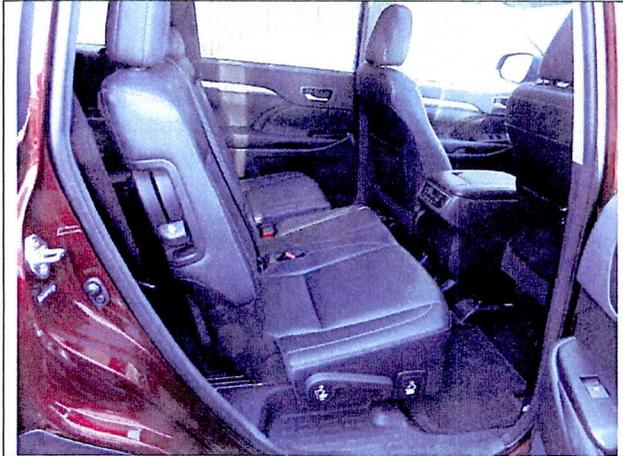
- a) Park the vehicle as follows:
 - Level paved ground
 - Engine off
- b) Slide the front passenger seat fully forward.

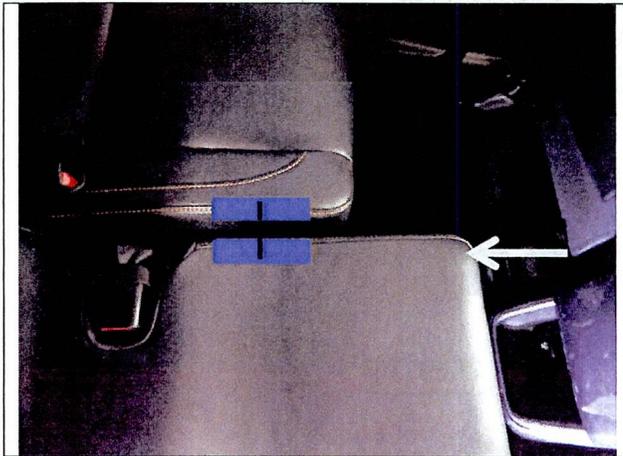
- a) Fully lift the for-aft adjustment bar.
- b) Slide the seat all the way forward.
- c) Release the adjustment bar.
- d) Slide seat to the rear until the seat latches in the number 1 (full forward) position.
- e) Slide the driver's side 2nd row seat fully rearward.

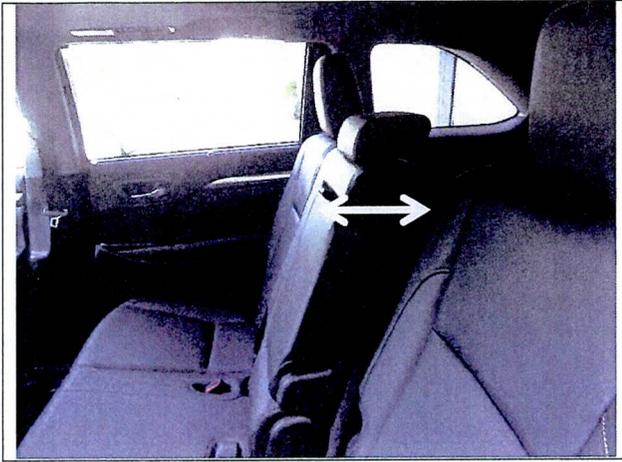
- f) Place a 2 to 4 inch long strip of tape on the edge of the left and right seat as shown.
- g) Place a light pencil mark across the 2 pieces of tape.

- h) From the right rear door. Using the tape or pencil mark as a reference, push the lower right seat cushion at the inner corner towards the rear until the seat latches.
- i) If the front inner corner of the right seat **MOVES** proceed to step 3.

If the front inner corner of the right seat **DOES NOT MOVE** proceed to step 4.

- a) From the left rear door. Move the seat forward and back by the backrest to verify if the seat will lock into position.
- b) Seat locks into position proceed to step 4.
- c) Seat **does not lock** into position. The seat frame/latch is not operating properly hold vehicle for seat replacement.
