TECHNICAL INSTRUCTIONS

SAFETY RECALL D3F

FRONT PASSENGER AIRBAG INFLATOR MODULE

CERTAIN 2003 – CERTAIN 2004 MODEL YEAR COROLLA

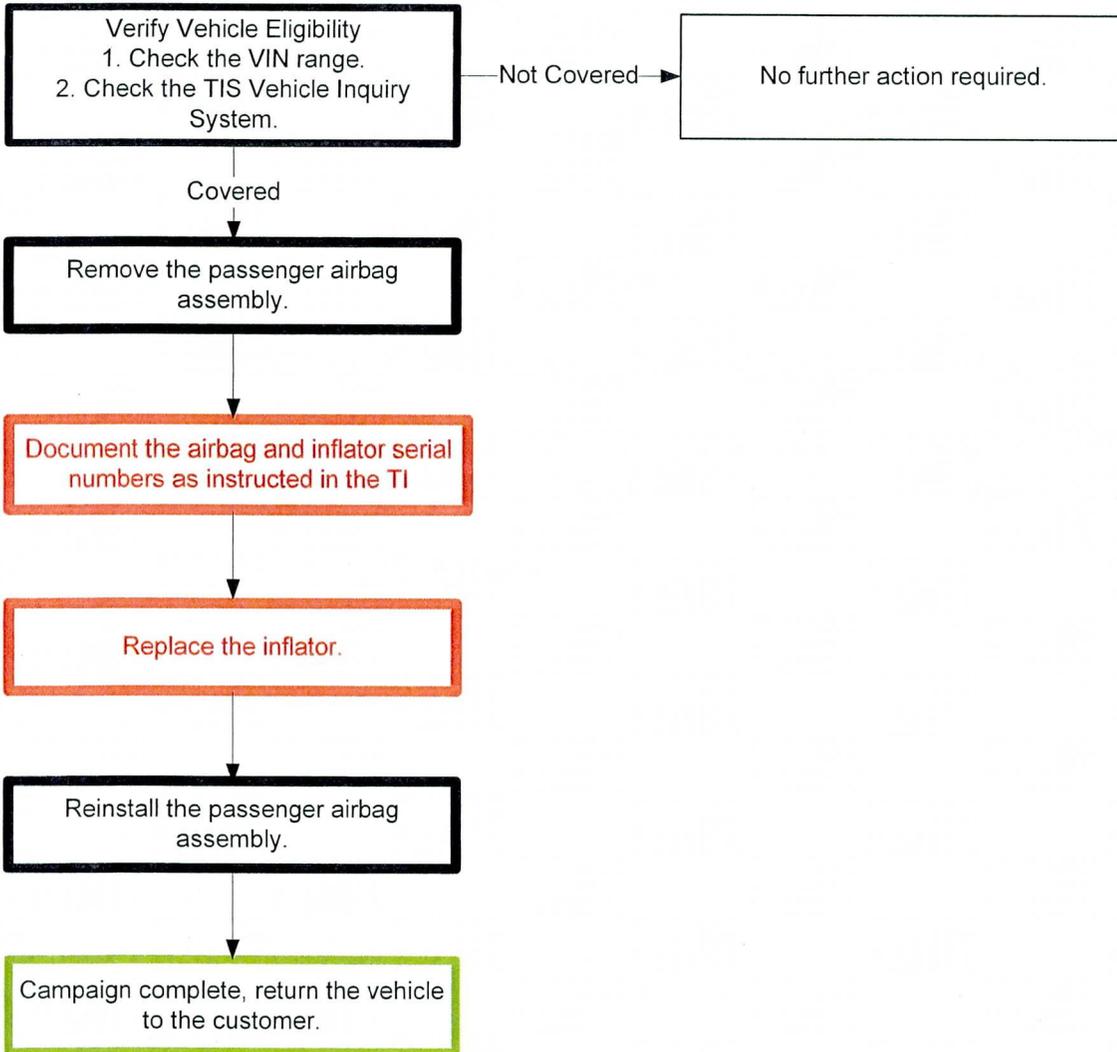
I. OPERATION FLOW CHART

The flow chart is for reference only. **DO NOT** use it in place of the full technical instructions. Follow **ALL** steps as outlined in the full technical instructions to confirm the campaign is completed correctly.

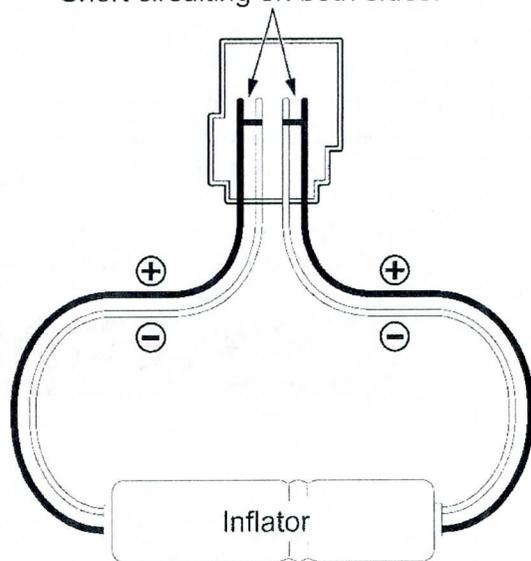
(1)

The connector of the inflator module contains a short circuiting mechanism to eliminate voltage variances when the connector(1) is disconnected. To allow for the replacement of the inflator module, a new short circuit(2) **MUST** be created before cutting the wires(3) and removing the inflator. The following steps **MUST** be followed exactly as described to ensure the work is completed correctly and safely.

Short circuiting on both sides.

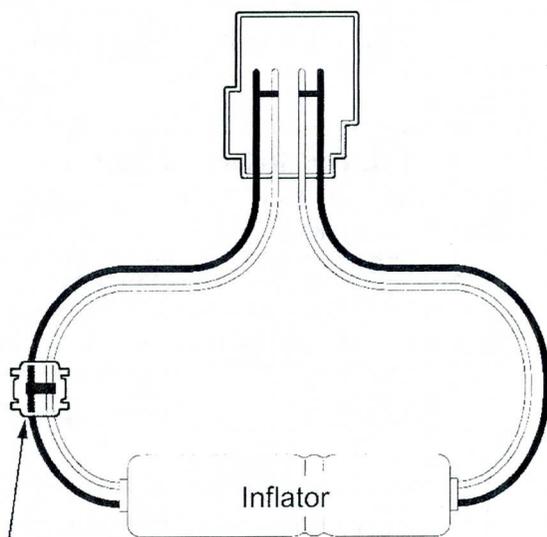
(2)

Create new short circuit using electro tap.

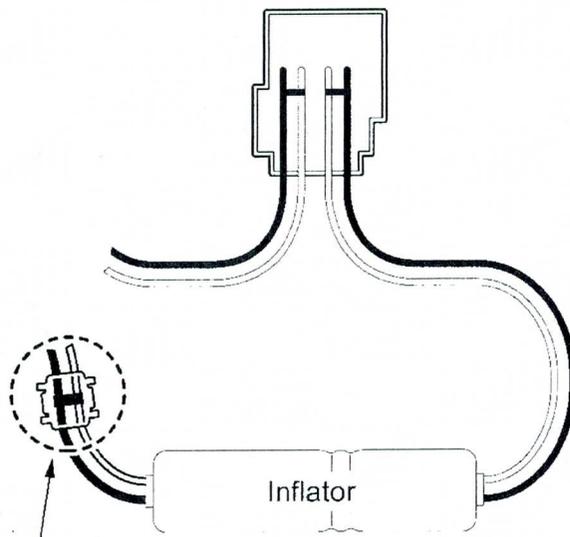
(3)

Short circuiting is maintained even after cutting harness.

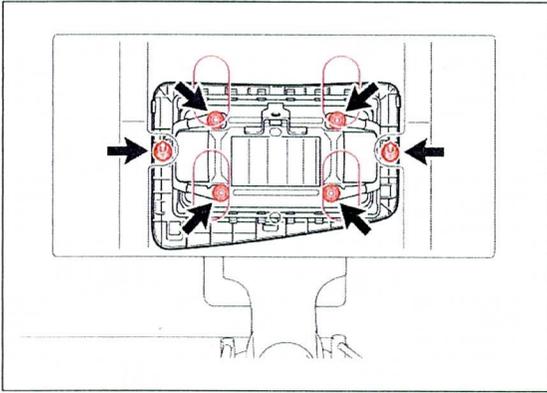
1. MOUNT THE AIRBAG IN THE MOUNTING BRACKET

- a) Position the two mounting studs on the airbag assembly into the holes on the bracket support bars.
- b) Install the airbag to the support bars with the nuts supplied in the bracket kit.
- c) Position the airbag so that all four stopper plate nuts can be removed through the access holes.
- d) Tighten the nuts holding the support bars to the mounting bracket.
- e) Confirm the following:
 - Mounting bracket is secure in the vise.
 - Airbag is secure in the support bars.
 - The center mounting bracket on the airbag assembly is facing upward.
 - Support bars are secure on the mounting bracket using 1 bolt/nut at the top of each support bar and 2 nuts/bolts at the bottom of each support bar.

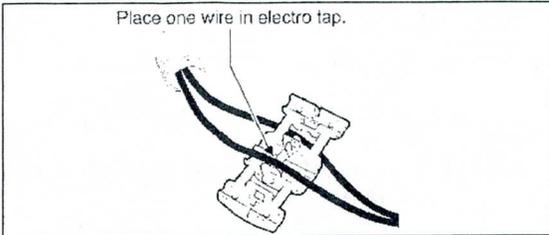
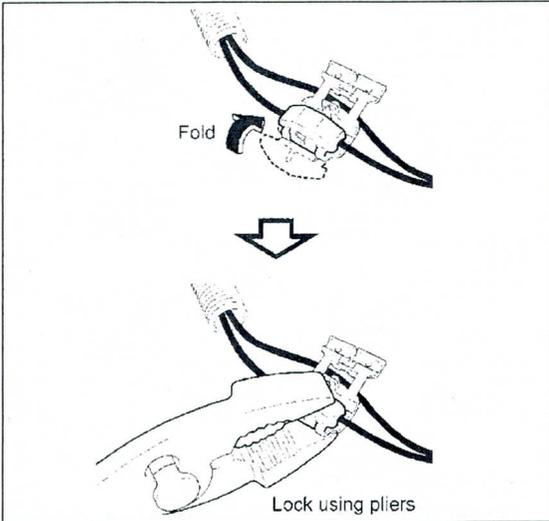
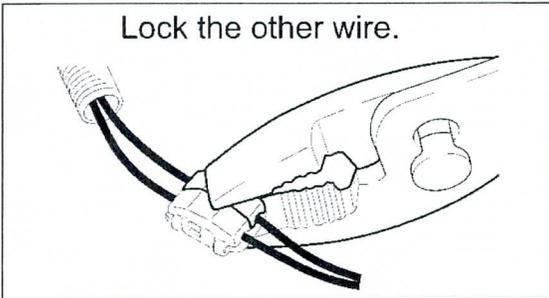
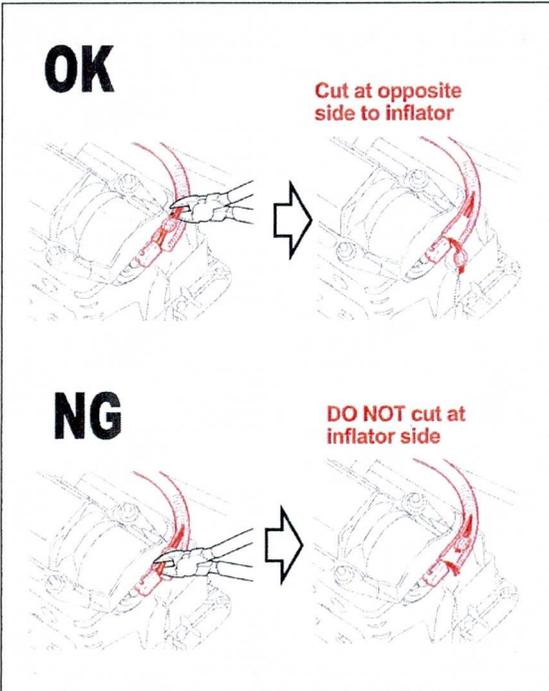
3. CREATE A NEW SHORT CIRCUIT IN THE INFLATOR HARNESS

a) Place one wire in the electro tap as shown in the illustration.

b) Fold and pinch the half of the electro tap with the wire and use pliers to lock the electro tap.

c) Set the other wire in the electro tap and lock it in place using pliers.

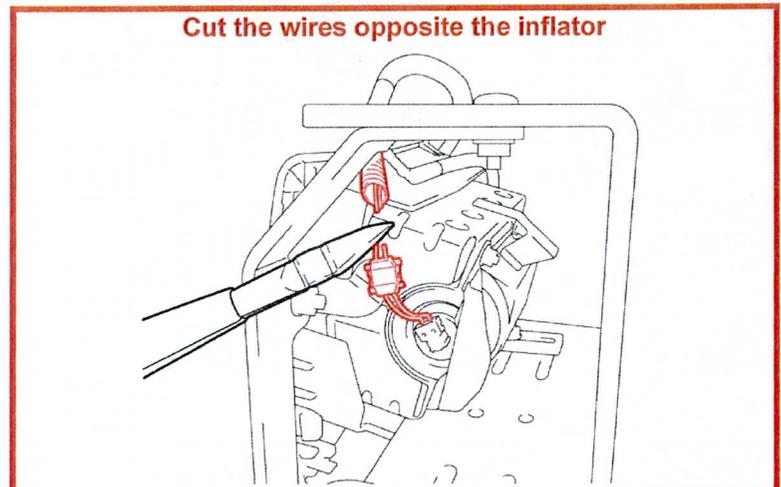
4. CUT THE INFLATOR WIRES

a) Cut the 2 wires at the side of the electro tap that is farthest away from the inflator.

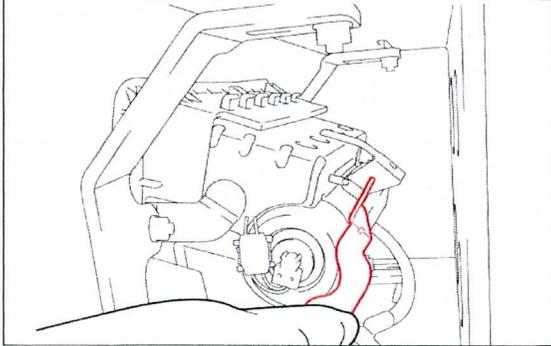
5. REMOVE THE SELF LOCKING NUTS

- a) Use the access holes in the bracket to remove the 4 nuts.

- **DO NOT** use power tools.
- The bracket support bars may need to be repositioned to remove the nuts through the access holes.

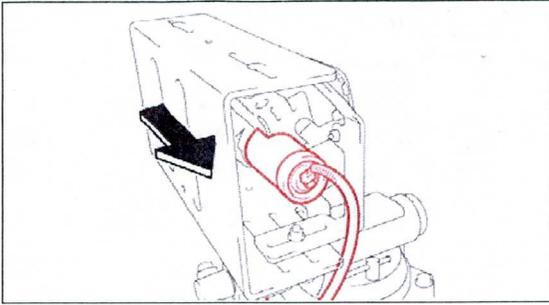
6. REMOVE THE INFLATOR

- a) Gently push in the 4 studs to loosen the inflator for removal.

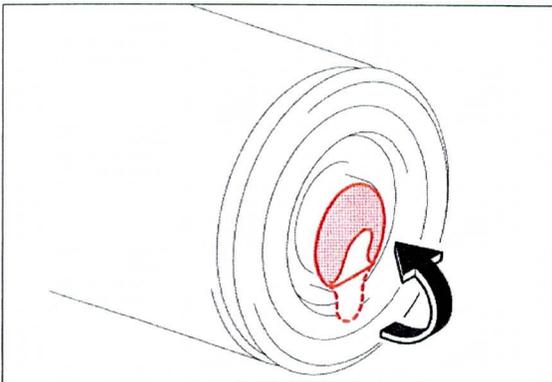
10. FOLD THE CONNECTOR SEAL

- a) Fold the seal in order to prevent it from being caught under the position determining plate in the next step.

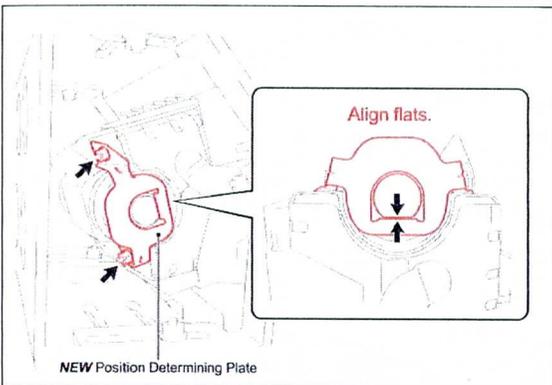
11. INSTALL THE **NEW** POSITION DETERMINING PLATE

- a) Place the **NEW** position determining plate on the airbag assembly on the side with the connector seal.
b) Install **NEW** nuts by hand.

- Confirm the flats on the position determining plate and inflator are aligned.
- **DO NOT** pinch the harness between the inflator and the plate.

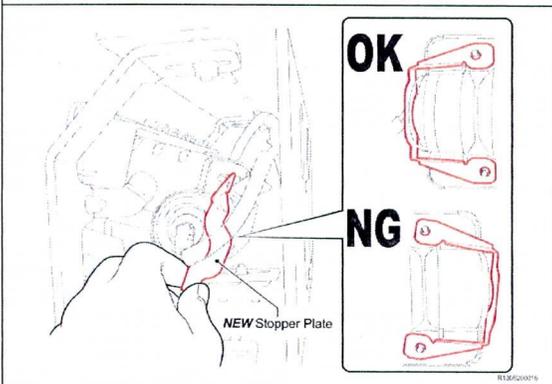
12. LOOSELY INSTALL A NEW STOPPER PLATE.

- a) Place the **NEW** stopper plate on the airbag assembly on the side where the harness is already connected.
b) Confirm the end of the inflator sits flat against the stopper plate. If they do not align the inflator is installed backward.
c) Install **NEW** stopper plate nuts by hand. They will be torqued on a later step.

- Confirm the stopper plate to inflator fitment is correct.
- **DO NOT** pinch the harness between the inflator and the stopper plate.
