IMPORTANT UPDATE

**TECHNICAL INSTRUCTIONS
FOR
SAFETY RECALL D3C
FRONT PASSENGER AIRBAG INFLATOR MODULE
CERTAIN 2002 – 2003 & 1 (one) 2004 MODEL YEAR SC430**

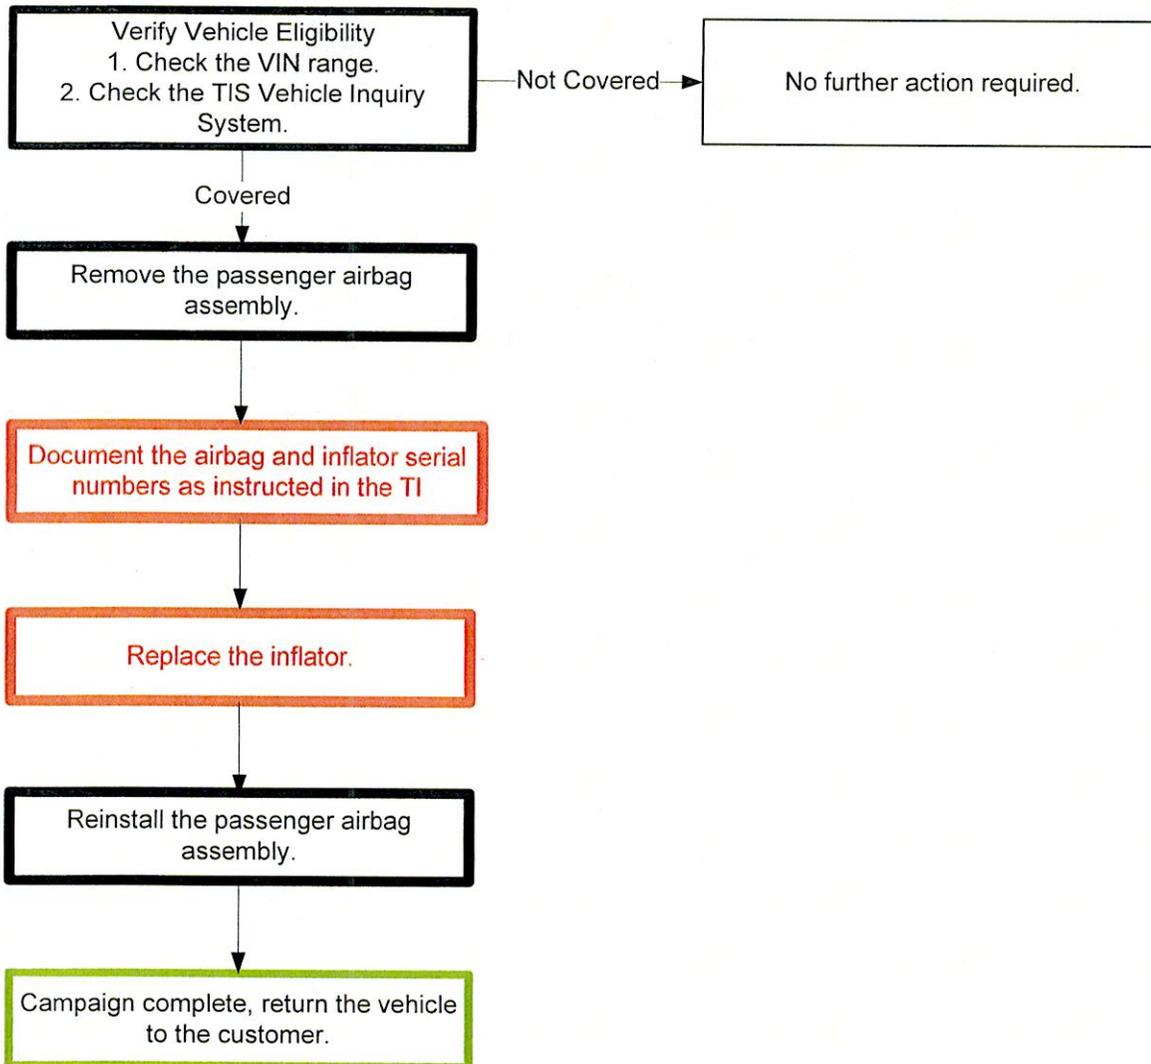
I. OPERATION FLOW CHART

The flow chart is for reference only. **DO NOT** use it in place of the full technical instructions. Follow **ALL** steps as outlined in the full technical instructions to confirm the campaign is completed correctly.

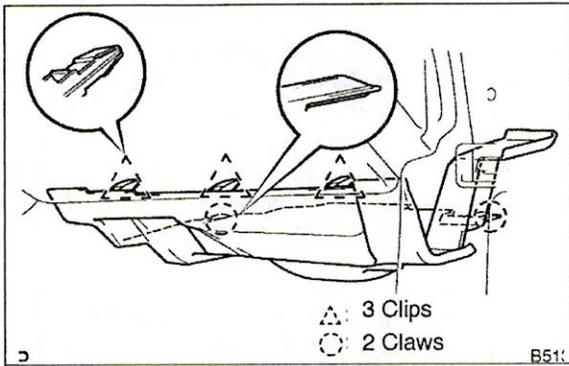
4. REMOVE THE GLOVE BOX

- a) Disengage the 3 clips and 2 claws and lower the panel under cover.
- b) Disconnect the connectors and remove the cover.

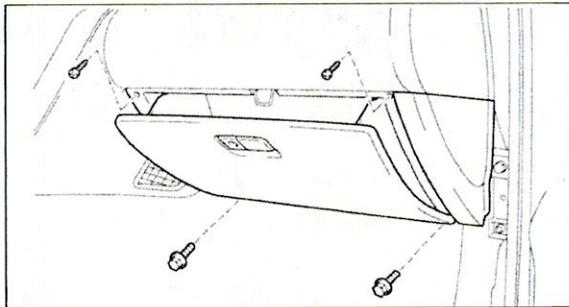
- c) Remove the 2 bolts and 2 screws and lower the glove box.
- d) Disconnect the connectors and remove the glove box.

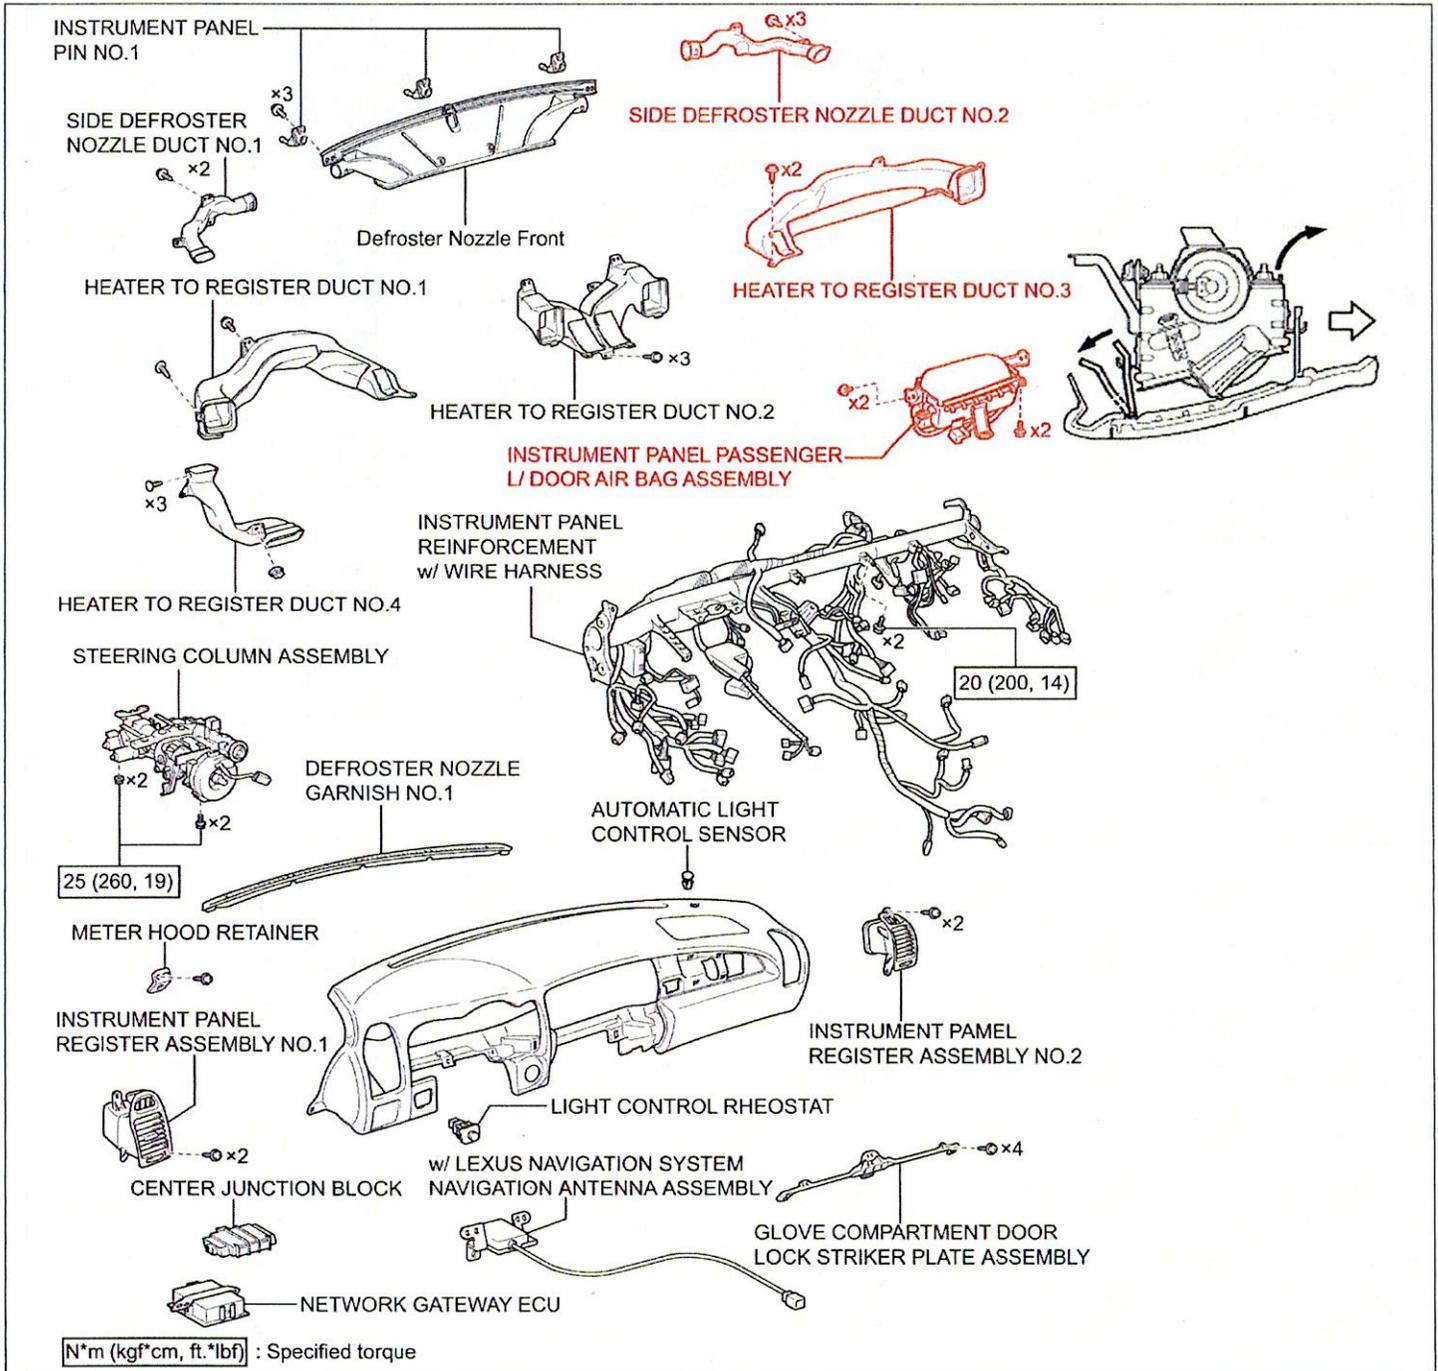
2. REMOVE THE AIRBAG FROM THE INSTRUMENT PANEL

- a) Remove the 3 screws and the side defroster nozzle.
- b) Remove the 2 screws and the heater to register duct.
- c) Remove the 4 bolts, disengage the straps, then remove the airbag assembly.

NOTE: Only remove the components highlighted in red, there is NO NEED to remove any other components.

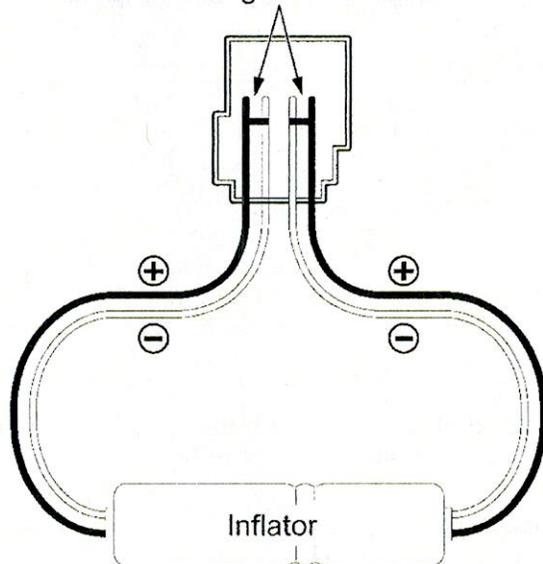
(1)

The connector of the inflator module contains a short circuiting mechanism to eliminate voltage variances when the connector(1) is disconnected. To allow for the replacement of the inflator module, a new short circuit(2) *MUST* be created before cutting the wires(3) and removing the inflator. The following steps *MUST* be followed exactly as described to ensure the work is completed correctly and safely.

Short circuiting on both sides.

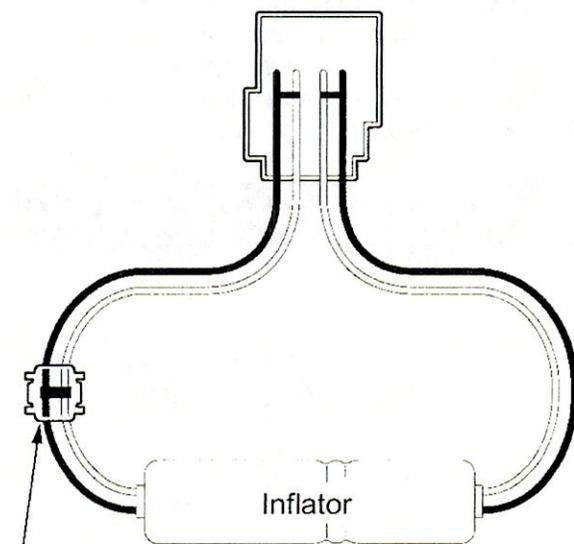
(2)

Create new short circuit using electro tap.

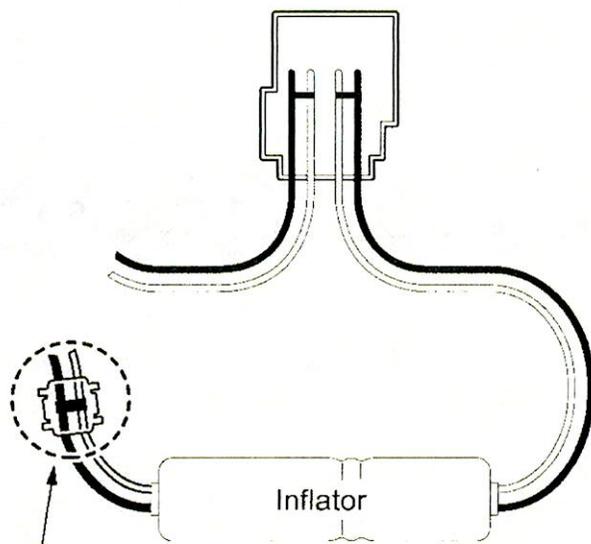
(3)

Short circuiting is maintained even after cutting harness.

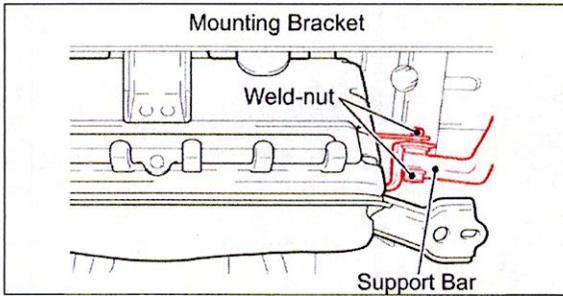
1. MOUNT THE AIRBAG IN THE MOUNTING BRACKET

a) Position the airbag so that the airbag weld-nuts are between the support bars and mounting bracket and install the bolts.

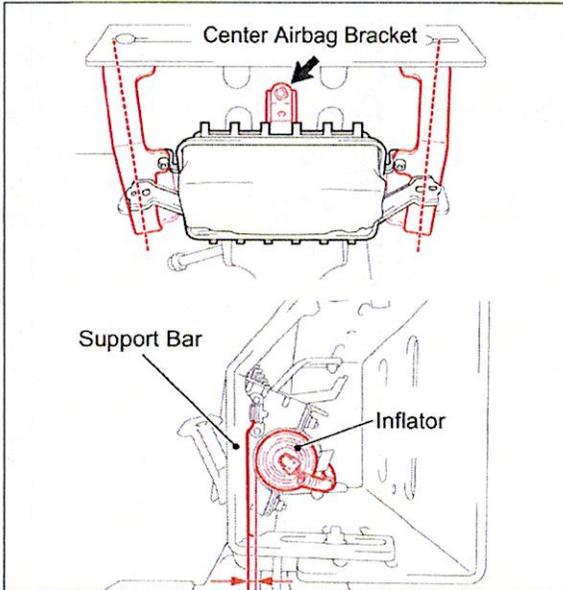
b) Position the support bars at an angle as shown in the illustration.

c) Confirm the center airbag bracket is facing up.

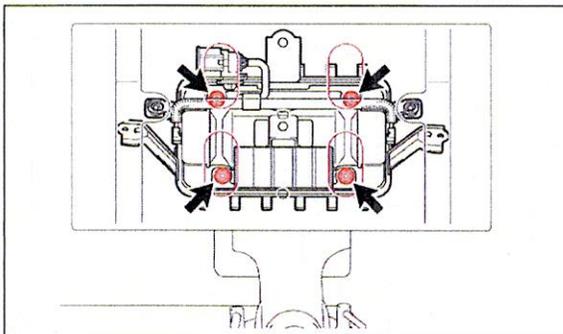
NOTE: The position of the support bars is critical to create clearance for the removal of the inflator.

d) Position the airbag so that all four nuts can be removed through the access holes.

e) Tighten the nuts holding the support bars to the mounting bracket.

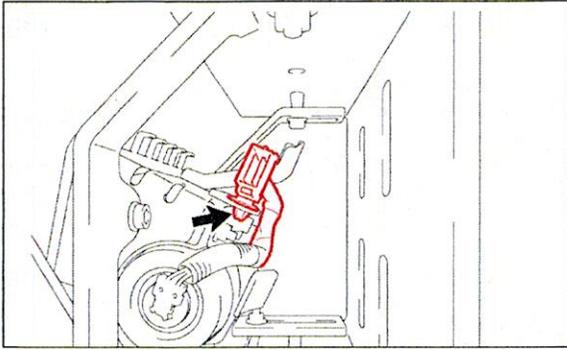
2. PREPARE TO INSTALL THE SHORT CIRCUIT

- a) Disengage the harness clamp.

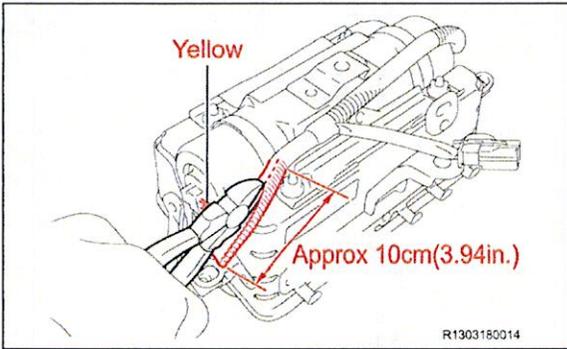
- b) Cut the yellow corrugated tube on the harness approximately 4 inches (10 cm) using nippers.

- **DO NOT** damage the wires in the tube.
- **DO NOT** use a knife or razor blade to cut the tube to avoid damaging the wires.
- This may be performed on either end of the inflator.

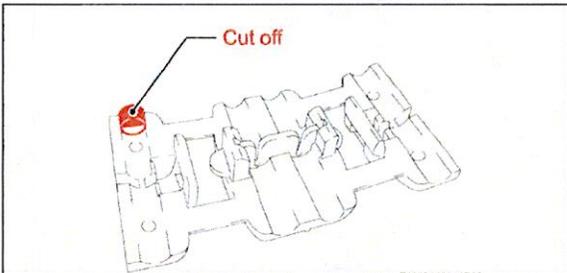
- c) Cut off the tab of the electro tap shown in the illustration.
- NOTE: The electro tap is included in the inflator parts kit.**

STOP This tab **MUST** be removed to ensure a good short.

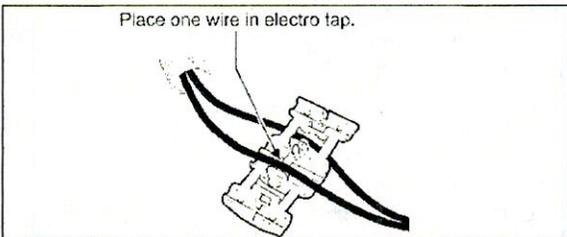
3. CREATE A NEW SHORT CIRCUIT IN THE INFLATOR HARNESS

- a) Place one wire in the electro tap as shown in the illustration.

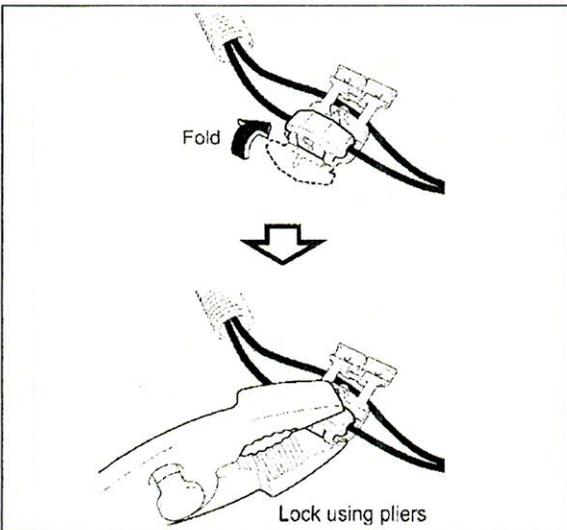
- b) Fold and pinch the half of the electro tap with the wire and use pliers to lock the electro tap.

- **DO NOT** work on both wires at the same time to avoid errors.
- Pliers **MUST** be used to confirm the electro tap is firmly locked in place.

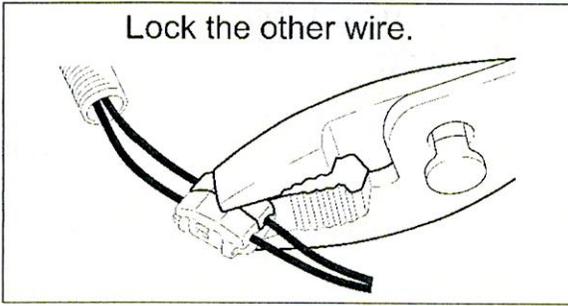
- c) Set the other wire in the electro tap and lock it in place using pliers.

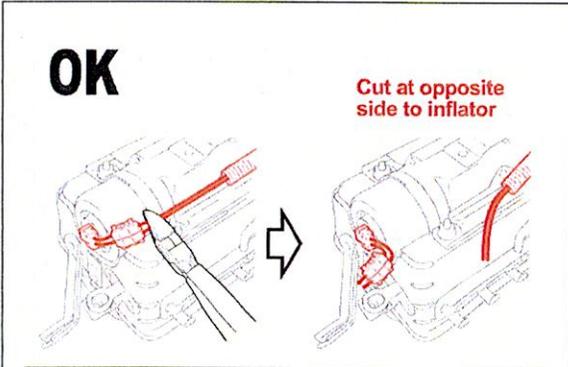
4. CUT THE INFLATOR WIRES

- a) Cut the 2 wires at the side of the electro tap that is farthest away from the inflator.

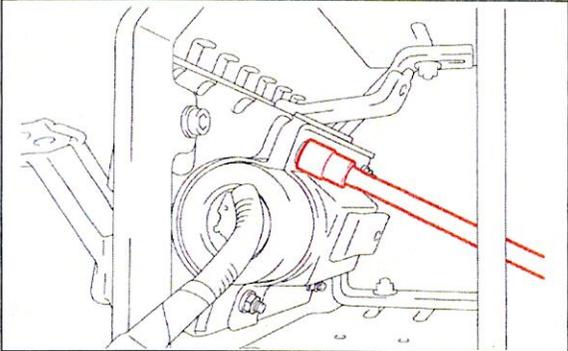
5. LOOSEN THE SELF LOCKING NUTS

- a) Use the access holes in the bracket to loosen the 4 nuts.

- *DO NOT* use power tools.
- *DO NOT* remove the nuts or the bag may fall out of the airbag assembly.

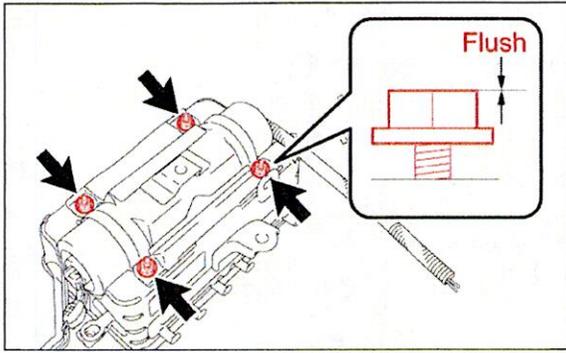
- b) Loosen the nuts until they are flush with the studs.
 - c) Use a marker to mark the nuts as they are not to be reused.
- NOTE: DO NOT reuse the old nuts, new nuts *MUST* be used.**

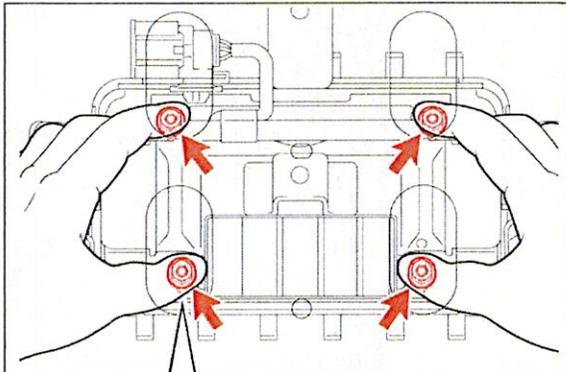
6. REMOVE THE INFLATOR

- a) Gently push in the 4 studs until the nuts contact the airbag case to allow for inflator removal.

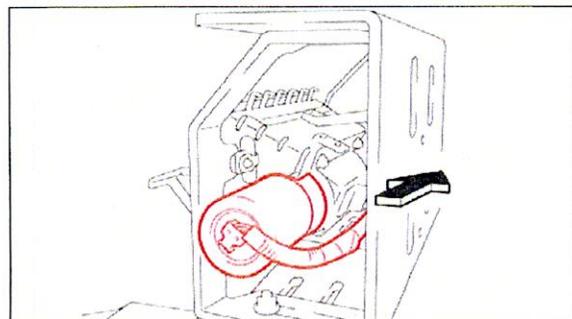
8. INSTALL THE NEW INFLATOR

- Carefully slide the new inflator into the airbag assembly.

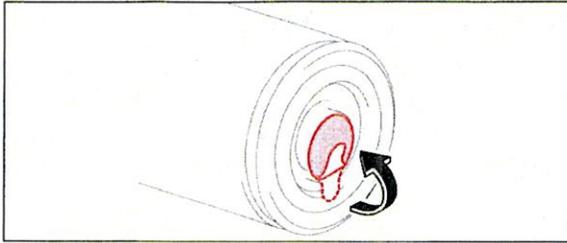
9. FOLD THE CONNECTOR SEAL

- a) Fold the seal in order to prevent it from being caught under the position determining plate in the next step.

NOTE: DO NOT fully remove the seal until just before connecting the harness.

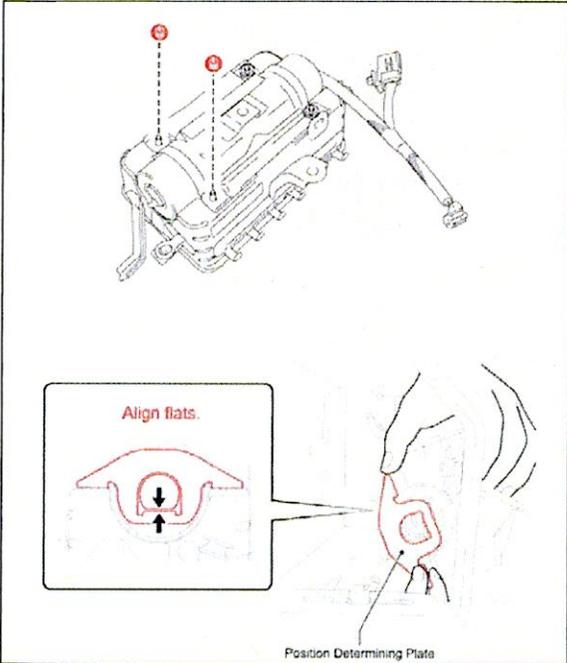
10. INSTALL THE NEW SELF LOCKING NUTS AND POSITION DETERMINING PLATE

- a) Remove the 2 old nuts.
- b) Install the position determining plate and install the 2 **NEW** nuts by hand. They will be torqued on a later step.

STOP The position determining plate can only be installed on one side in one position, confirm the plate is aligned correctly.

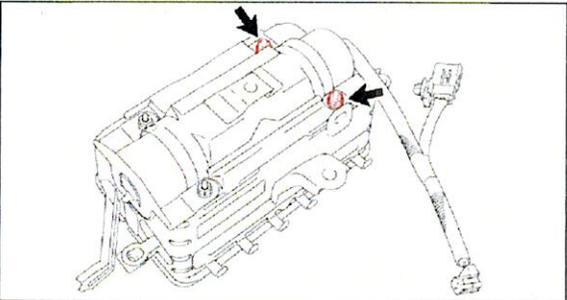
- c) Remove the 2 old nuts.
- d) Install the 2 **NEW** nuts by hand. They will be torqued on the next step.

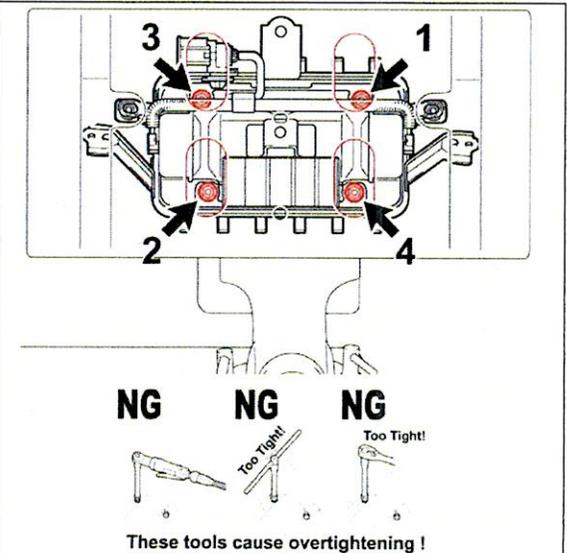
11. TORQUE THE NUTS

- a) Push the inflator so that it contacts the position determining plate.
- b) Tighten the nuts evenly in two increments following the sequence shown in the illustration. Use a socket driver or torque wrench to tighten the nuts.

Torque: 35in. lbf (3.9N·m)

- If the inflator is not positioned correctly in the position determining plate the airbag may not deploy correctly when activated.
- There will be some resistance when tightening the nuts because they are self-locking, confirm the nuts are tightened correctly.
- **DO NOT** use a power tool, T-handle, or ratchet when tightening the nuts to avoid overtightening.

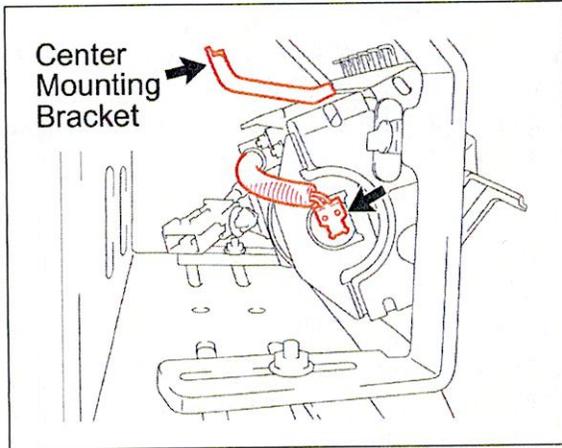
12. CONNECT THE INFLATOR CONNECTOR

- Remove the connector seal from the inflator.
- Confirm the alignment of the harness connector as shown in the illustration, then connect the harness. The connector wires should lead toward the center mounting bracket on the airbag assembly.

- The connector should be connected **IMMEDIATELY** after removing the seal.
- The connector is one-way, once it is installed it **CANNOT** be removed.
- If the connector is installed in the incorrect orientation the terminals may be bent or the connector may not fully engage.

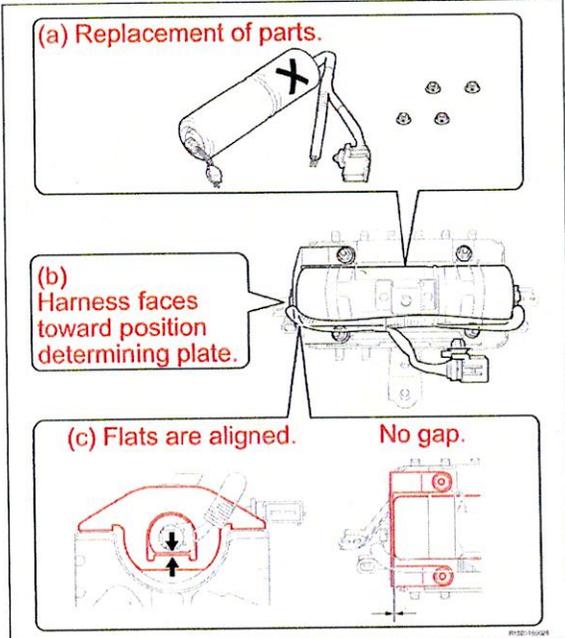
14. INSPECT THE AIRBAG BEFORE INSTALLATION

- Confirm that the 4 **NEW** nuts are installed and tight.
- Confirm the **NEW** position determining plate is installed.
- Confirm the flats on the position determining plate and inflator are aligned.

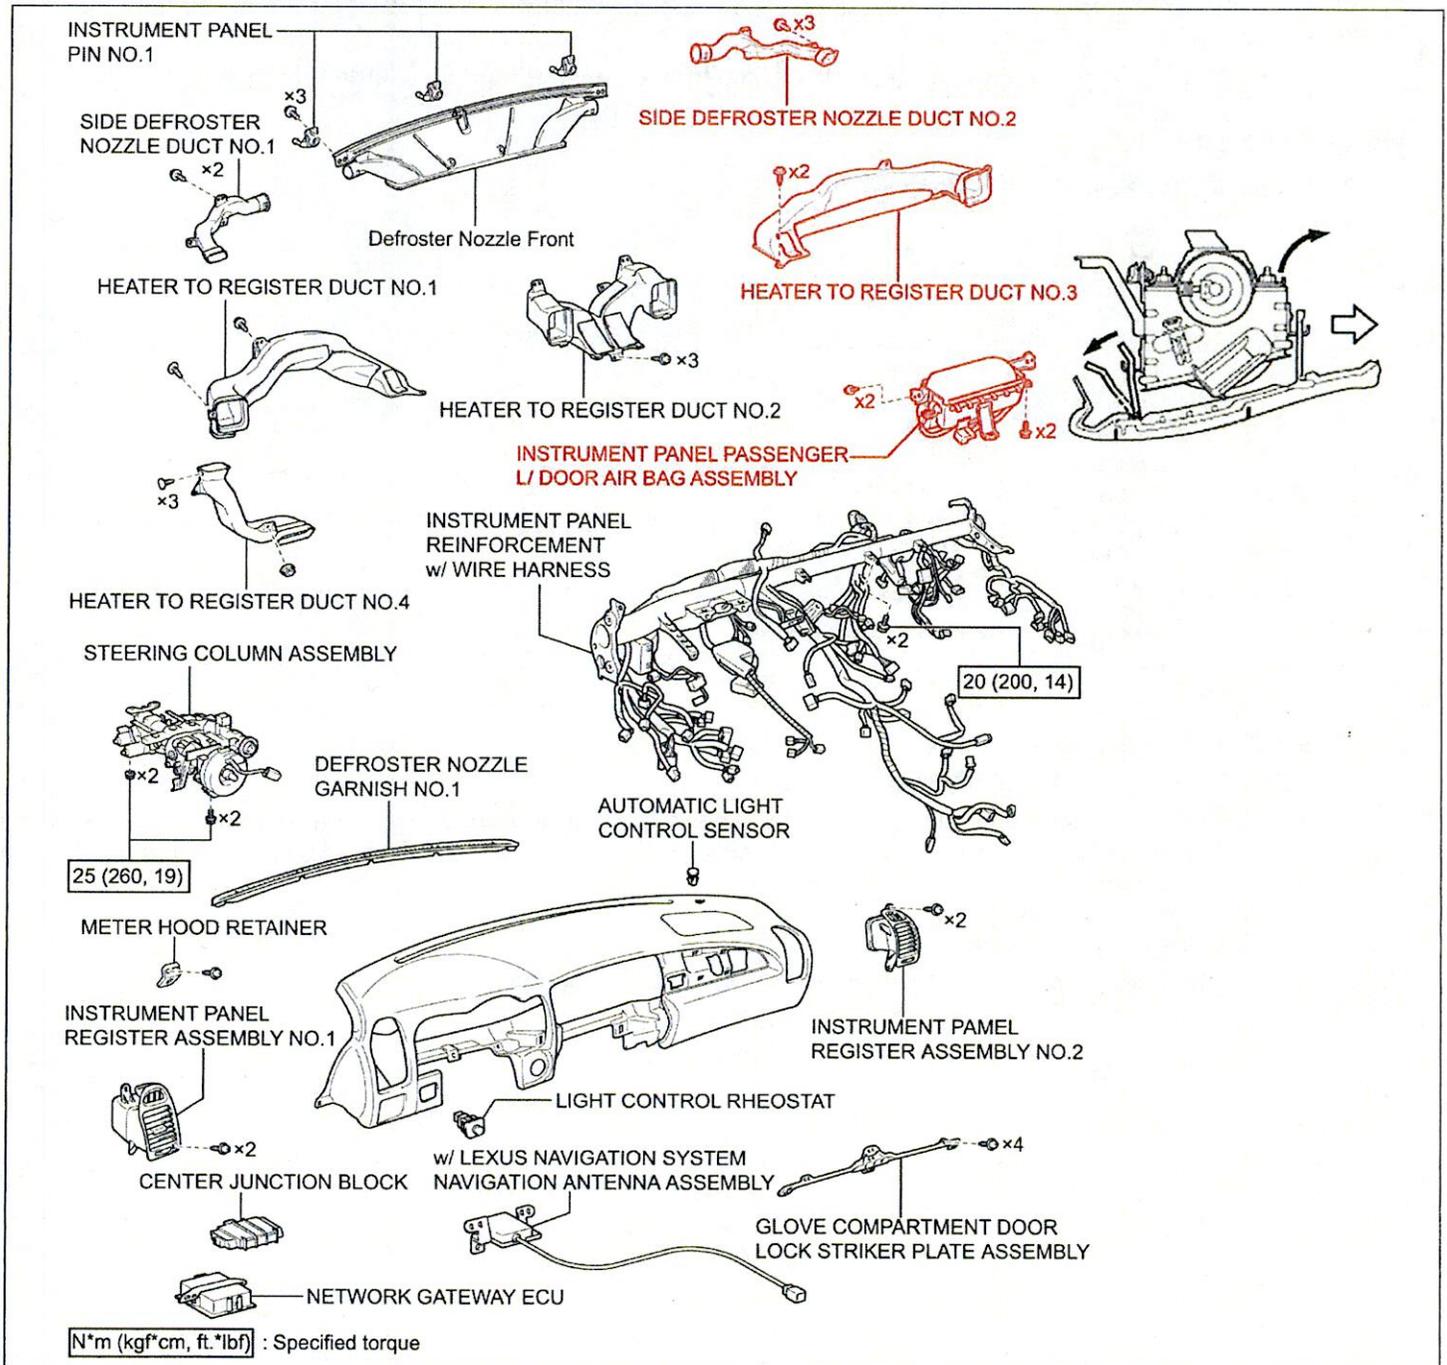
1. REINSTALL THE AIRBAG ASSEMBLY IN THE INSTRUMENT PANEL

- Position the airbag assembly in the instrument panel, engage the straps, then install the 4 bolts.
- Install the 2 screws and the heater to register duct.
- Install the 3 screws and the side defroster nozzle.
