## OC3 Seat Mat Modification for Passenger Seat, Comfort Seat

### Preliminary work

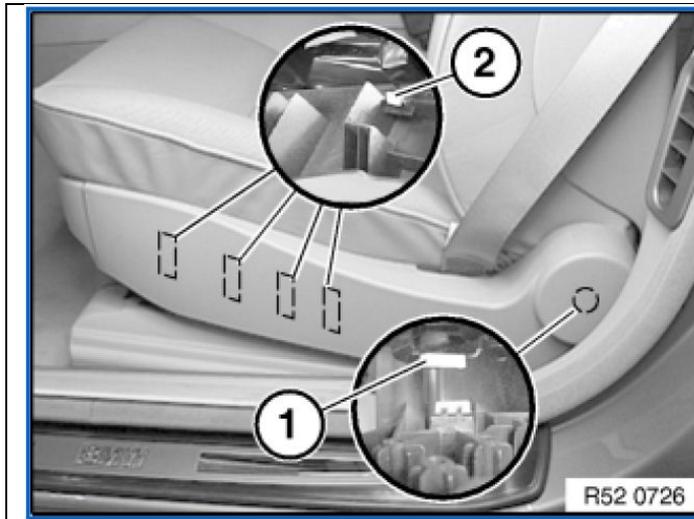
#### E65 and E66

- Detach the cover from the retaining clip (1).
- Unlock the tabs (2) towards the bottom.

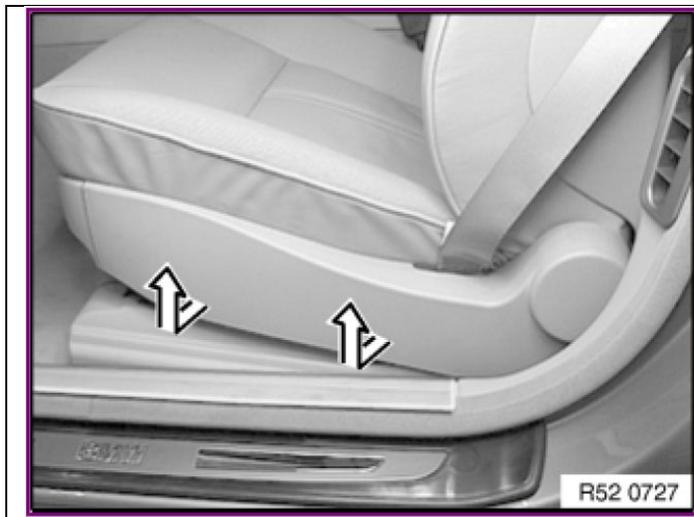
#### E65 and E66

- Raise the seat cover from below and remove towards the top.

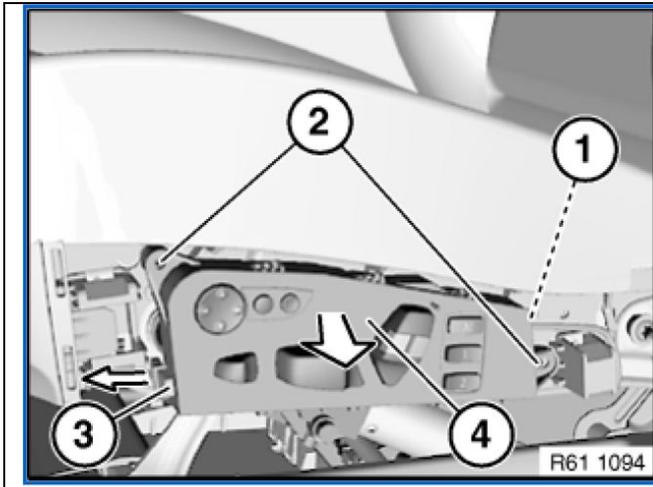
- Unfasten the plug connection (1) and disconnect.
- Loosen the screws (2).
- Unlock the catch (3) in the direction of the arrow and remove the seat adjustment switch combination (4) towards the front.

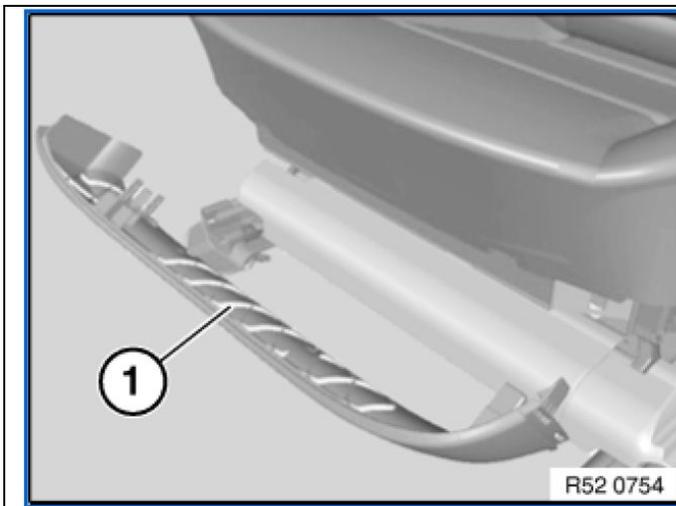
Unclip the cover (1) on the front seat.

To avoid damaging the OC3 mat:

- Do not kink the OC3 mat.
- Handle the OC3 mat with extreme care.

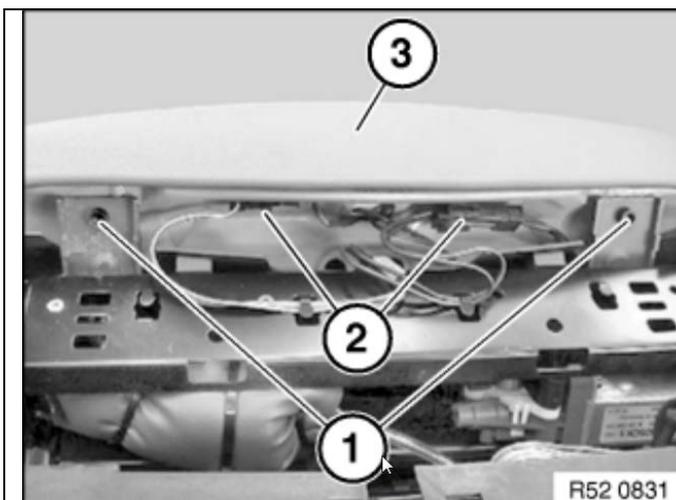
- Release the screws (1).
- If necessary, detach the plug connections (2).
- Remove the thigh support (3).

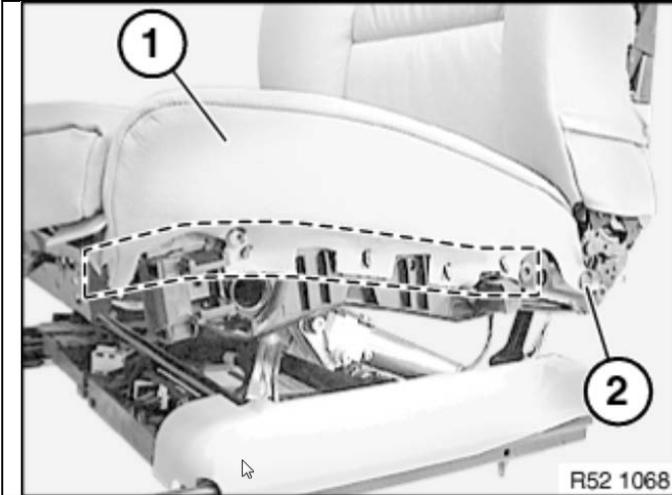
Note:  
Operation shown on the driver's seat as an example.

Unhook the seat cover (1) in the marked area on the exit side.

Take off the clip (2)

If necessary, replace faulty clips (2).

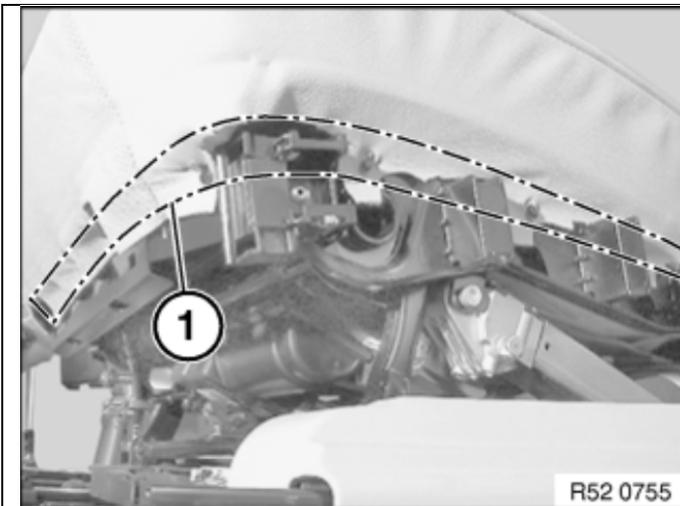
Detach the seat cover (1) in the marked area at all attachment points.

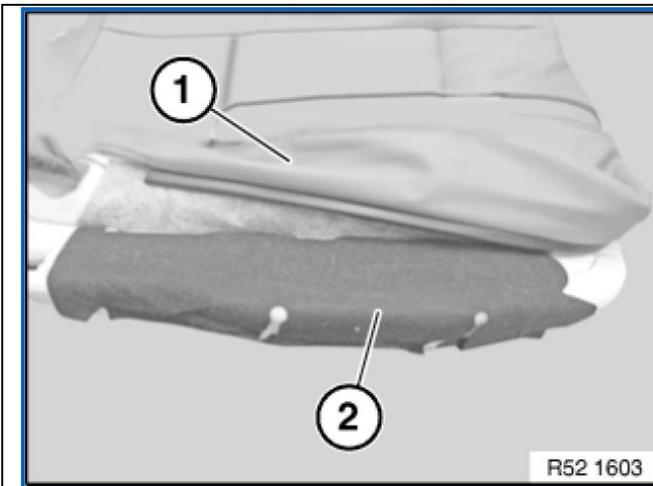
The padding must not be damaged.

Fold back the seat cover (1) at the side.

Carefully detach the OC3 mat (2) from the side section of the upholstery.

If necessary, cut off the OC3 mat (2) with a heavy-duty knife without damaging the upholstery.

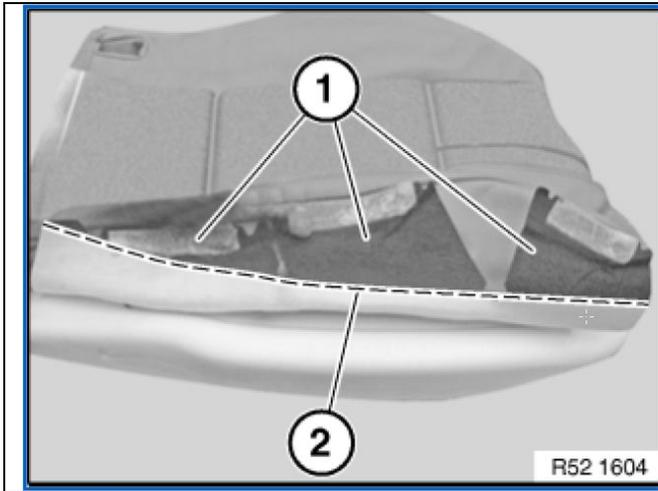
Do not damage the strip conductors of the OC3 mat.

Carefully cut off the protruding material (1) of the OC3 mat above the contour (2).

Multifunction seat for the E65 and E66 only:  
Pull off the lower protective film from the double-sided adhesive tape (2).

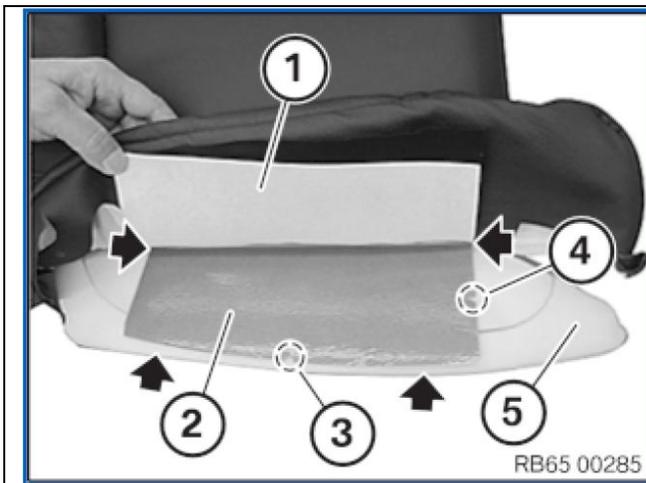
Fold back the OC3 mat (1).

Position the double-sided adhesive tape (2) on the side section (5) as follows:

- The notch (4) must face forwards in the direction of travel.
- The notch (3) must face outwards in the direction of travel.
- Double-sided adhesive tape (2) must be flush with the OC3 mat (1) and with the side section (5), as shown by the arrow.

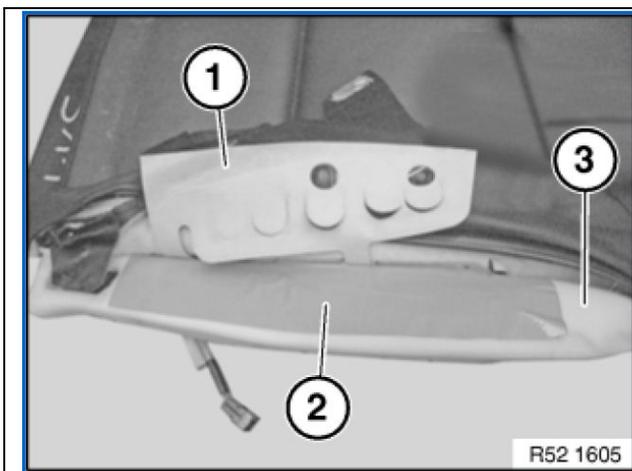
- Fold back the OC3 mat (1).
- Stick double-sided adhesive tape (2) to the upholstery (3).
- Pull the protective film off the double-sided adhesive tape (2).

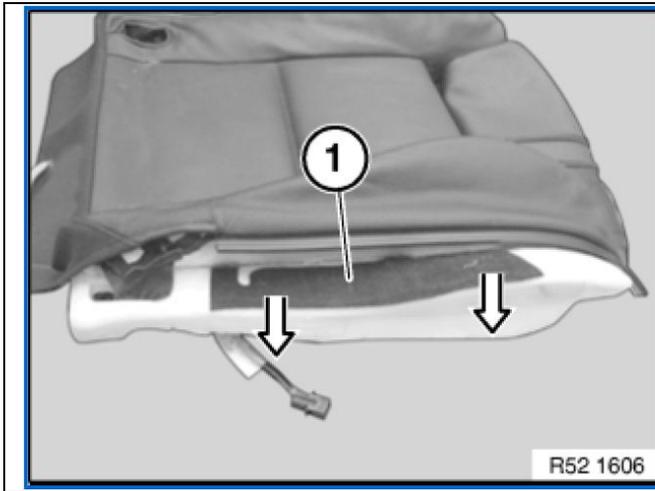
Pulling gently, stick the OC3 mat (1) to the side section.

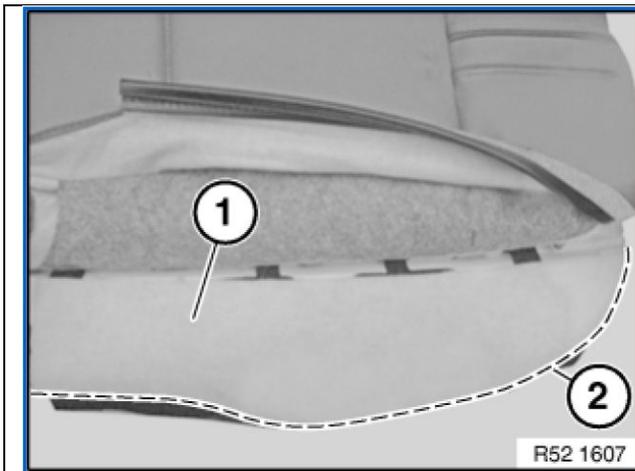
Stick the fleece (1) in the area of the OC3 mat to the side section.

Stick the fleece (1) to the side section edge (2) so that it is flush.
