INSTRUCTION TO SERVICE

ITS: 5843	
SECTION:	350 Driver's Control
WRITTEN BY:	Iman Fatemi
SUBJECT:	Replace brake pedal mounting plate and BVA valve

ITS5843

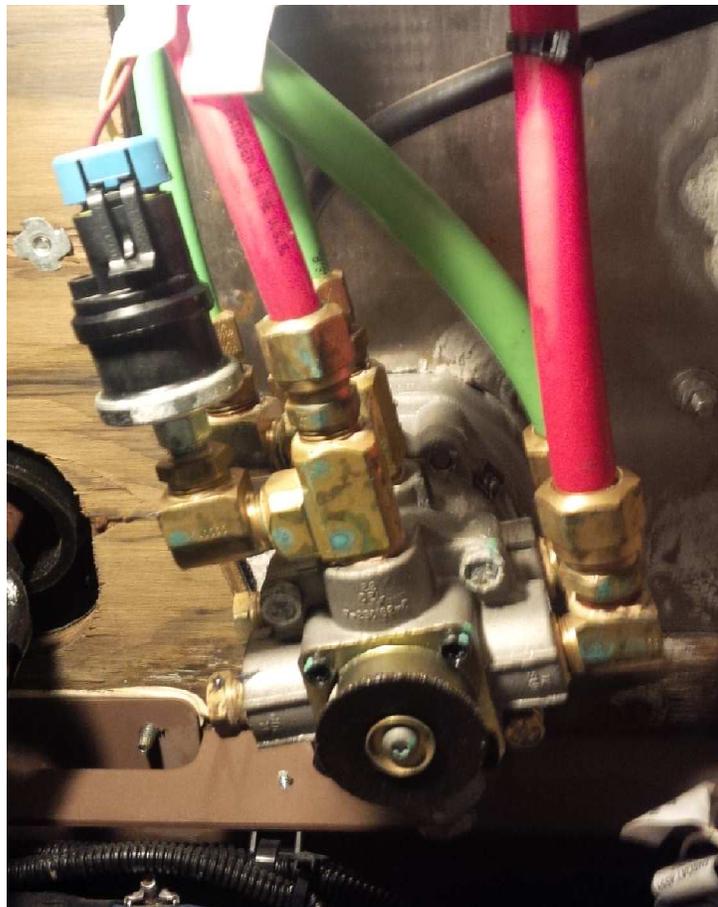
Figure 1: Brake Treadle Valve Assembly

1. Turn the main battery disconnect switch to the “OFF” position.
2. Raise coach in accordance with the New Flyer Service Manual.
3. Open the access door for the brake treadle valves under the driver’s platform.
4. Locate the brake treadle valve assembly, see Figure 1.
5. Deplete all system air pressure.
6. Disconnect all airlines from E6 and BVA valve, see Figure 1.

7. Disconnect the electrical connector from the pressure switch, see Figure 1.

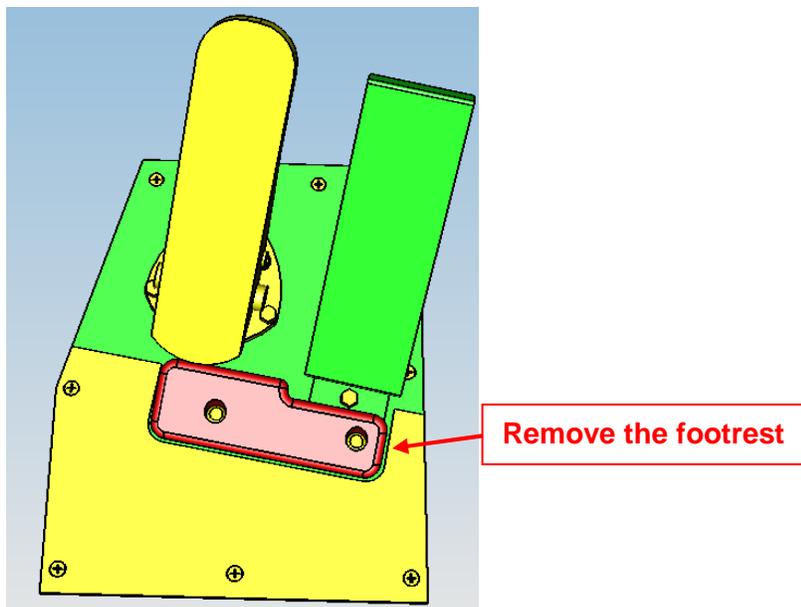
Figure 2(b): Brake/Accelerator Treadle Assembly

8. Close the treadle valve access door before lowering the coach.
9. Lower coach in accordance with the New Flyer Service Manual.
 - ⚠ WARNING:** Ensure the treadle valve access door is closed before lowering the coach.
10. Remove p-clips securing the accelerator harness to the brake pedal assembly. Set aside the P-clips and hardware for reuse, see Figure 2.
11. Disconnect the harness from the accelerator sensor, see Figure 3.
12. Remove 7 screws which attach brake/accelerator pedal assembly to floor, see Figure 2.
13. Remove the entire assembly from bus and put it on a work bench.
14. Remove screws which attach the treadle footrest to the mounting plate, remove the footrest. Discard locknuts and retain all remaining hardware for reuse, See Figure 2(b).

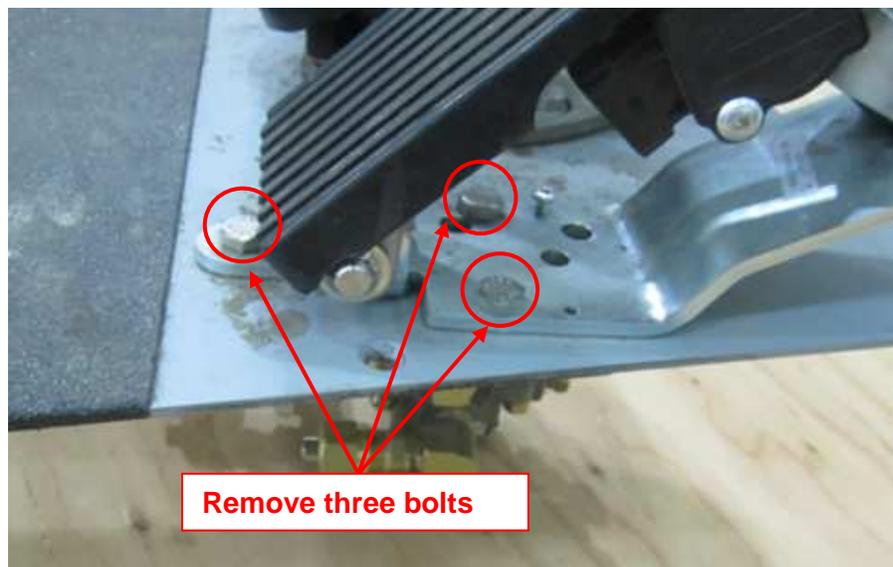
Figure 4: Remove Accelerator Treadle Assembly

15. Remove 3 bolts which attach the accelerator treadle to the plate. Discard locknuts and retain all remaining hardware for reuse, see Figure 4.
16. Remove the cotter pin from the brake pedal, see Figure 5. Remove the brake pedal from the mount, set the hinge pin and pedal aside for re-use, discard the cotter pin.

27. Using the hardware previously removed in Step 15 and 3 new lock nuts (PN: 40N05000), install the accelerator treadle on the new modified brake plate (PN: 558483), see Figures 4, 10(a) and 10(b).

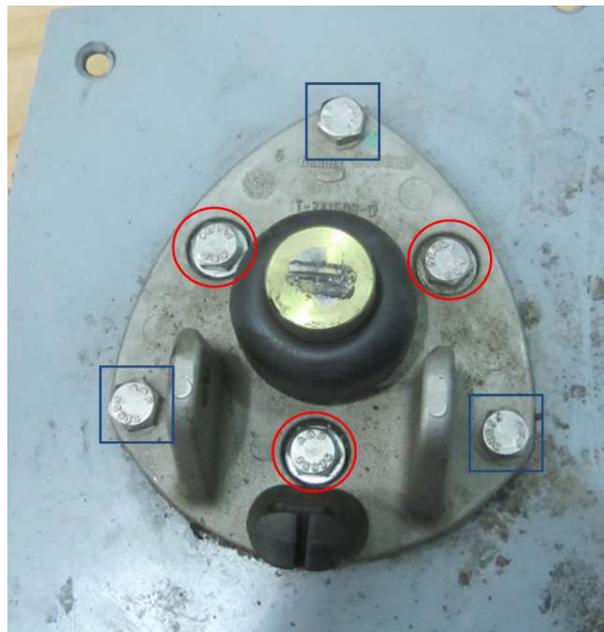
Figure 6: Pedal Mount

17. Remove the pedal plunger and rubber boots, set aside for reuse.
18. Remove 3 inner bolts shown by three circles in Figure 6 and disconnect the valve assembly. Set aside the hardware for reuse.
19. Remove 3 outer bolts shown by three squares in Figure 6 and disconnect the pedal mount from the pedal plate. Discard lock nuts and retain all remaining hardware for reuse.
20. Discard the brake pedal mounting plate (stainless steel plate).

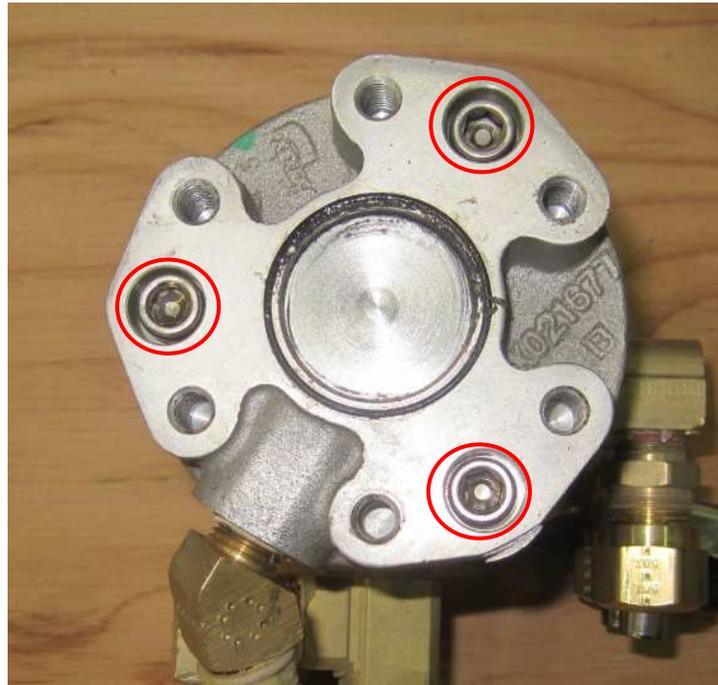
Figure 7: Remove BVA Valve

21. Remove three allen bolts which attach the BVA valve to the E6 treadle valve, see Figure 7. Retain the allen bolts for reuse.
22. Remove the BVA valve from E6.
23. Remove the 45 degree elbow from BVA valve, retain the elbow and discard the BVA valve.
24. Align a new BVA valve (PN: 477422) with the E6 valve as shown in Figure 8. Attach the BVA valve using the 3 allen bolts previously removed in Step 21, see Figure 7.
 - ☞ **NOTE: Apply loctite – 243 (PN: 081034) Medium to the allen bolts.**
25. Install the 45 degree elbow previously removed in step 23 at the BVA port, see Figure 9.
 - ☞ **NOTE: Apply loctite 567 – Thread Sealant (PN: 8110442) to the thread fitting.**
26. Align the elbow as shown in Figure 9 (15 ° relative to BVA mounting surface).

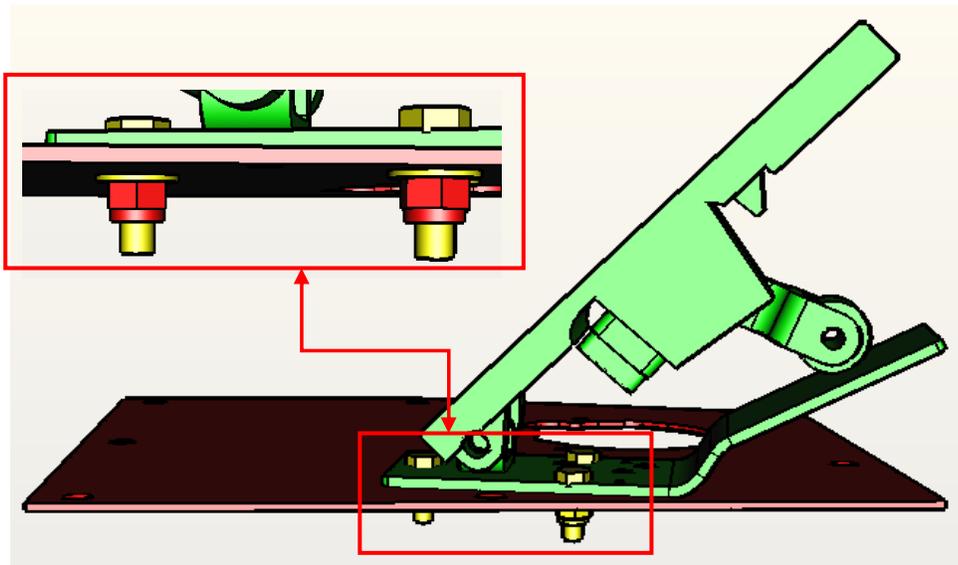
Figure 10(b): Install Accelerator Treadle

☞ **NOTE: Place a washer between the new plate and the locknuts, see Figure 10(b). No washer between the bolt head and the accelerator base plate.**

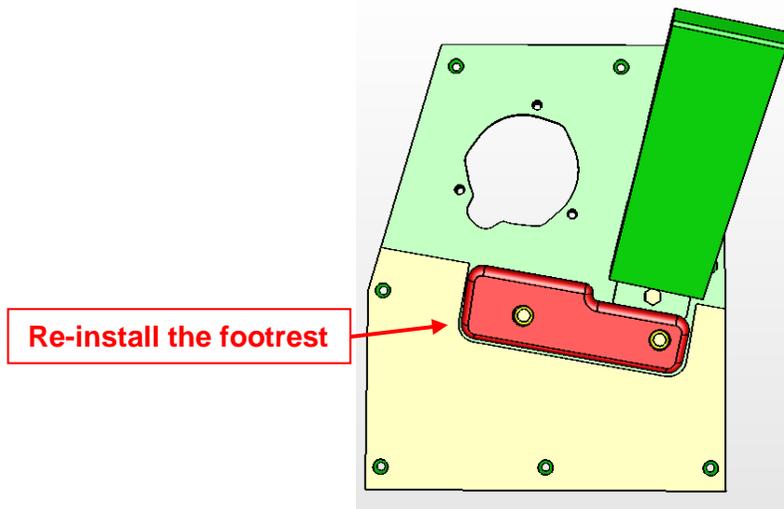
Figure 10(c): Install Treadle Footrest

28. Using the hardware previously removed in Step 14 and 2 new lock nuts (PN: 40N05000), reinstall the treadle footrest. Place a washer between mounting plate and lock nuts, see Figure 3(c).

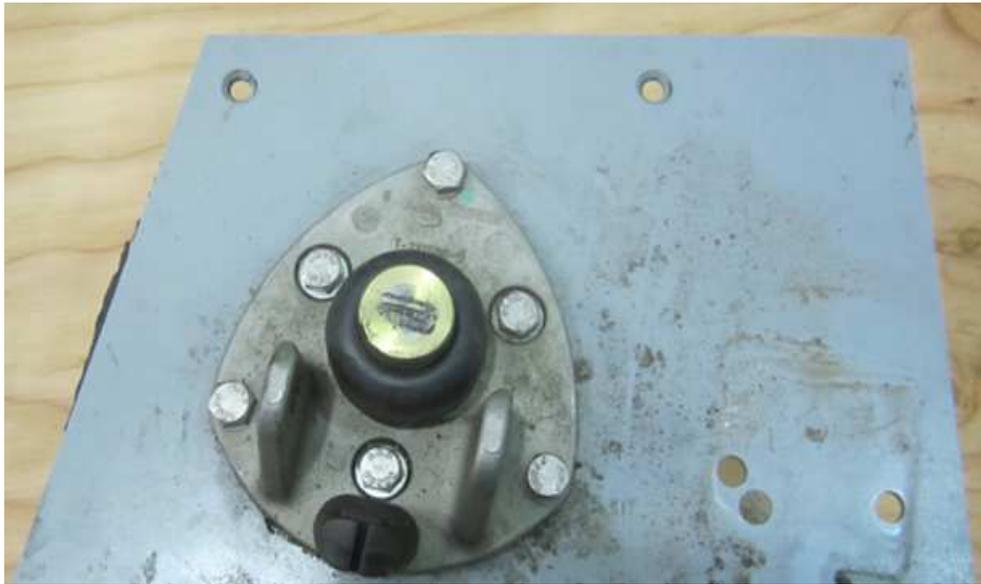
Figure 11: Pedal Mount

29. Locate the pedal mount on top of the hole in the brake pedal mounting plate, see Figure 11.
30. Secure the pedal mount to the brake plate using the hardware previously removed in Step 19 and 3 new lock nuts (PN: 40N05000), see Figure 12. Tighten the bolts.
- ☞ **NOTE: Place a washer between the new plate and the locknuts, see Figure 13. No washer between the bolt head and the pedal mount, see Figures 12 and 13.**
31. Align the BVA valve and the 45 degree elbow with the open slot in new plate as shown in Figure 14.
32. Attach the pedal mount to the BVA valve using the hardware previously removed in Step 18 (3 bolts, 6 washers), see Figure 11. Tighten the bolts.
- ☞ **NOTE: Place two washers between the bolt head and the pedal mount, see Figure 15.**
- ☞ **NOTE: Apply loctite – 243 (PN: 081034) Medium to the mounting bolts.**

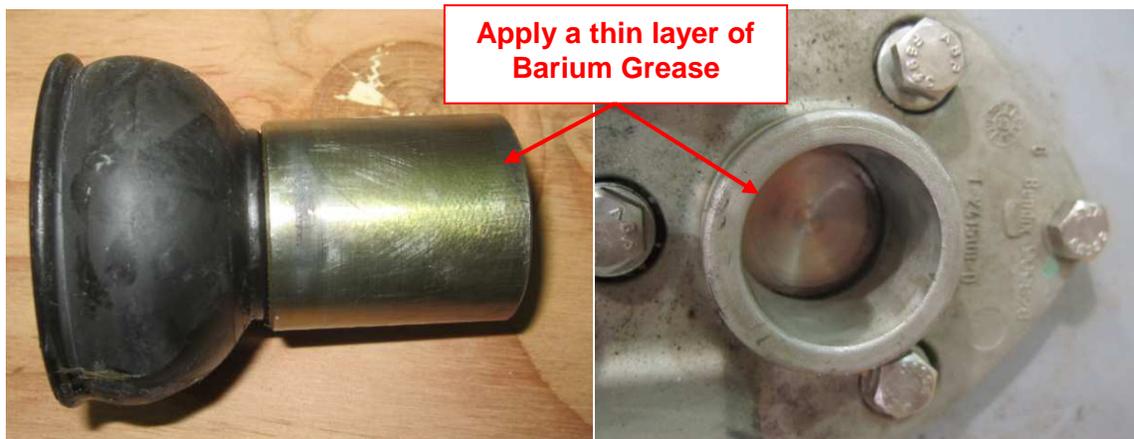
Figure 16: Apply Barium Grease

33. Clean and inspect the treadle roller, the roller pin, the hinge pin, the pedal mount, the plunger and the rubber boot in accordance with in accordance with the New Flyer Service Manual, Preventive Maintenance, Section Brake Treadle Assembly & Brake Valve, see Appendix A.
34. Apply a thin layer of Barium based grease per BW-204-M (PN: 117267) to pedal plunger and the bore in pedal mount, see Figure 16.
35. Put the plunger in the bore and install the rubber boot, ensure the rubber boot is seated properly.
36. Re-install the hinge pin and the brake pedal. Install a new cotter pin (PN: 6325654). Bend the cotter pin ends, see Figure 17.

- Apply a thin layer of Barium grease between the plunger and the mounting plate bore. Do not use excessive amounts of lubricant.
- Perform operation and leakage tests on the brake valve. Refer to Section 8 of this manual for test procedures.

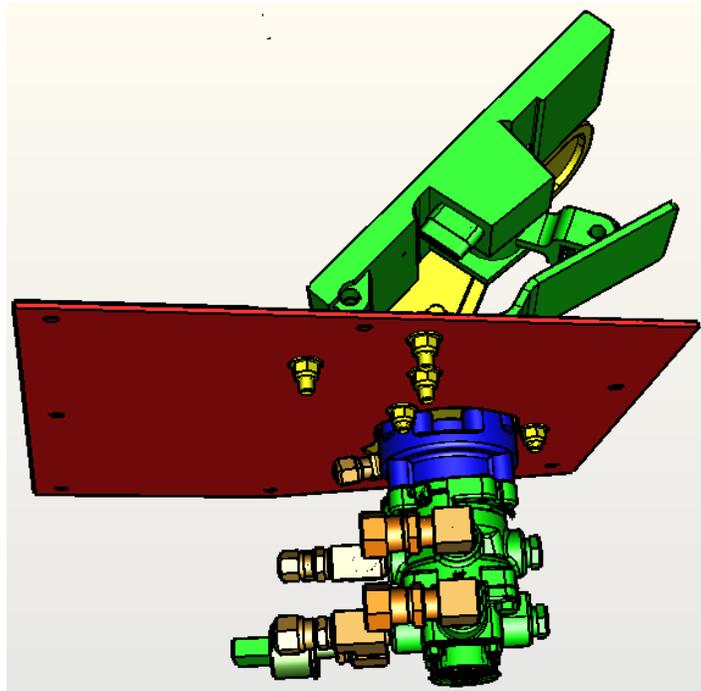
Figure 18: Pedal Assembly

37. The pedal assembly should look like Figure 18.
38. Apply a thin layer of Barium grease per BW-204-M (PN: 117267) to the roller and the roller pin, see Figure 19.
39. Apply Sika 221 Black (PN: 055700) on plywood to the border of the mounting frame as shown in Figure 20.
40. Re-install the pedal assembly using the 7 screws previously removed in Step 12. See Figure 21.
41. Secure the accelerator harness as it was originally installed using the P-clips and hardware previously removed in Step 10, see Figure 21.

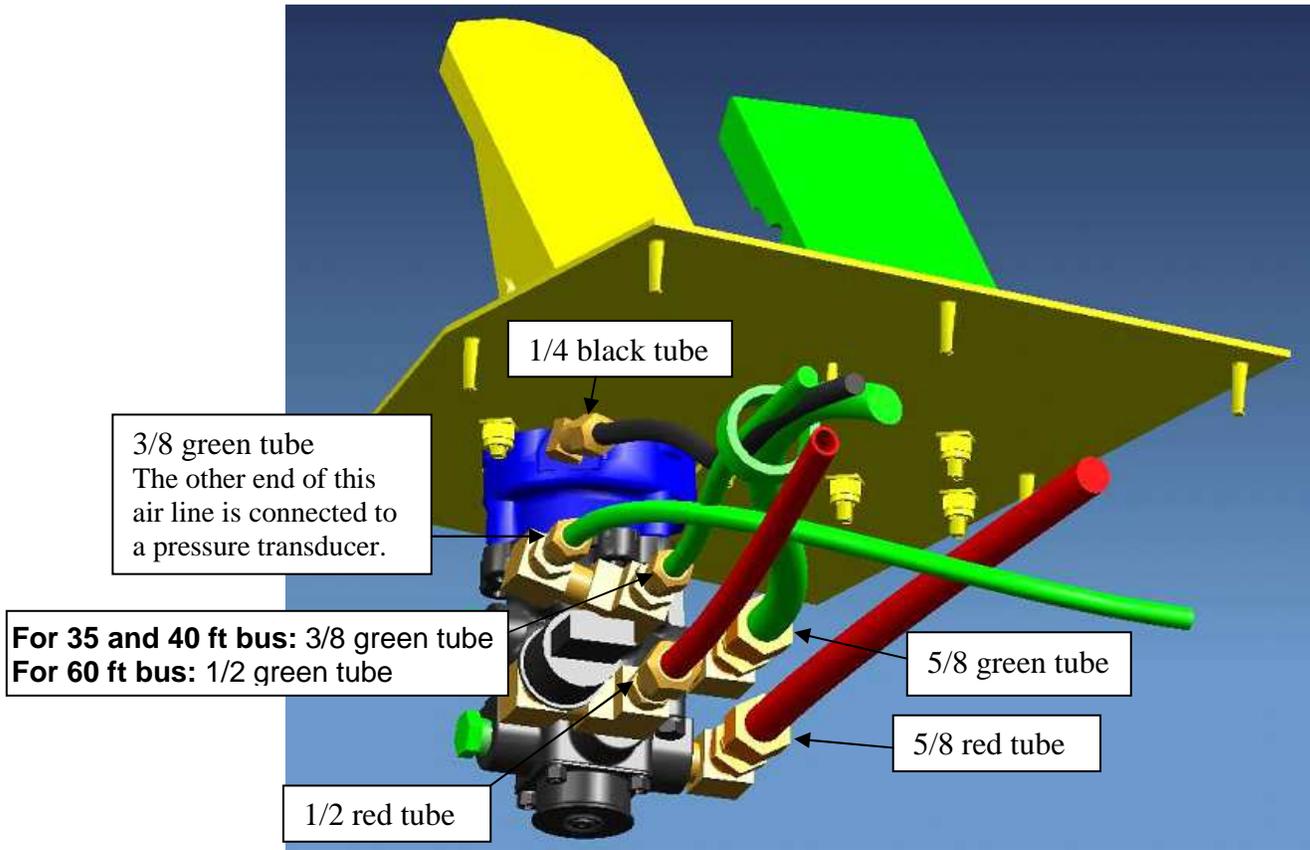
Figure 22: Airline Connections to the E6 and BVA Valves

44. Re-connect the air lines and the pressure switch harness as per original configuration. Use the marks applied in Step 6 to find the right port for each air line.

**NOTE:** Double-check the connections with Figure 22.

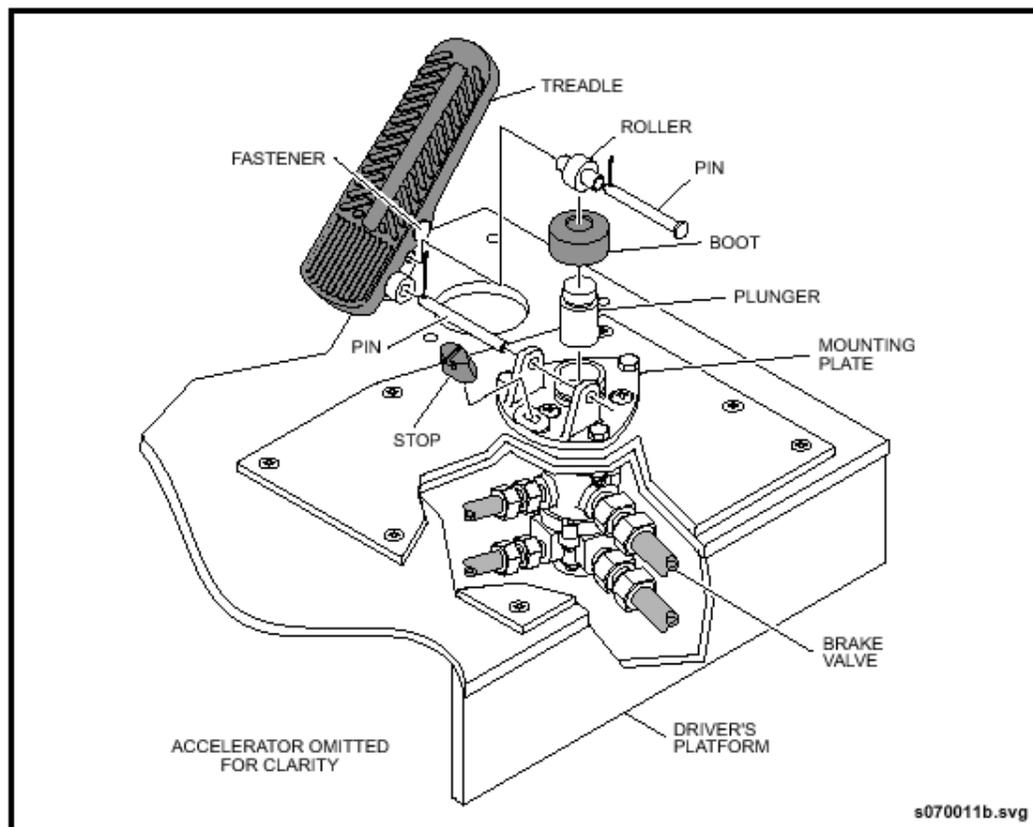
Fig. PM-28: Brake Valve Inspection

- Perform maintenance on the brake treadle assembly and brake valve every 24,000 miles (38,600 km), 900 operating hours or three months, whichever occurs first. Remove any accumulated contamination, such as dirt and gravel, from the heel of the treadle, the plunger, the plunger boot and the mounting plate. See "Fig. PM-28: Brake Valve Inspection" on page 59.

- Inspect the plunger boot for cracks, holes or deterioration and replace boot if damaged.
- Inspect the plunger for wear or corrosion. Replace plunger if required.

- Check that the brake treadle mounting plate is securely fastened. Inspect pivot pin holes and plunger bore in mounting plate for wear or corrosion. Replace mounting plate if required.
