# IMPORTANT UPDATE

## TECHNICAL INSTRUCTIONS FOR SAFETY RECALL E04 FRONT PASSENGER AIRBAG INFLATOR MODULE CERTAIN 2002 –2005 MODEL YEAR SEQUOIA

**Updated 10-24-14**

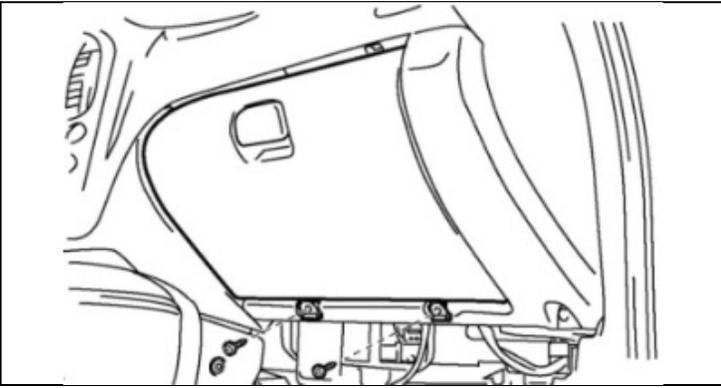
### 1. REMOVE THE GLOVE BOX AND FINISH PANEL

- a) Remove the 2 screws and the glove box.
- b) Remove the 3 screws, disconnect the courtesy light connector and remove the lower No.2 finish panel that is behind the glove box.

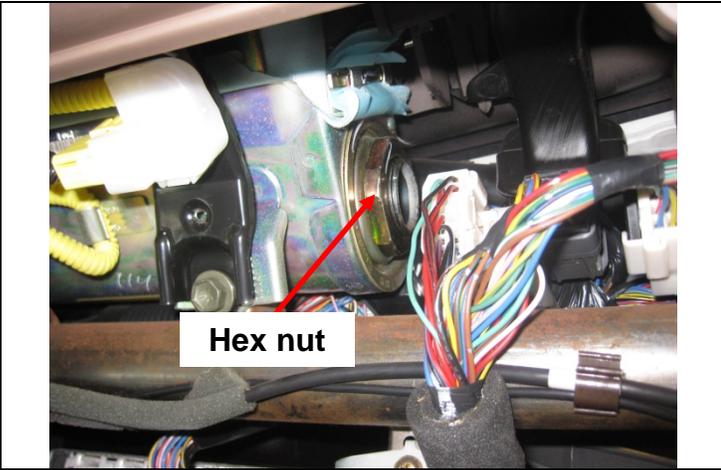
### 2. INSPECT INFLATOR TYPE

- a) Inspect the inflator to determine if it has a large nut on the right side as shown.

**NO:** Proceed to section VIII.

**YES:** The vehicle is **NOT INVOLVED** in the Safety Recall.

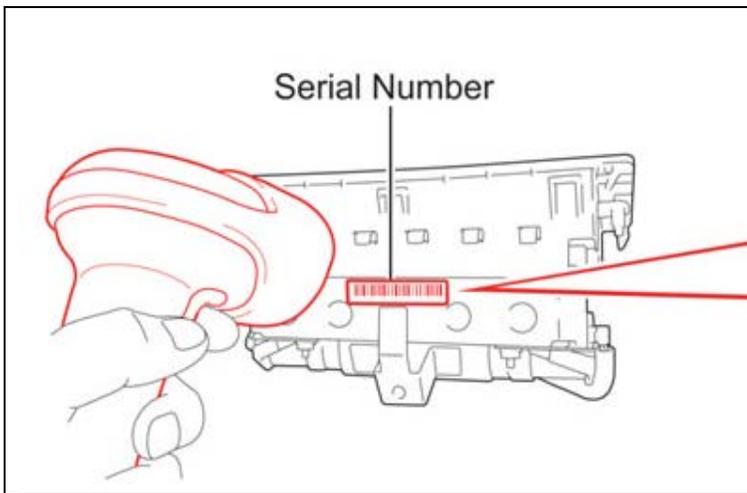
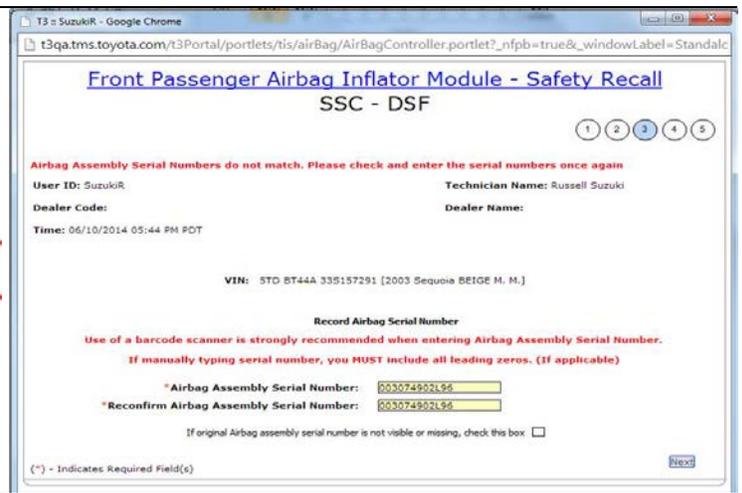
#### Airbag Serial Number Label Example

### AIRBAG SERIAL NUMBER IDENTIFICATION

- The airbag serial number is **ALWAYS** the 12 **DIGITS** located between the asterisks.
- The 3 digits before the asterisk **ARE NOT** part of the serial number, and **SHOULD NOT** be entered or an inaccurate response may be returned.

The **AIRBAG ASSEMBLY** serial number and the **INFLATOR** serial number are **DIFFERENT**. The **AIRBAG ASSEMBLY** serial number **MUST** be recorded prior to replacement.

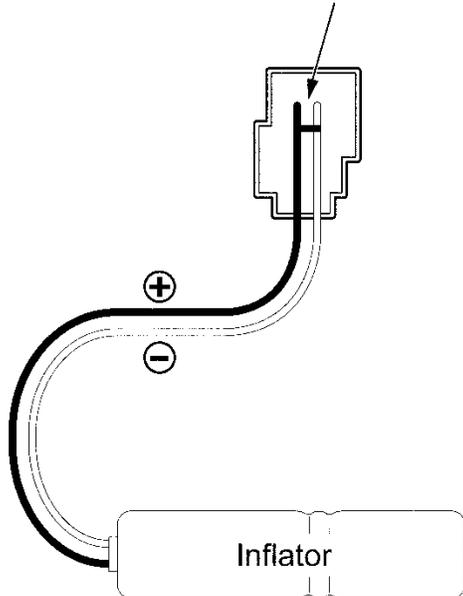
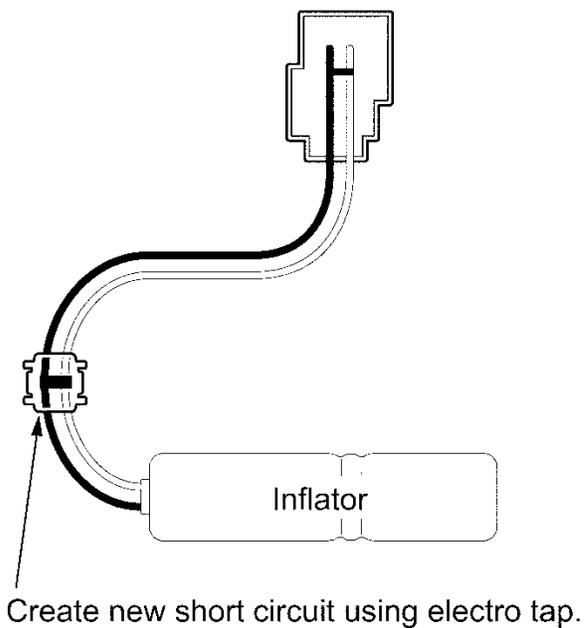
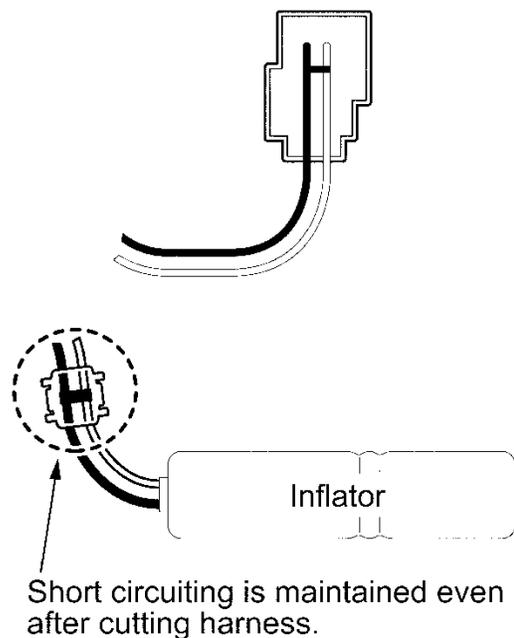
The connector of the inflator module contains a short circuiting mechanism to eliminate voltage variances when the connector(1) is disconnected. To allow for the replacement of the inflator module, a new short circuit(2) **MUST** be created before cutting the wires(3) and removing the inflator. The following steps **MUST** be followed exactly as described to ensure the work is completed correctly and safely.

Short circuiting on both sides.

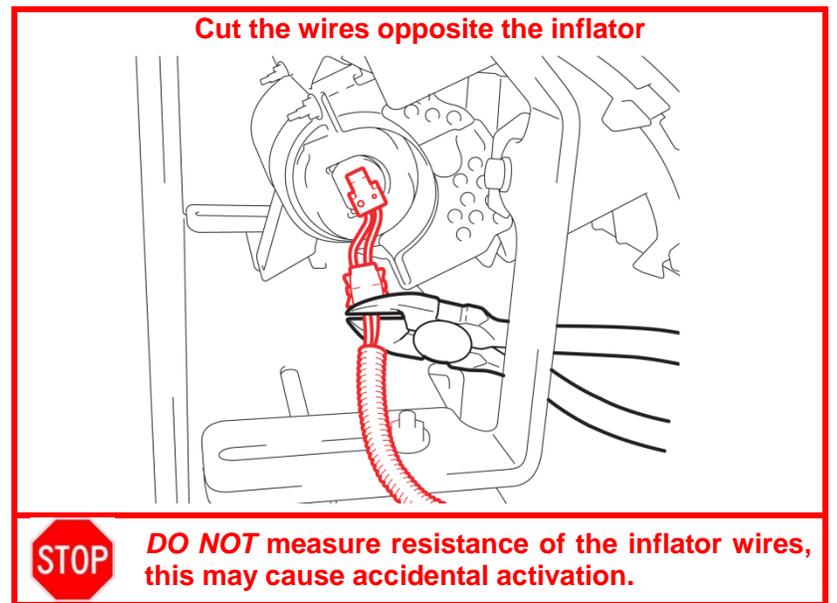
### 4. CUT THE INFLATOR WIRES

- a) Cut the 2 wires at the side of the electro tap that is farthest away from the inflator.

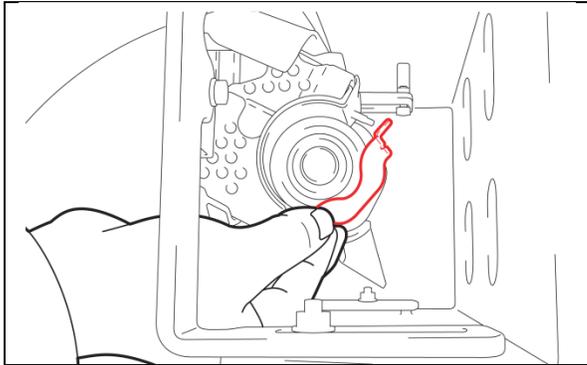
## 5. REMOVE THE SELF LOCKING NUTS

- a) Use the access holes in the bracket to remove the 4 nuts.

- **DO NOT** use power tools.
- The bracket support bars may need to be repositioned to remove the nuts through the access holes.

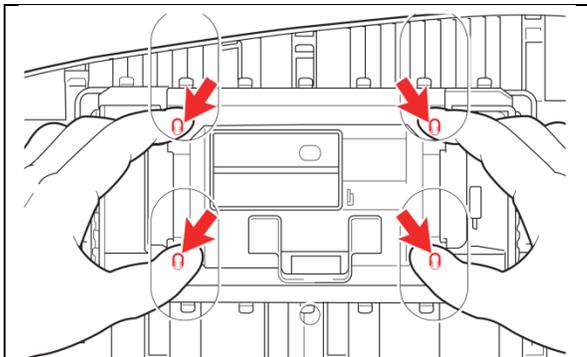
- b) Remove the stopper plate and place in a secure location because it will be reused.

**STOP** **DO NOT** discard the Stopper Plate, it will be reused.

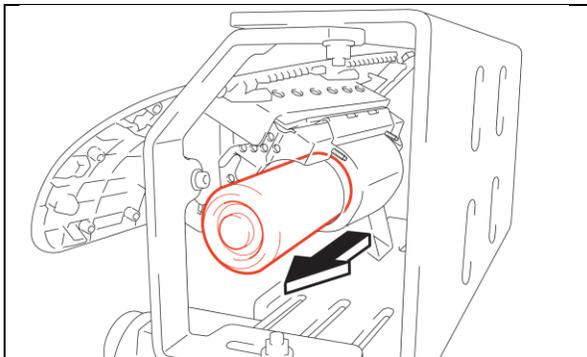
## 6. REMOVE THE INFLATOR

- a) Gently push in the 4 studs to loosen the inflator for removal.

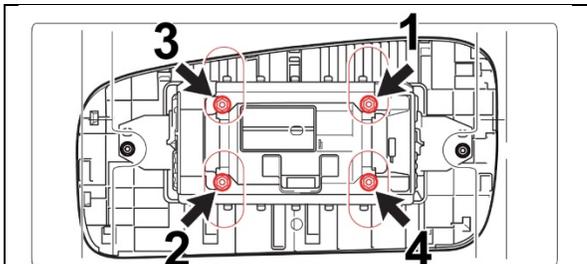
## 11. REINSTALL THE STOPPER PLATE.

- a) Place the stopper plate on the airbag assembly.

- b) Install stopper plate nuts (**NEW**) by hand. They will be torqued on a later step.
- c) Install the **NEW** nuts on the airbag assembly bracket by hand. They will be torqued on a later step.

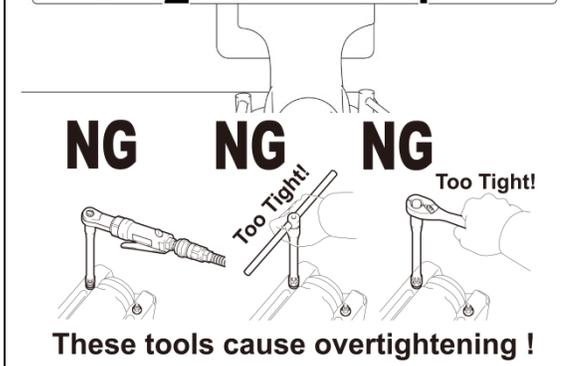
## 12. TORQUE THE PLATE NUTS

- a) Tighten the nuts evenly in two increments following the sequence shown in the illustration. Use a socket driver or torque wrench to tighten the nuts.

**Torque: 35in. lbf (3.9N·m)**

- There will be some resistance when tightening the nuts because they are self-locking, confirm the nuts are tightened correctly.
- **DO NOT** use a power tool, T-handle, or ratchet when tightening the nuts to avoid over torqueing.

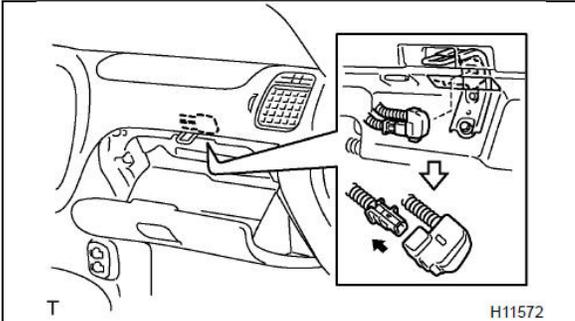
#### 2. REMOVE GLOVE COMPARTMENT DOOR

- a) Remove the 2 screws and glove compartment door.
- b) Remove the 3 screws and the Lower No. 2 Finish Panel
- c) Disconnect the glove box light connector.

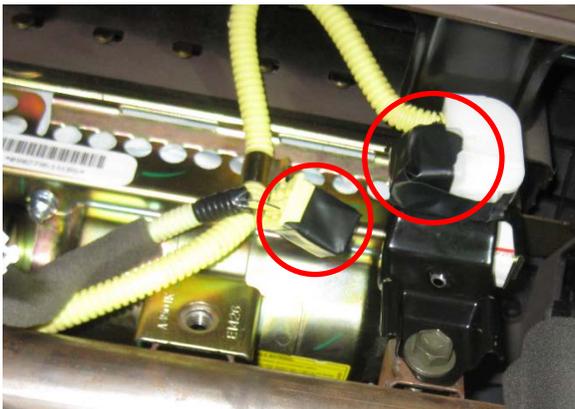
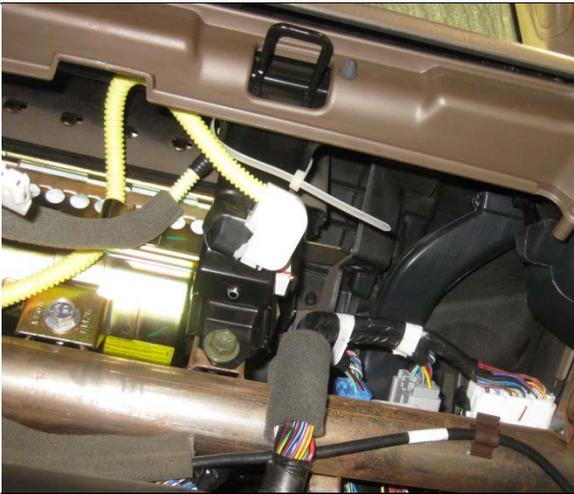
#### 3. DISCONNECT AIRBAG CONNECTOR

- a) Using a clip remover, disengage the connector clamp.
  - b) Disconnect the connector.
- c) Wrap SRS connectors in tape to protect them.

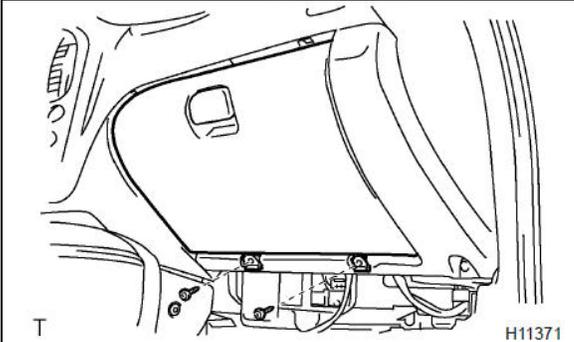
- d) Tie-wrap the SRS connector to the upper portion of the glove box latch bracket as shown to prevent the wire harness from creating a rattle.
