# IMPORTANT UPDATE

## TECHNICAL INSTRUCTIONS FOR SAFETY RECALL E04 FRONT PASSENGER AIRBAG INFLATOR MODULE CERTAIN 2003 – CERTAIN 2005 MODEL YEAR COROLLA CERTAIN 2003 – CERTAIN 2005 MODEL YEAR MATRIX

**Updated 10-24-14**

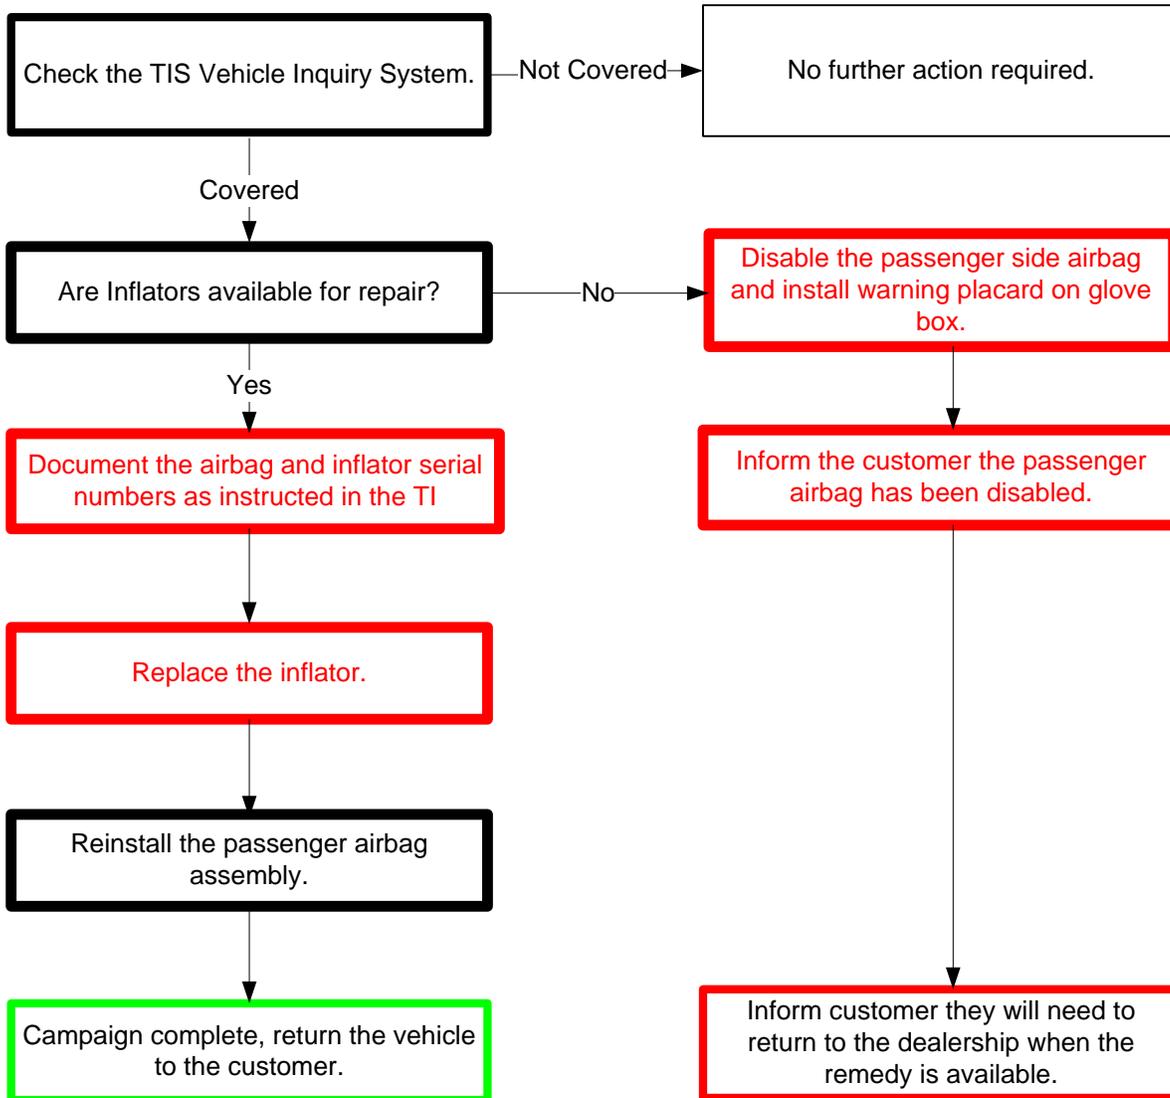
# I. OPERATION FLOW CHART

The flow chart is for reference only. **DO NOT** use it in place of the full technical instructions. Follow **ALL** steps as outlined in the full technical instructions to confirm the campaign is completed correctly.

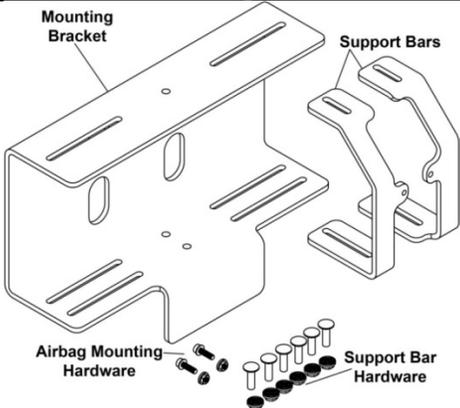
Airbag Mounting Bracket & hardware	1

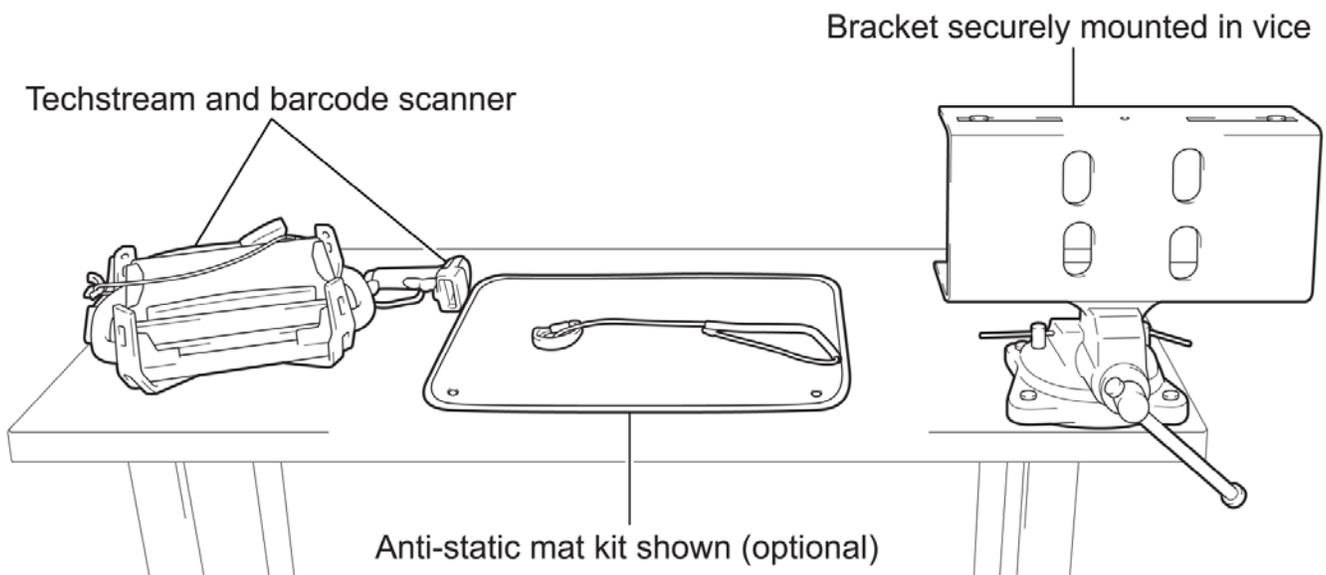
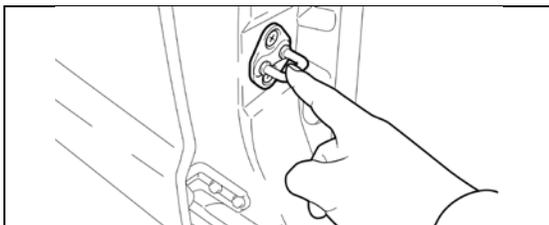
The bracket assembly that was provided at the launch of SSC D0F is a critical added-safety feature that **MUST** be used when replacing the inflator module. Confirm the bracket assembly is installed securely in the vise and confirm the work area being used is appropriate. The anti-static mat set that is an essential SST may be available at your dealership and is optional to use during inflator replacement. If the anti-static kit is not available, before starting work and periodically while working on the vehicle, touch a metallic part of the vehicle to discharge static electricity in the body.

Confirm there are no loose objects or people exposed to the back side of the bracket for safety in the unlikely event of airbag deployment due to improper work procedures (Remember that the inflator **IS NOT** being replaced due to an inadvertent deployment concern).

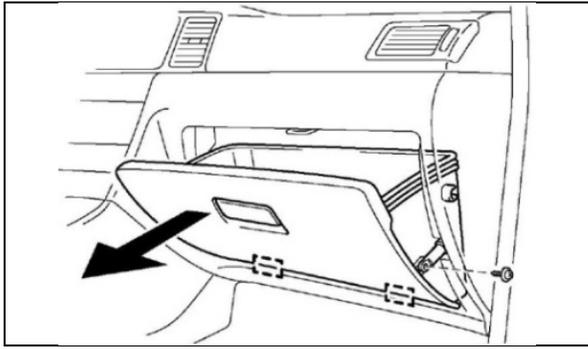
If the anti-static kit is not available, before starting work and periodically while working on the vehicle, touch a metallic part of the vehicle to discharge static electricity in the body.

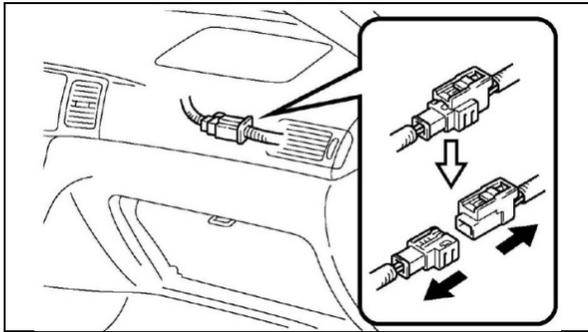
## 3. REMOVE THE AIRBAG ASSEMBLY

- a) Disconnect the negative battery cable.

- Wait at least 90 seconds after disconnecting the cable from the negative battery terminal to prevent airbag and seat belt pre-tensioner deployment.
- Follow all precautions as outlined on TIS before servicing the SRS system.

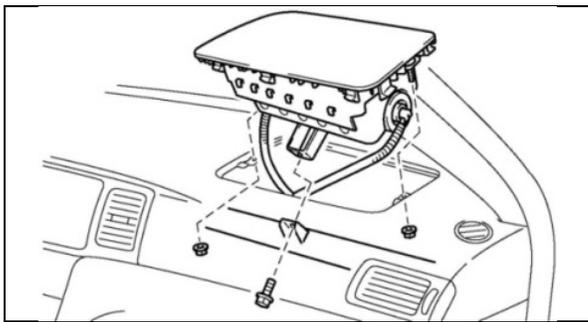
- b) Disconnect the airbag connector.

- c) Remove the bolt and 2 nuts and remove the airbag assembly.
- NOTE:** Use caution to avoid scratching or damaging the dashboard assembly, place protective tape on the dashboard if needed.

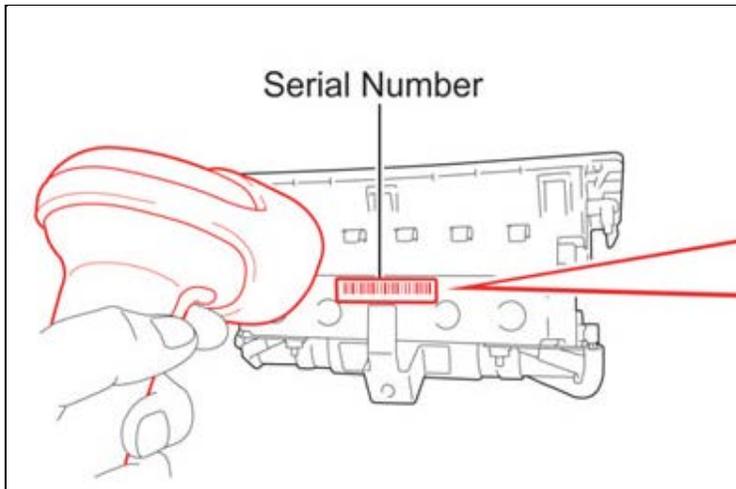
**Airbag Serial Number Label Example**

### AIRBAG SERIAL NUMBER IDENTIFICATION

- The airbag serial number is **ALWAYS** the **12 DIGITS** located between the asterisks.
- The 3 digits before the asterisk **ARE NOT** part of the serial number, and **SHOULD NOT** be entered or an inaccurate response may be returned.

The **AIRBAG ASSEMBLY** serial number and the **INFLATOR** serial number are **DIFFERENT**. The **AIRBAG ASSEMBLY** serial number **MUST** be recorded prior to replacement.

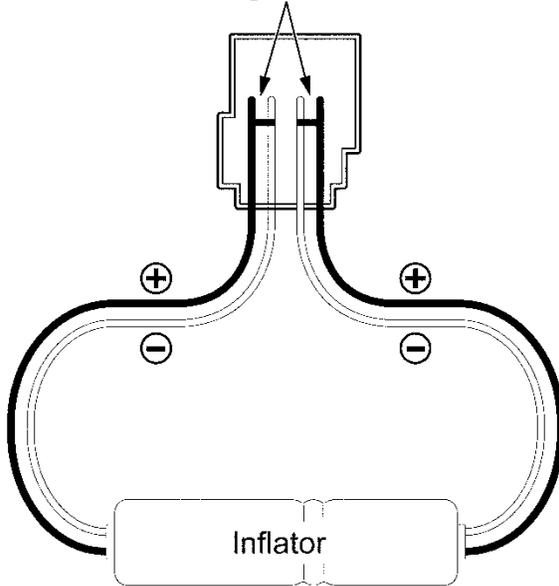
(1)

The connector of the inflator module contains a short circuiting mechanism to eliminate voltage variances when the connector(1) is disconnected. To allow for the replacement of the inflator module, a new short circuit(2) **MUST** be created before cutting the wires(3) and removing the inflator. The following steps **MUST** be followed exactly as described to ensure the work is completed correctly and safely.

Short circuiting on both sides.

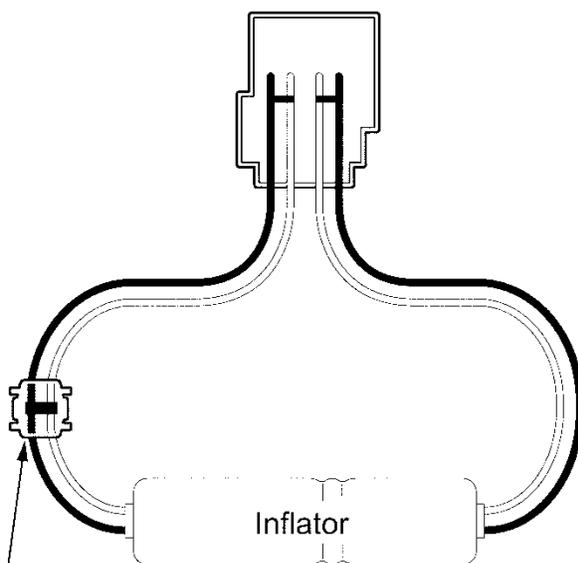
(2)

Create new short circuit using electro tap.

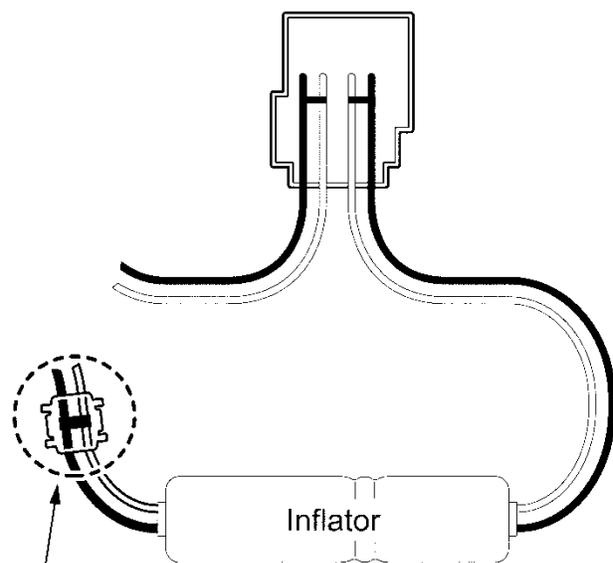
(3)

Short circuiting is maintained even after cutting harness.

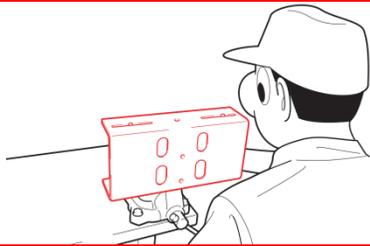
**STOP**

**ALWAYS** keep as much of your body as possible in front of the bracket when working on the airbag assembly.

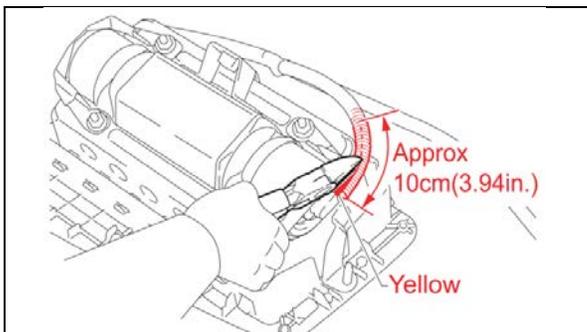
## 2. PREPARE TO INSTALL THE SHORT CIRCUIT

- Cut the yellow corrugated tube on the harness approximately 4 inches (10 cm) using nippers.

- DO NOT** damage the wires in the tube.
- DO NOT** use a knife or razor blade to cut the tube to avoid damaging the wires.
- This may be performed on either end of the inflator.

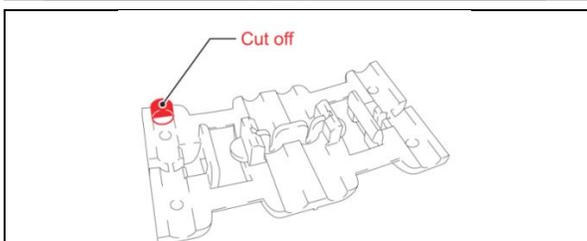
- Cut off the tab of the electro tap shown in the illustration.  
**NOTE: The electro tap is included in the inflator parts kit.**

This tab **MUST** be removed to ensure a good short.

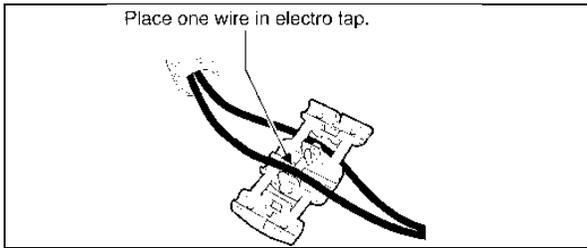
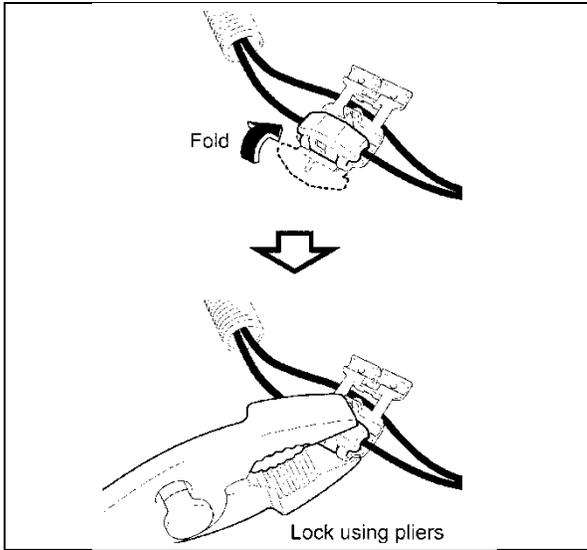
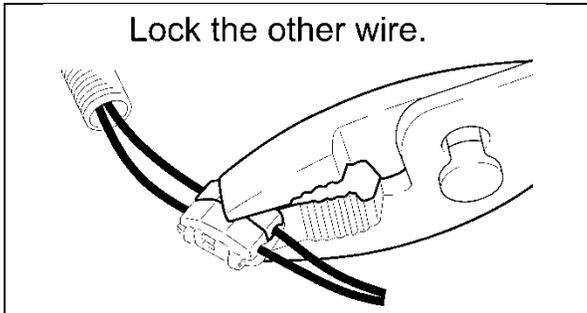
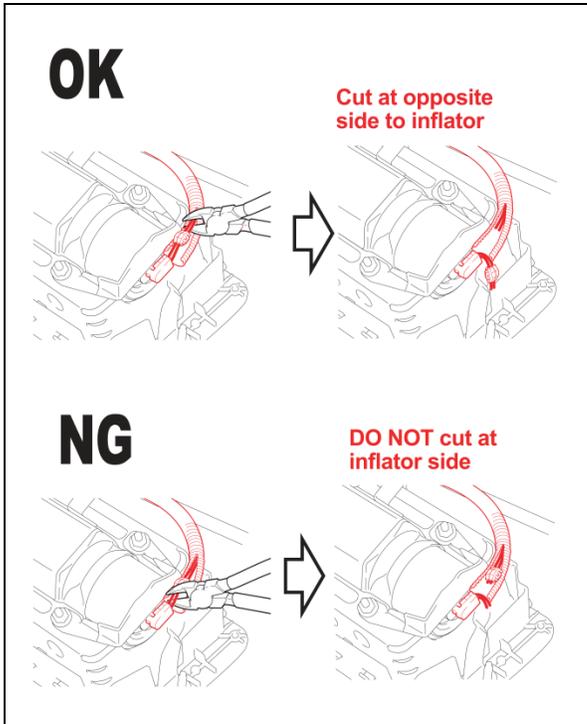
### 3. CREATE A NEW SHORT CIRCUIT IN THE INFLATOR HARNESS

a) Place one wire in the electro tap as shown in the illustration.

b) Fold and pinch the half of the electro tap with the wire and use pliers to lock the electro tap.

- **DO NOT** work on both wires at the same time to avoid errors.
- Pliers **MUST** be used to confirm the electro tap is firmly locked in place.

c) Set the other wire in the electro tap and lock it in place using pliers.

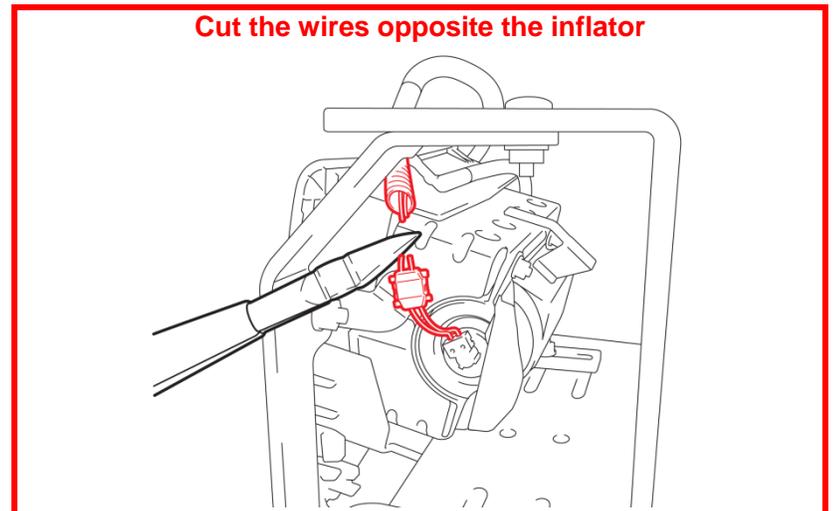
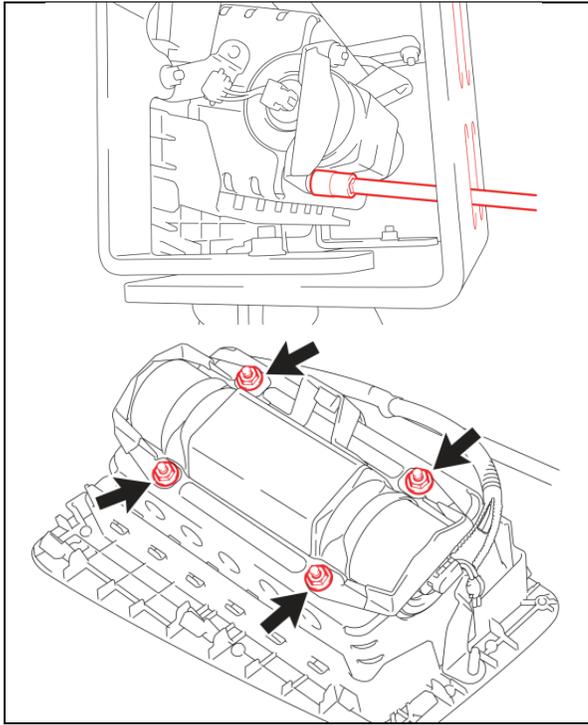
### 4. CUT THE INFLATOR WIRES

a) Cut the 2 wires at the side of the electro tap that is farthest away from the inflator.

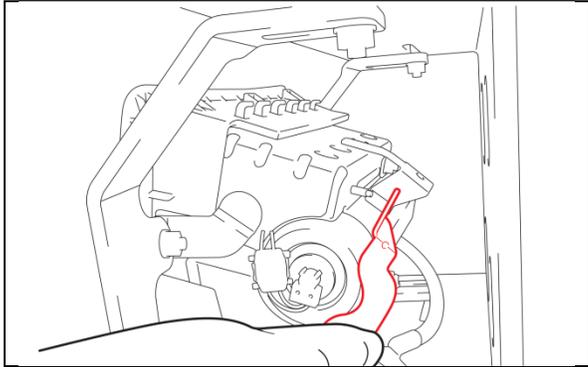
## 5. REMOVE THE SELF LOCKING NUTS

a) Use the access holes in the bracket to remove the 4 nuts.

- **DO NOT** use power tools.
- The bracket support bars may need to be repositioned to remove the nuts through the access holes.

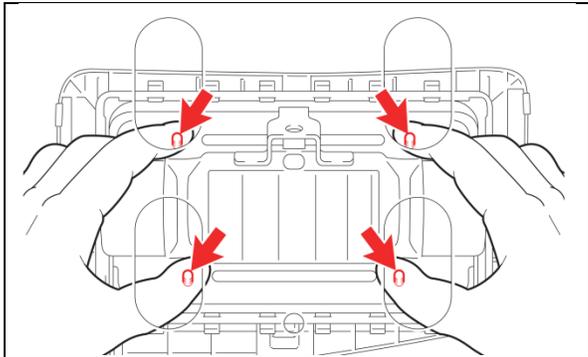
b) Remove the stopper plates.

c) Discard the 4 nuts and 2 stopper plates as they are not to be reused.

**NOTE: DO NOT** reuse the old nuts, new nuts **MUST** be used.

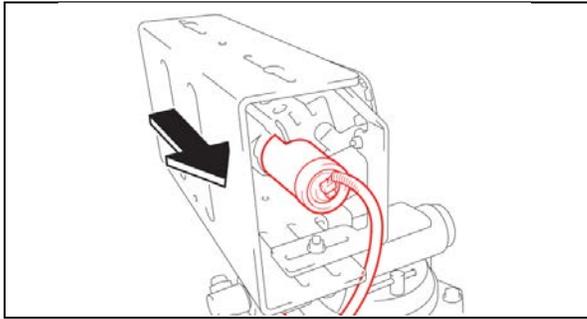
## 6. REMOVE THE INFLATOR

a) Gently push in the 4 studs to loosen the inflator for removal.

- b) Remove the inflator from the airbag assembly and place it on a safe work surface.

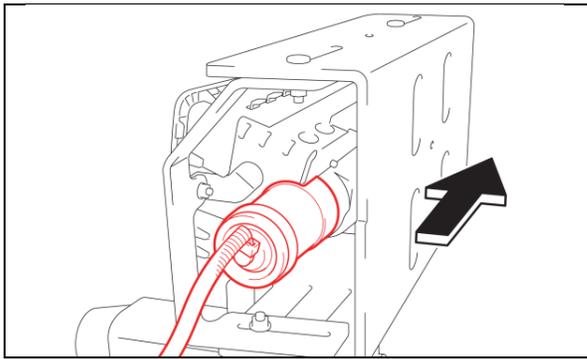
## 8. INSTALL THE **NEW** INFLATOR

- a) Carefully slide the new inflator into the airbag assembly.

- **DO NOT** connect the inflator harness at this time. It is **CRITICAL** to install the plates first to confirm the inflator is installed in the correct position before connecting the harness.

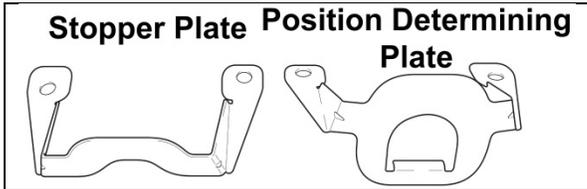
## 9. CONFIRM THE **NEW** PLATES

- a) Confirm the identification of the stopper plate and the position determining plate, **THEY ARE DIFFERENT**.

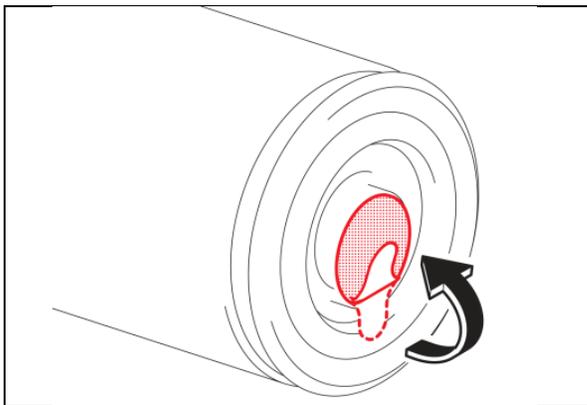
## 10. FOLD THE CONNECTOR SEAL

- a) Fold the seal in order to prevent it from being caught under the position determining plate in the next step.

**NOTE: DO NOT** fully remove the seal until just before connecting the harness.

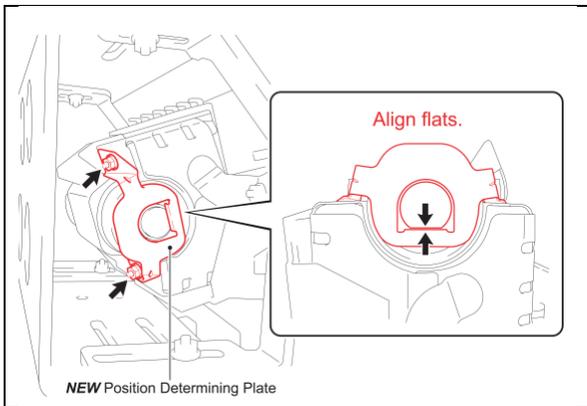
## 11. INSTALL THE **NEW** POSITION DETERMINING PLATE

- a) Place the **NEW** position determining plate on the airbag assembly on the side with the connector seal.  
b) Install **NEW** nuts by hand.

- Confirm the flats on the position determining plate and inflator are aligned.
- **DO NOT** pinch the harness between the inflator and the plate.

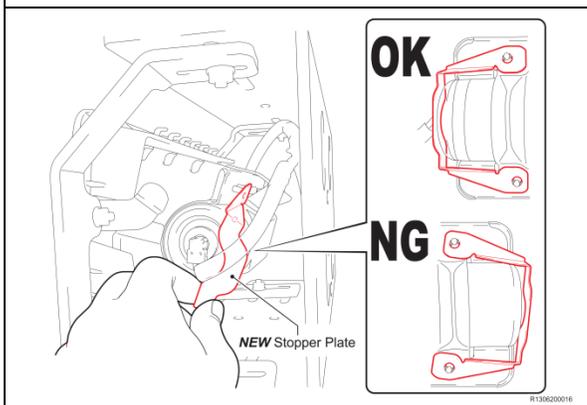
## 12. LOOSELY INSTALL A **NEW** STOPPER PLATE.

- a) Place the **NEW** stopper plate on the airbag assembly on the side where the harness is already connected.  
b) Confirm the end of the inflator sits flat against the stopper plate. If they do not align the inflator is installed backward.  
c) Install **NEW** stopper plate nuts by hand. They will be torqued on a later step.

- Confirm the stopper plate to inflator fitment is correct.
- **DO NOT** pinch the harness between the inflator and the stopper plate.

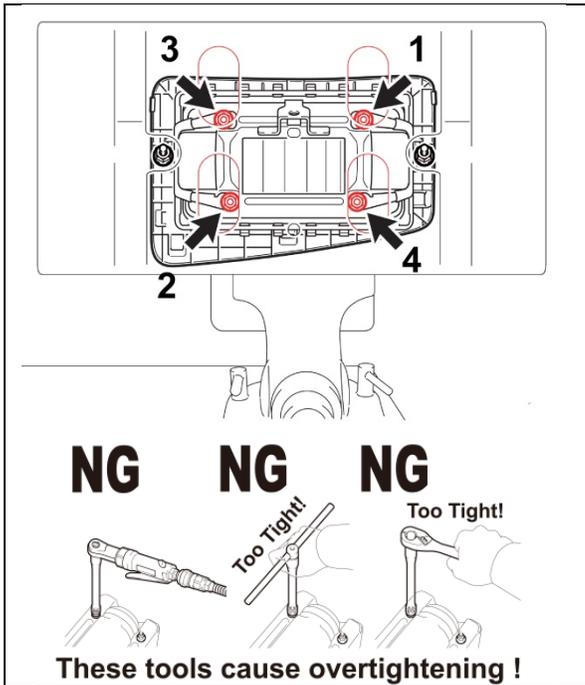
### 13. TORQUE THE PLATE NUTS

- a) Tighten the nuts evenly in two increments following the sequence shown in the illustration. Use a socket driver or torque wrench to tighten the nuts.

- There will be some resistance when tightening the nuts because they are self-locking, confirm the nuts are tightened correctly.
- DO NOT** use a power tool, T-handle, or ratchet when tightening the nuts to avoid over torquing.

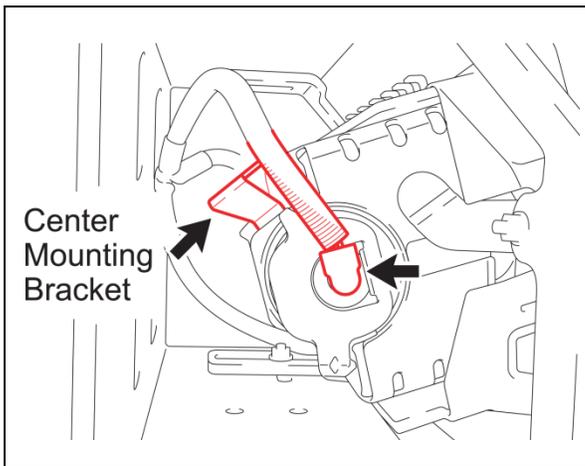
### 14. CONNECT THE INFLATOR CONNECTOR

- a) Remove the connector seal from the inflator.
- b) Confirm the alignment of the harness connector as shown in the illustration, then connect the harness. The connector wires should lead toward the center mounting bracket on the airbag assembly.

- The connector should be connected **IMMEDIATELY** after removing the seal.
- The connector is one-way, once it is installed it **CANNOT** be removed.
- If the connector is installed in the incorrect orientation the terminals may be bent or the connector may not fully engage.

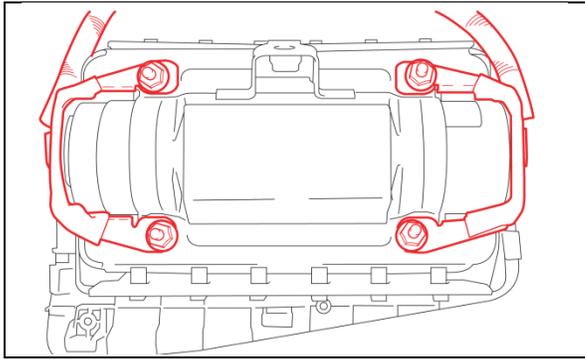
## 17. INSPECT THE AIRBAG BEFORE INSTALLATION

- a) Confirm that the 4 **NEW** plate nuts are installed and tight.
- b) Confirm the **NEW** stopper and position determining plates are installed.
- c) Confirm the flats on the position determining plate and inflator are aligned.
- d) Confirm the orientation of the inflator wire harness.

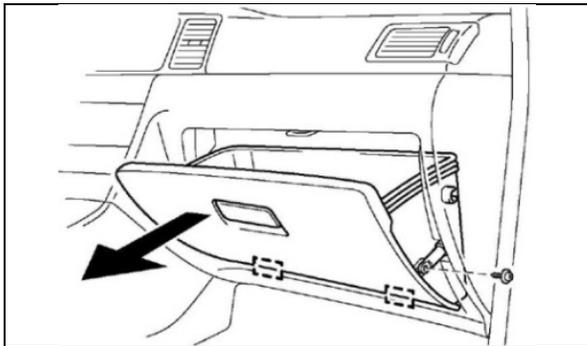
- Wait at least 90 seconds after disconnecting the cable from the negative battery terminal to prevent airbag and seat belt pre-tensioner deployment.
- Follow all precautions as outlined on TIS before servicing the SRS system.

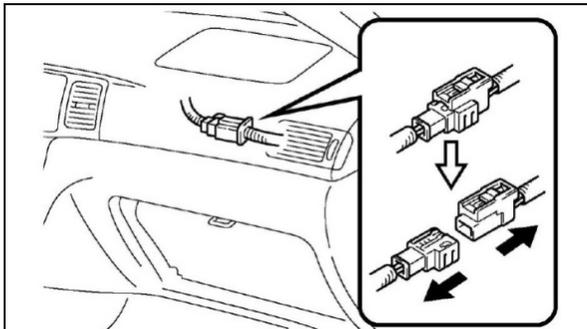
### 2. REMOVE THE GLOVE BOX

- a) Remove the screw and disconnect the stopper sub-assembly.
- b) Completely remove the glove box from the dashboard.

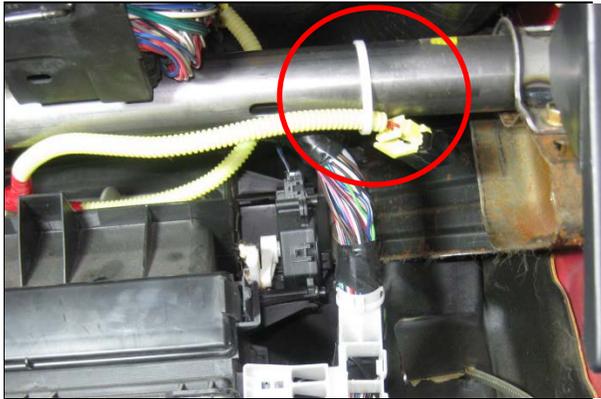
### 4. WRAP THE AIRBAG CONNECTORS WITH ELECTRICAL TAPE

Note: Wrapping the airbag connectors with tape will protect the electrical connectors and pins until the complete remedy is available.

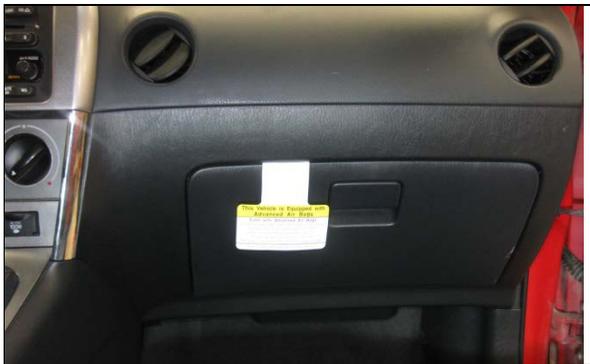
6. REINSTALL THE GLOVE BOX ASSEMBLY

- a) Install the stopper sub-assembly and secure it with the screw.
- b) Install the glove box and ensure it closes properly
