SERVICE BULLETIN

Subject: S-Series Platforms: 34in. x 54in., 32in. x 51in.
Applicable Products: S1205, S2005, S2010, S5005, S5010, S5505, S5010
Effectivity: 6/24/2014

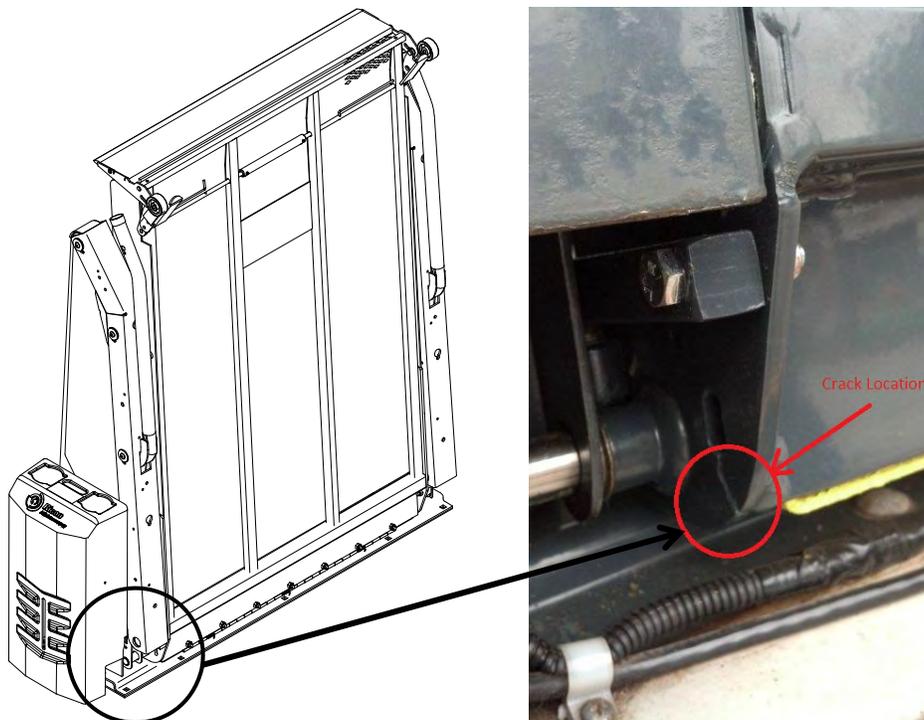
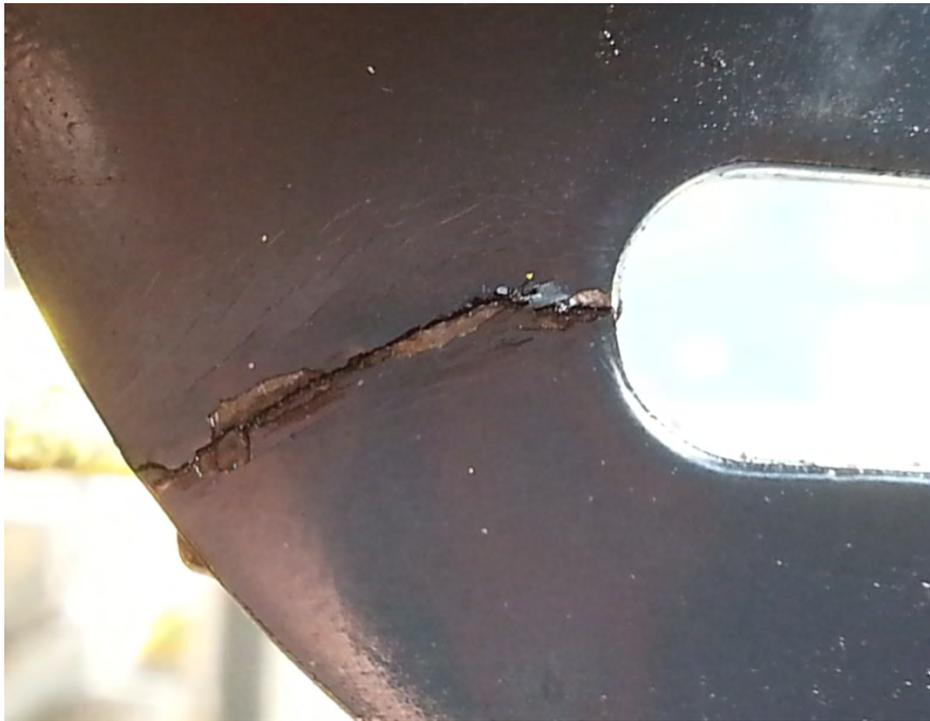
Under certain conditions the side plate of the larger platforms included on the subject S-Series model wheelchair lifts can exhibit cracking while in the stowed position which, if left unchecked can propagate to the point where separation of the rear portion of the side plate occurs rendering the lift inoperable and possibly unsafe to use.

The cracking as illustrated has been observed on less than 5% of the subject population and appears to be caused by a combination of factors including but not necessarily limited to, incomplete stowing of the lift and/or maladjustment or otherwise malfunctioning of the stow lock device combined with a violent side- to- side movement that might be associated with traversing curbs, speed bumps and other variable road conditions, especially at higher speeds.

If cracks are found, the platform must be replaced as soon as possible. Use the following part numbers for the associated model numbers.

For Models S1205-G, S1205VG	Use PN 33851
For Models S2005-S, S5005-S, S2005-T, S5005-T	Use PN V2-PF-389
For Models S2005-F, S5005-F, S2005-G, S2005-C, S2005VF, S2005-J	Use PN 32466
For Models S2005-L, S5005-L	Use PN 38330
For Models S2010-S, S2010-T, S5010-S, S5010-T	Use PN 16622
For Models S2010VF, S2010-C, S2010-F, S5010-F	Use PN 32469
For Models S5505-S	Use PN 34846
For Models S5505VF, S5505-C, S5505-F	Use PN 33485
For Models S5510VF, S5510-F, S5510C, S5510-J	Use PN 34249
