ATB 01724-01765 Version 3

Recall: Driver's Airbag Inflator May Produce Excessive Pressure After Long-Term Exposure to High Absolute Humidity

Year	Model	Trim	VIN Range
2008	Pilot	ALL	Check the iN VIN status for eligibility

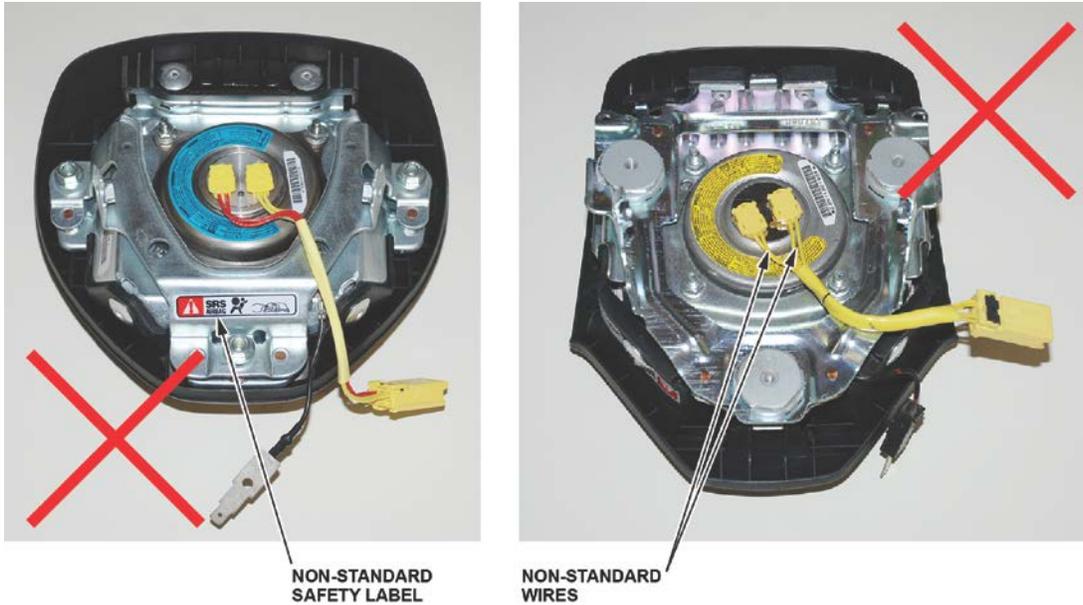
4. Visually inspect the airbag and the inflator for any unusual writing or markings.
 - If there is nothing unusual about the airbag or the inflator, go to step 5.
 - If there are any unusual markings, like an incorrect label or a model year written in marker, the airbag and inflator may not be the correct airbag and/or inflator for the vehicle or it may be a counterfeit part. For more information about counterfeit airbags, you can refer to safercar.gov, enter keywords **MANAGING COUNTERFEIT**, and select **Recommended Dealer Guidance for Managing Counterfeit Air Bags** from the list. **If you suspect that the airbag or inflator is counterfeit, do not continue this procedure.** Contact your DPSM for assistance.

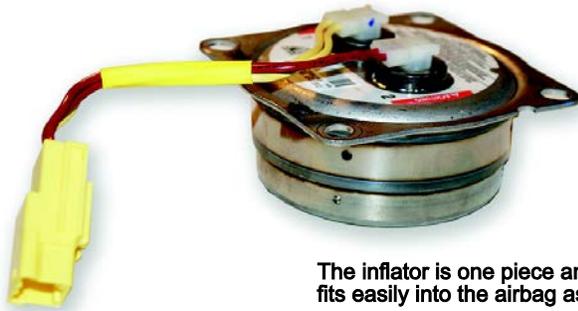
04770-S9A-306

Refer to **Driver's Inflator Type 1** in the video.

The inflator is one piece and fits easily into the airbag assembly.

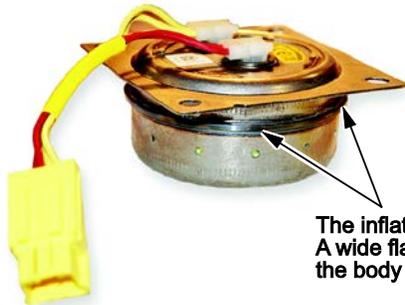
04770-S9A-405

Refer to **Driver's Inflator Type 2** in the video.

The inflator is one piece.
A wide flange is halfway up
the body of the inflator.
