**TECHNICAL INSTRUCTIONS
FOR
SAFETY RECALL DSF
FRONT PASSENGER AIRBAG INFLATOR MODULE
CERTAIN 2002 – EARLY 2004 MODEL YEAR SEQUOIA
SSC D0F is no longer valid and has been replaced by SSC DSF**

Updated 4/15/15

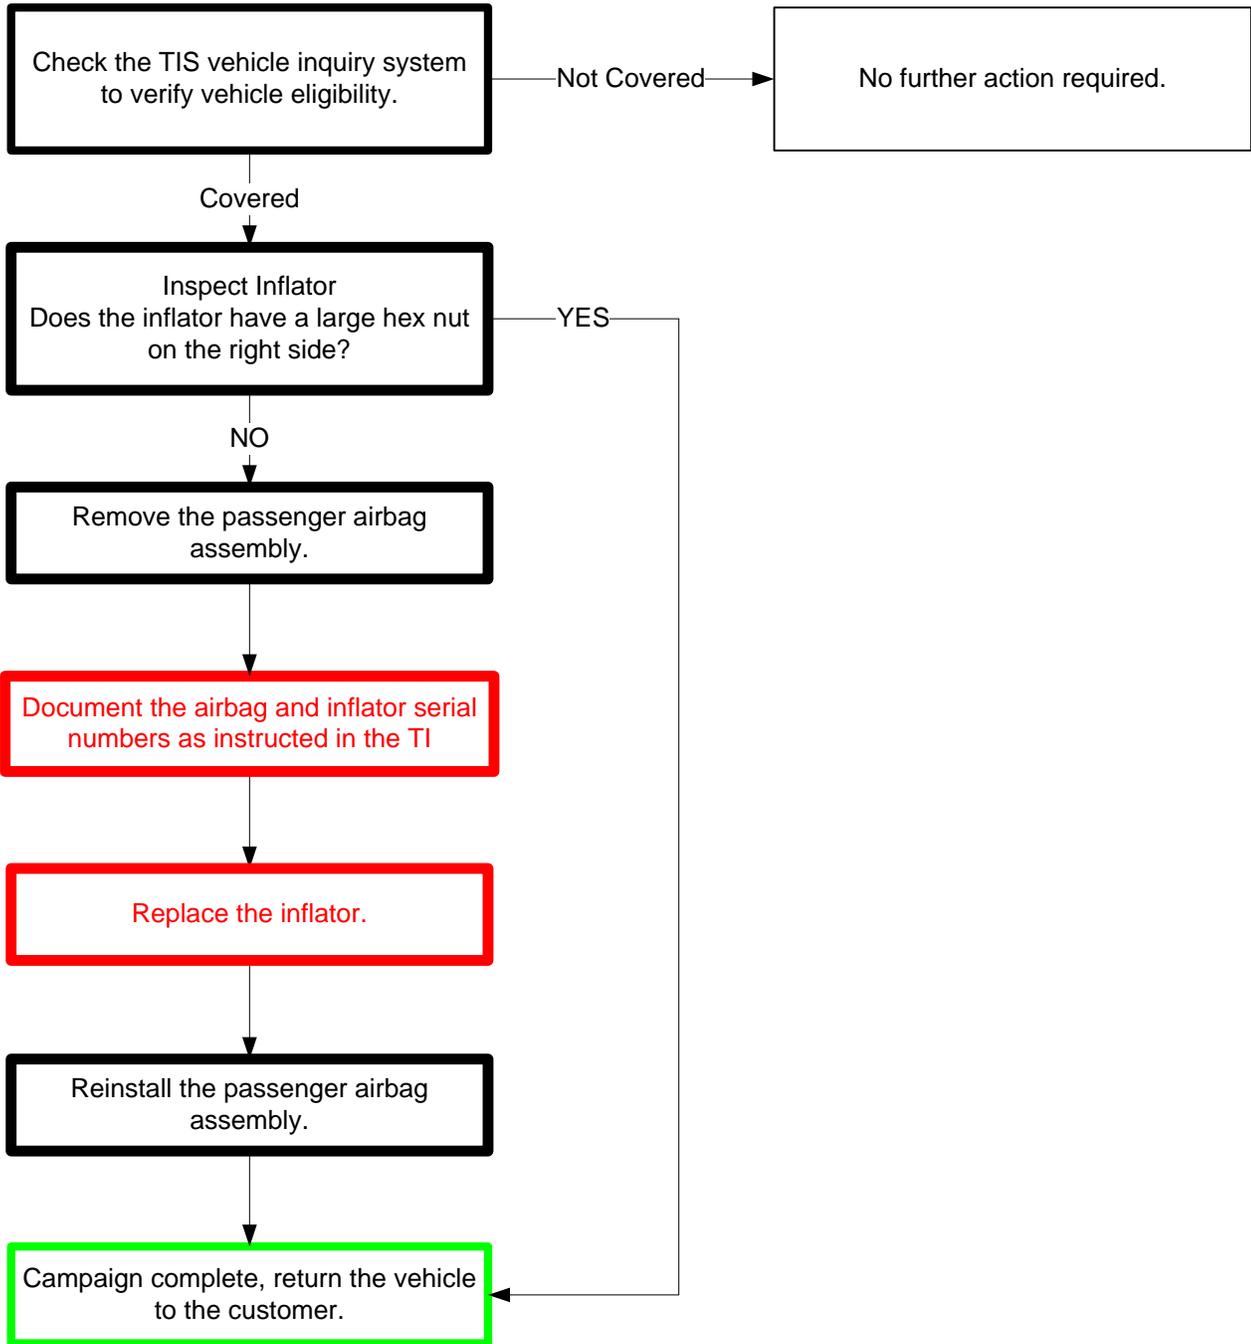
I. OPERATION FLOW CHART

The flow chart is for reference only. **DO NOT** use it in place of the full technical instructions. Follow **ALL** steps as outlined in the full technical instructions to confirm the campaign is completed correctly.

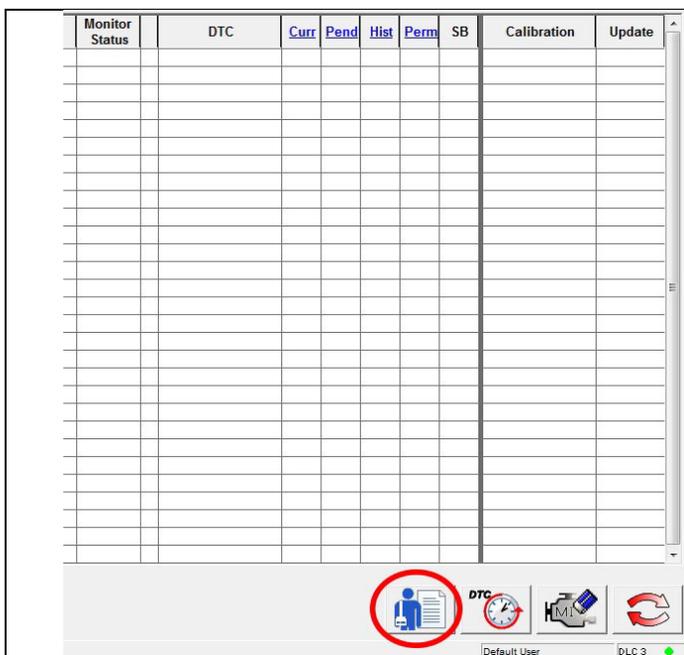
2. RUN A DIAGNOSTIC REPORT

- After the health check has completed, run a diagnostic report by clicking on the link on the health check screen.

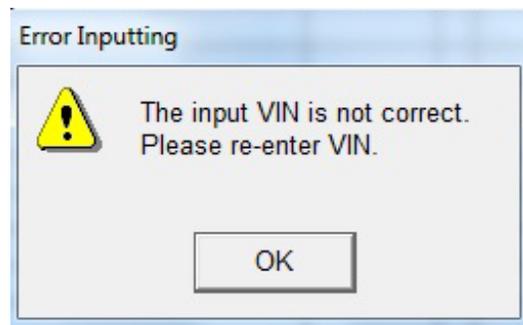
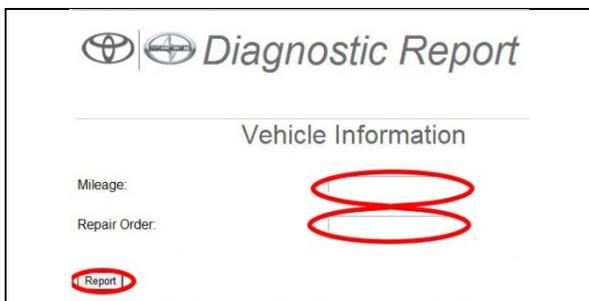
NOTE: If the VIN was not entered in ALL CAPS when Techstream was launched, an error will be displayed and there will be a prompt to reenter the VIN

- Enter the vehicle mileage and repair order information, then click the 'report' button.

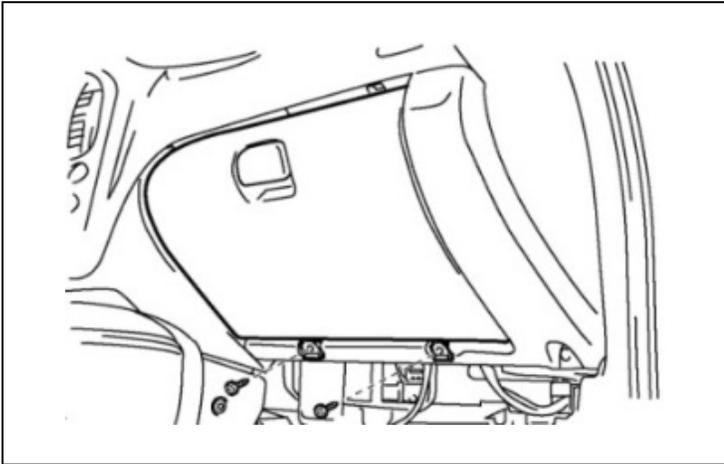
1. REMOVE THE GLOVE BOX AND FINISH PANEL

- a) Remove the 2 screws and the glove box.
- b) Remove the 3 screws, disconnect the courtesy light connector and remove the lower No.2 finish panel that is behind the glove box.

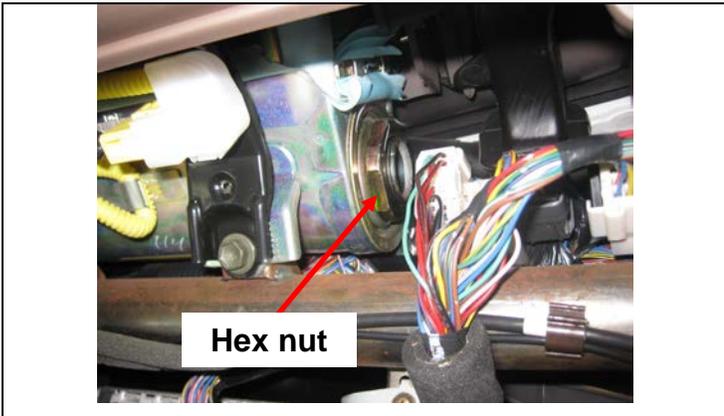
2. INSPECT INFLATOR TYPE

- a) Inspect the inflator.
- b) If the inflator has a large hex nut on the right side this vehicle is **NOT INVOLVED** in the SSC.
- c) Proceed to Step 3.
- d) If the inflator **DOES NOT** have the large hex nut. Proceed to **Section IX Front passenger airbag assembly removal**.

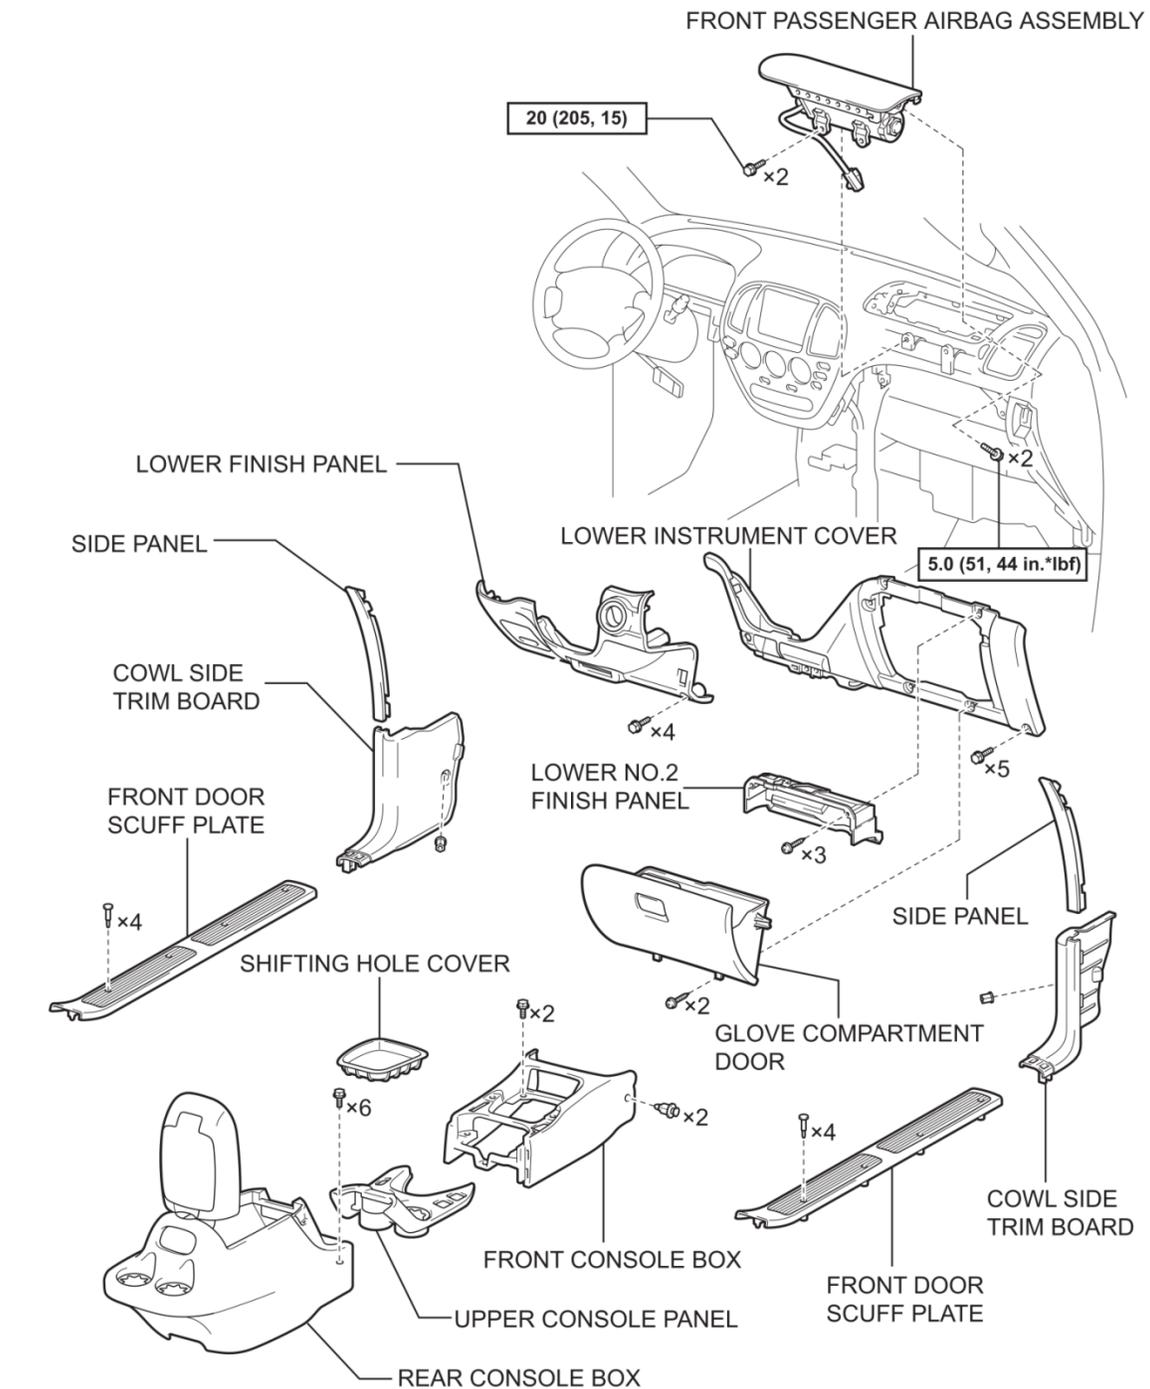
R1302220006

a) Refer to TIS for instructions on airbag removal: [Sequoia](#)

N*m (kgf*cm, ft.*lbf) : Specified torque

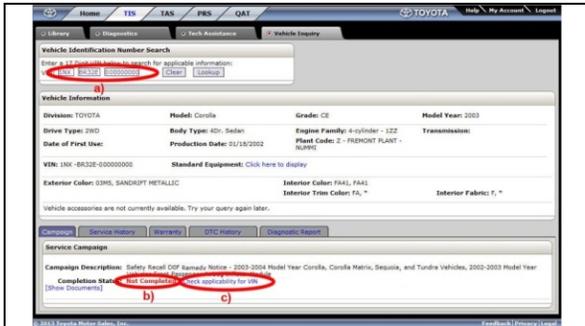
LAUNCH THE SERIAL NUMBER RECORDING APPLICATION

- Log in to TIS and input the VIN of the vehicle in the Vehicle Inquiry tab.
- Confirm the VIN is applicable and that the campaign has not been completed.
- Click on the link to launch the serial number recording application.

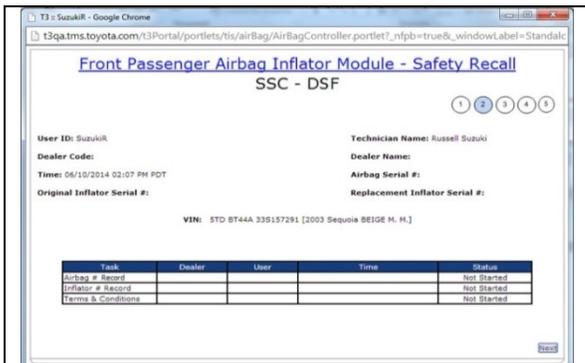
d) Reenter TIS password in the serial number recording application.

NOTE: The person logged-in to TIS should be the person performing the repair.

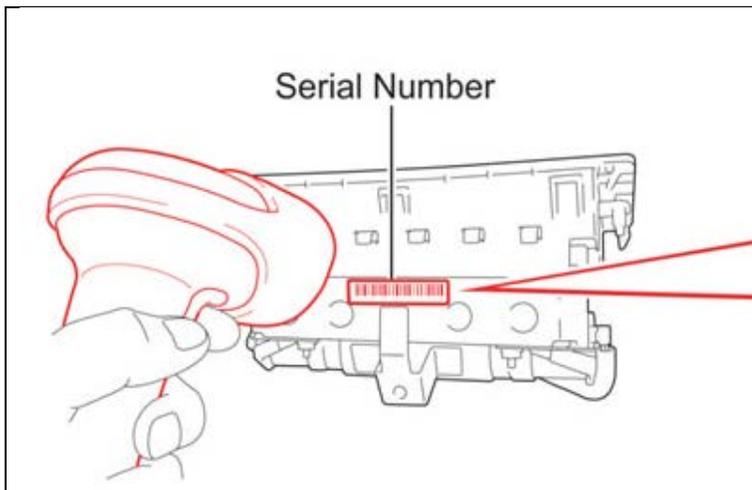
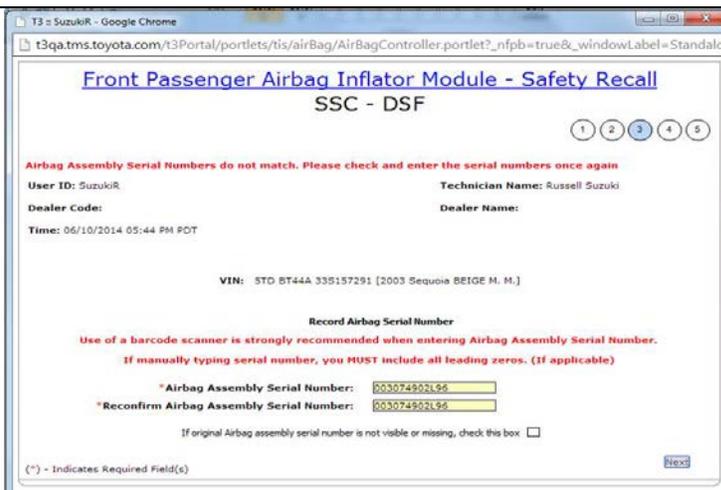
Airbag Serial Number Label Example

- The airbag serial number is **ALWAYS** the 12 **DIGITS** located between the asterisks.
- The 3 digits before the asterisk **ARE NOT** part of the serial number, and **SHOULD NOT** be entered or an inaccurate response may be returned.

The **AIRBAG ASSEMBLY** serial number and the **INFLATOR** serial number are **DIFFERENT**. The **AIRBAG ASSEMBLY** serial number **MUST** be recorded prior to replacement.

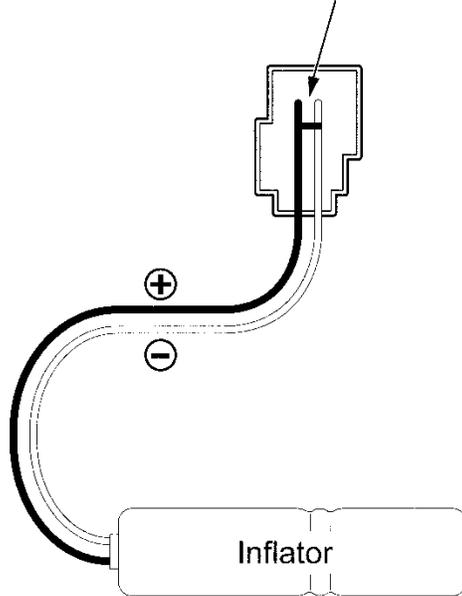
(1) Short circuiting on both sides.

The connector of the inflator module contains a short circuiting mechanism to eliminate voltage variances when the connector(1) is disconnected. To allow for the replacement of the inflator module, a new short circuit(2) **MUST** be created before cutting the wires(3) and removing the inflator. The following steps **MUST** be followed exactly as described to ensure the work is completed correctly and safely.

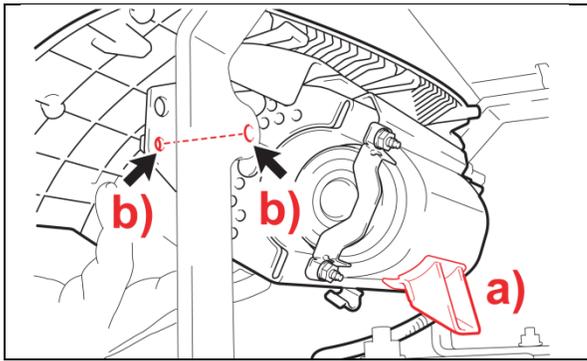
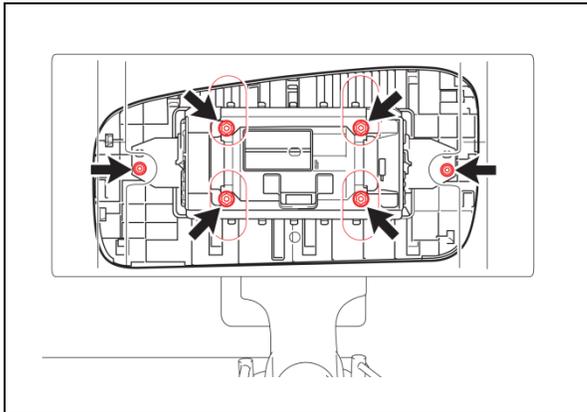
1. MOUNT THE AIRBAG IN THE MOUNTING BRACKET

- Position the airbag assembly so that the center mounting bracket is facing towards the ground.
- Install the airbag to the support bars with the bolts supplied in the bracket kit.

NOTE: The airbag assembly will only fit on the support brackets one way.

- Position the airbag so that all four stopper plate nuts can be removed through the access holes.
- Tighten the bolts holding the support bars to the mounting bracket.
- Confirm the following:
 - Mounting bracket is secure in the vise.
 - Airbag is secure in the support bars.
 - The center mounting bracket on the airbag assembly is facing downward.
 - Support bars are secure on the mounting bracket using 1 bolt/nut at the top of each support bar and 2 nuts/bolts at the bottom of each support bar.

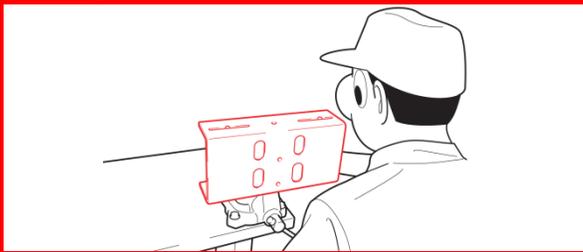
ALWAYS keep as much of your body as possible in front of the bracket when working on the airbag assembly.

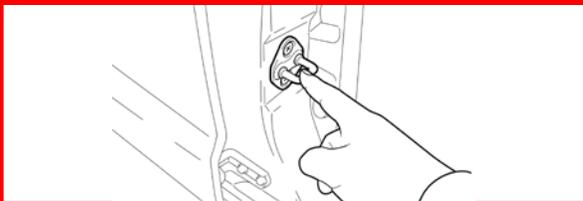
Remember to periodically touch a metallic part of the vehicle to discharge static electricity in the body if the anti-static kit is not being used.

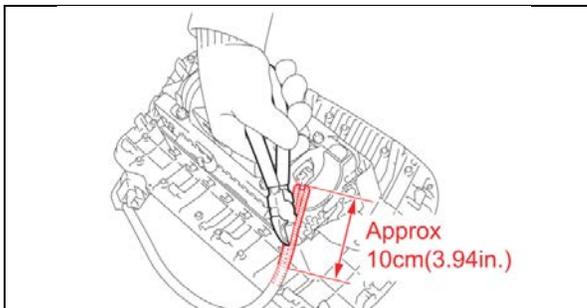
2. PREPARE TO INSTALL THE SHORT CIRCUIT

- Cut the yellow corrugated tube on the harness approximately 4 inches (10 cm) using nippers.

- DO NOT** damage the wires in the tube.
- DO NOT** use a knife or razor blade to cut the tube to avoid damaging the wires.
- This may be performed on either end of the inflator.

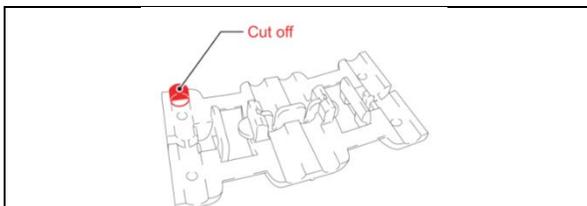
- Cut off the tab of the electro tap shown in the illustration.

This tab **MUST** be removed to ensure a good short.

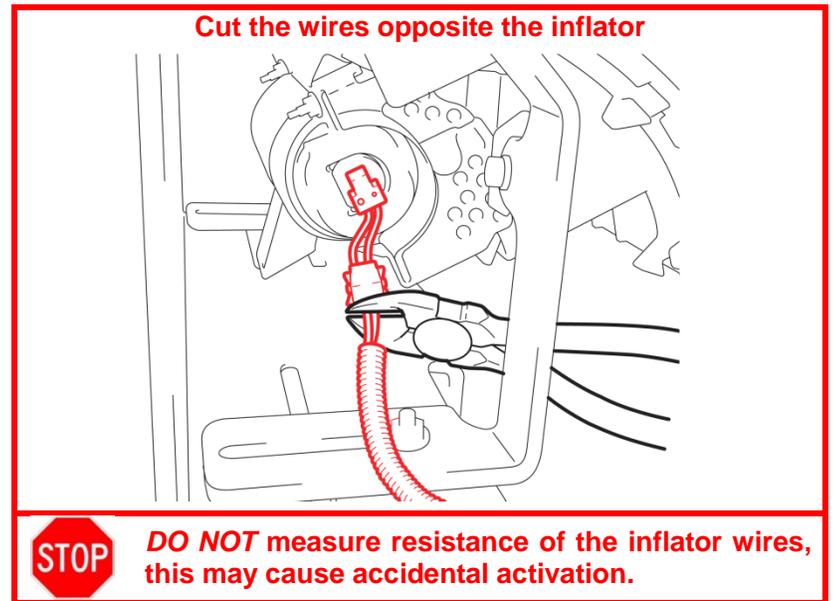
4. CUT THE INFLATOR WIRES

- a) Cut the 2 wires at the side of the electro tap that is farthest away from the inflator.

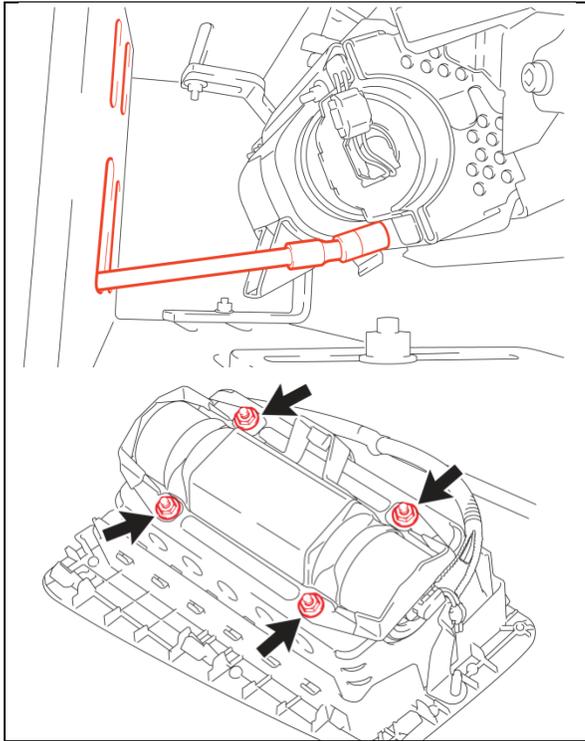
5. REMOVE THE SELF LOCKING NUTS

a) Use the access holes in the bracket to remove the 4 nuts.

- **DO NOT** use power tools.
- The bracket support bars may need to be repositioned to remove the nuts through the access holes.

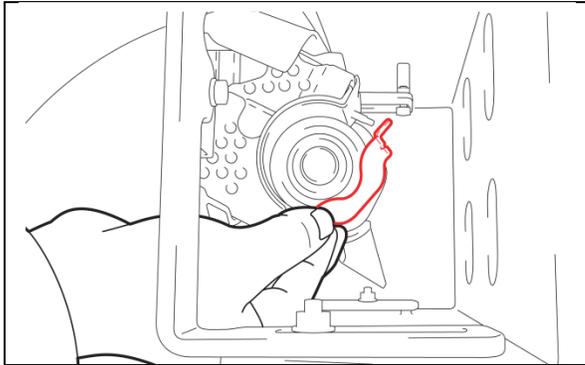
b) Remove the stopper plate and place in a secure location because it will be reused.

STOP **DO NOT** discard the Stopper Plate, it will be reused.

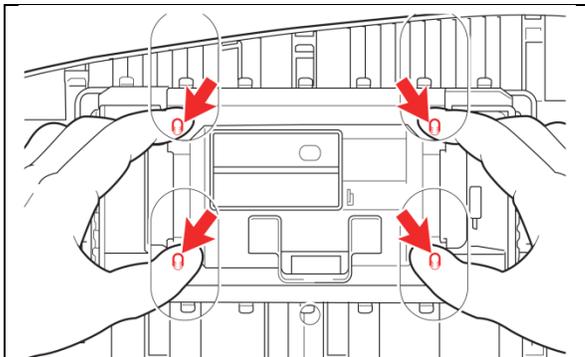
6. REMOVE THE INFLATOR

a) Gently push in the 4 studs to loosen the inflator for removal.

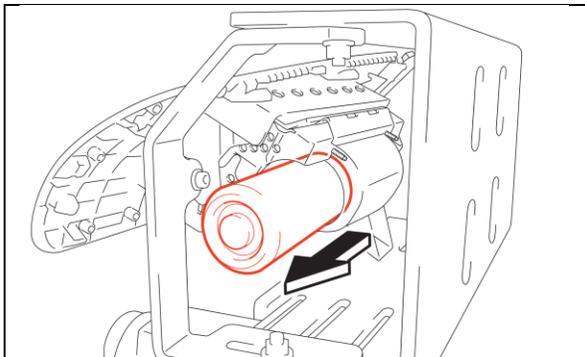
b) Remove the inflator from the airbag assembly and place it on a safe work surface.

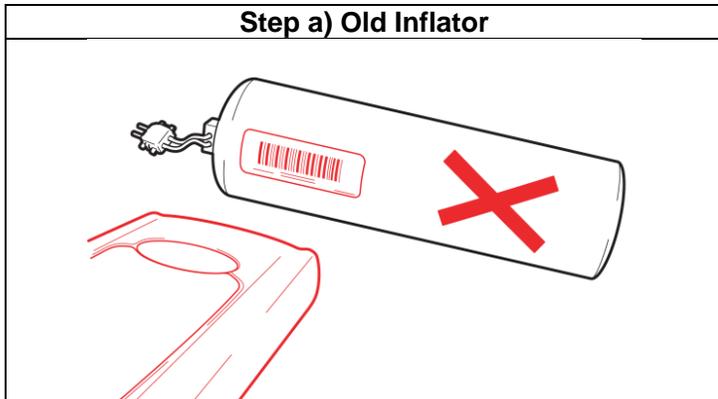
- Confirm agreement by checking the two boxes.
- Record the Warranty Authorization # to be included in the warranty claim.
- Place the old inflator in the parts box and take it immediately to the parts department.

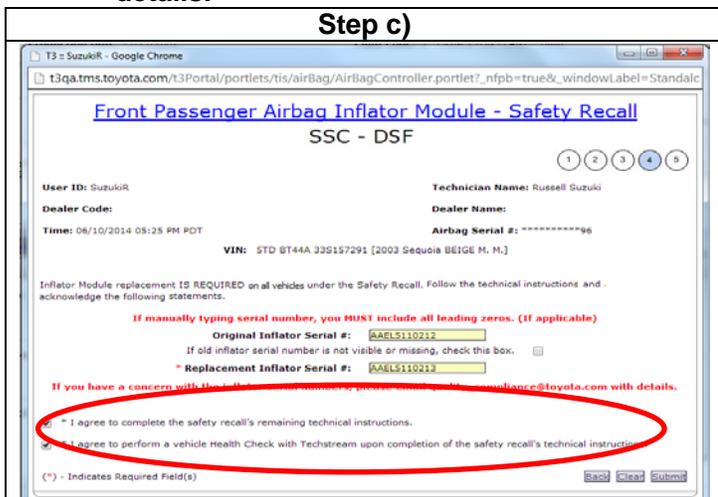
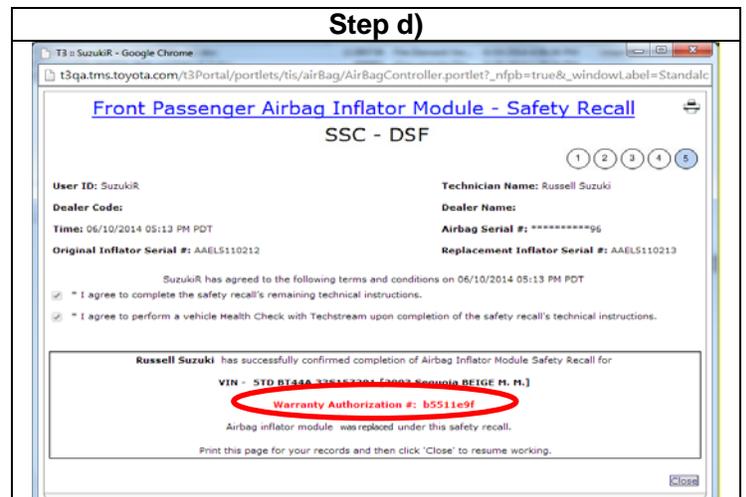
- Confirm the cursor is in the correct serial number input box before scanning.
- If the serial number barcode will not scan, it can be entered manually.
- If there are any difficulties or concerns with this process, email quality_compliance@toyota.com with details.

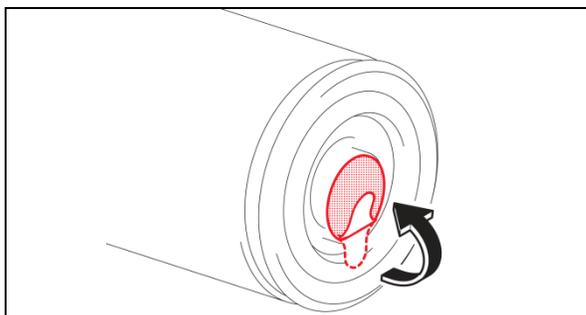
8. FOLD THE CONNECTOR SEAL

- Fold the seal in order to prevent it from being caught under the airbag assembly bracket in the next step.

NOTE: DO NOT fully remove the seal until just before connecting the harness.

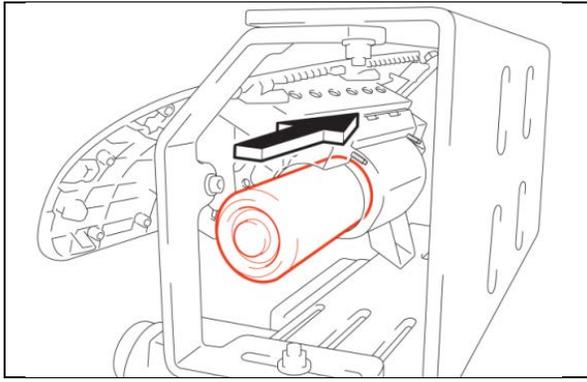
9. INSTALL THE **NEW** INFLATOR

- a) Carefully slide the new inflator into the airbag assembly.

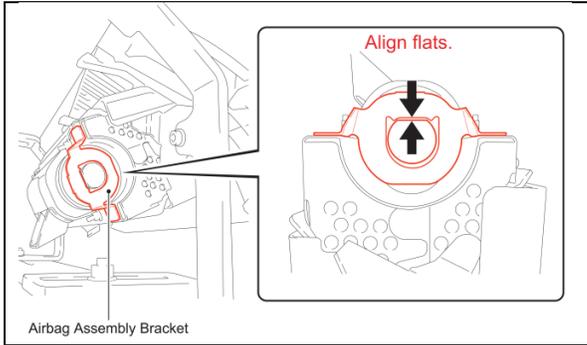
10. CONFIRM THE INFLATOR ALIGNMENT

- a) Align the flat on the inflator with the flat on the airbag assembly bracket.

Confirm the flats on the airbag assembly and inflator are aligned.

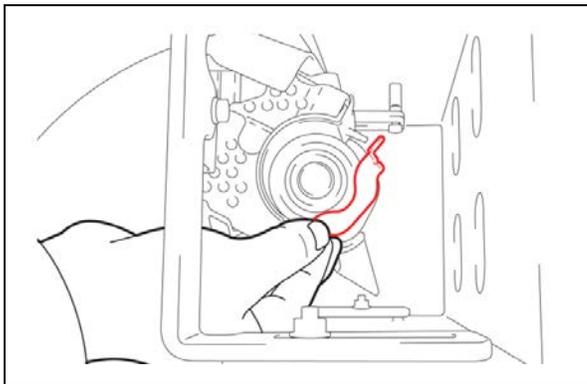
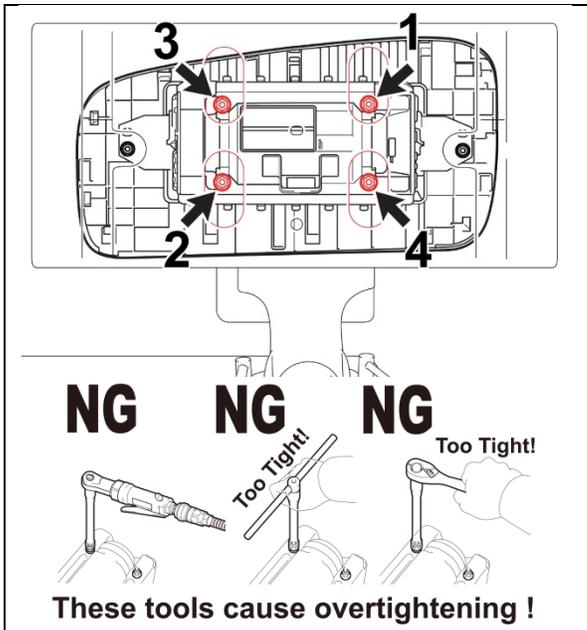
12. TORQUE THE PLATE NUTS

- a) Tighten the nuts evenly in two increments following the sequence shown in the illustration. Use a socket driver or torque wrench to tighten the nuts.

Torque: 35in. lbf (3.9N·m)

- There will be some resistance when tightening the nuts because they are self-locking, confirm the nuts are tightened correctly.
- **DO NOT** use a power tool, T-handle, or ratchet when tightening the nuts to avoid overtightening.

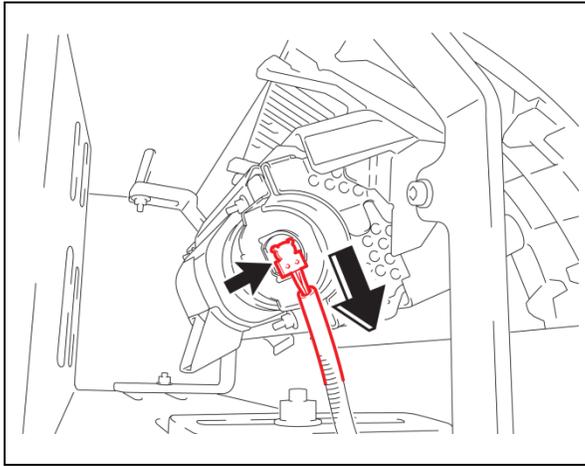
13. CONNECT THE INFLATOR CONNECTOR

- a) Remove the connector seal from the inflator.
- b) Confirm the alignment of the harness connector as shown in the illustration, then connect the harness. The connector wires should lead downward toward the center airbag mounting bracket.

- The connector should be connected **IMMEDIATELY** after removing the seal.
- The connector is one-way, once it is installed it **CANNOT** be removed.
- If the connector is installed in the incorrect orientation the terminals may be bent or the connector may not fully engage.

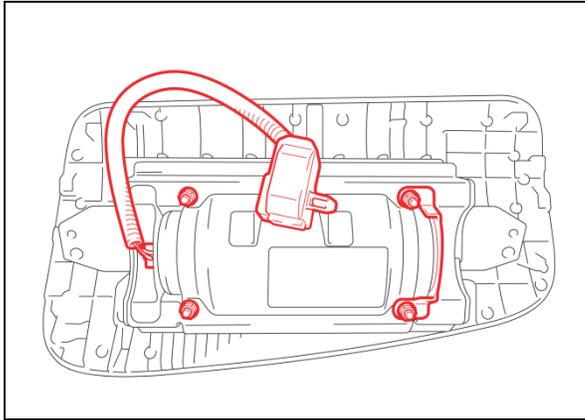
14. REMOVE THE AIRBAG ASSEMBLY FROM THE BRACKET

- a) Remove the two bolts and the airbag assembly, then place the assembly on a cloth or the anti-static mat if it being used.
