ATB 51971-01680 Version 7

Safety Recall: Replacement Driver's Airbag Inflator Can Be Over-Pressurized

REPAIR PROCEDURE – ACCORD ONLY

REPAIR PROCEDURE B – CIVIC, CIVIC HYBRID, CR-V, AND ODYSSEY

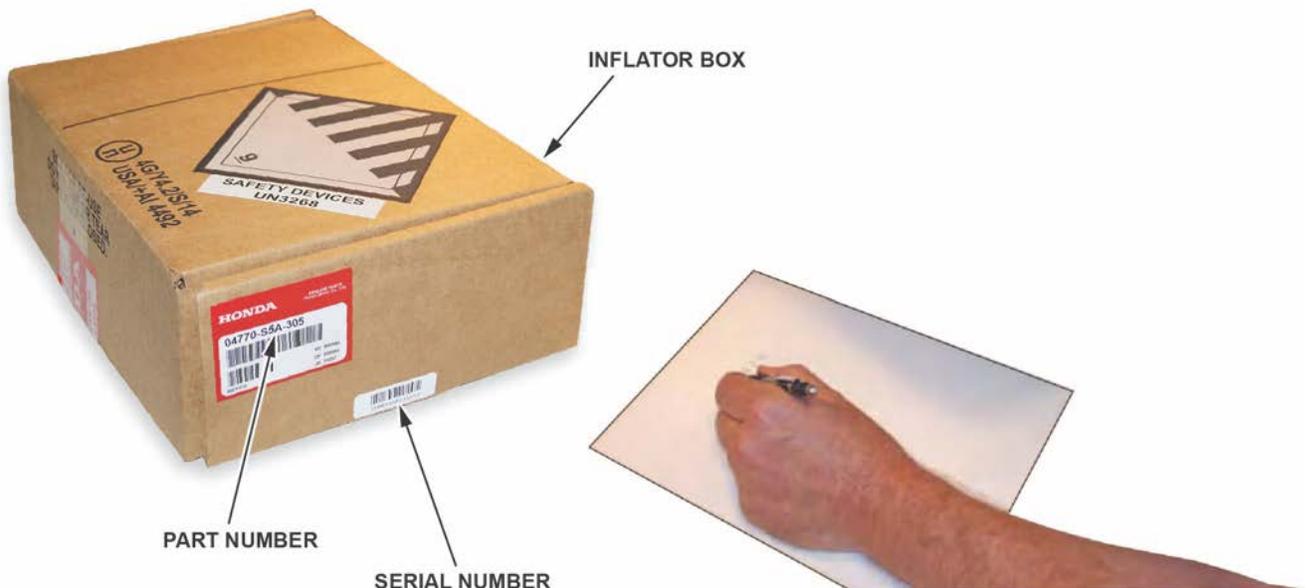
- Be careful not to damage any parts when replacing the inflator, and **follow the procedure exactly**.
- If, before removing the airbag, you suspect that it may be the incorrect airbag for the vehicle or a counterfeit, **do not remove the airbag**. Contact your DPSM for assistance.
- Do not open the inflator kit until you have confirmed a Takata inflator is installed in the vehicle because if you have to return the inflator, the kit must be unopened.
 1. Remove the driver's airbag by referring to the applicable electronic service manual.
 2. Write down the serial number and part number located on the right side of the new inflator's box. For the warranty claim to be paid, the **replacement inflator part number that you received** must be on the warranty claim and your warranty clerk must enter the serial number in the Diagnostic Trouble Codes field.

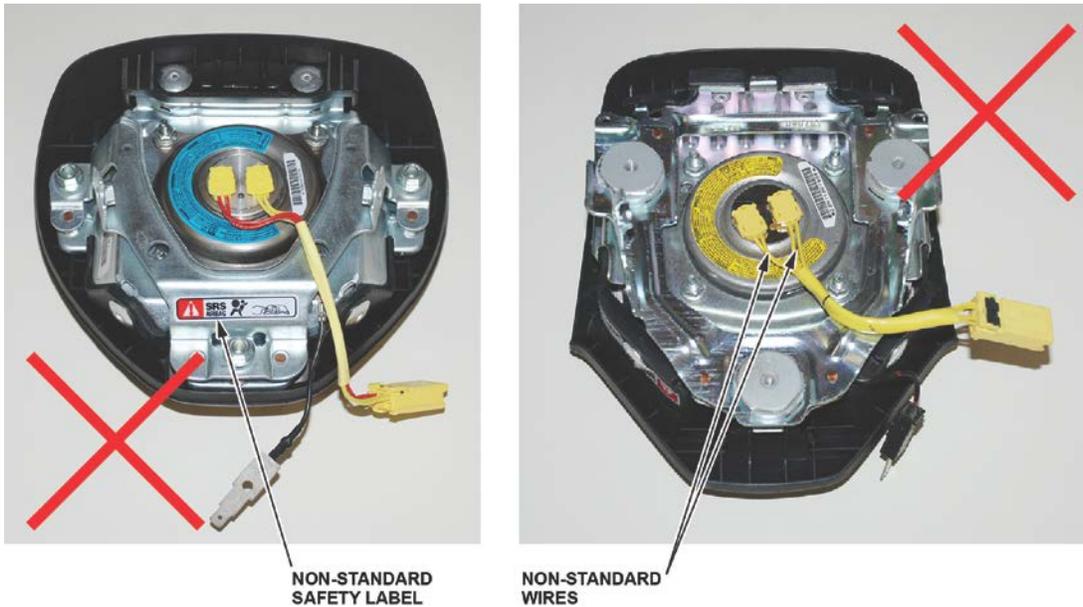
3. Place the airbag, face down, on a clean shop towel.
4. Visually inspect the airbag and the inflator for any unusual writing or markings.
 - If there is nothing unusual about the airbag or the inflator, go to step 5.
 - If there are any unusual markings, like an incorrect label or a model year written in marker, the airbag and inflator may not be the correct airbag and/or inflator for the vehicle or it may be a counterfeit part. For more information about counterfeit airbags, you can refer to safercar.gov, enter keywords **MANAGING COUNTERFEIT**, and select **Recommended Dealer Guidance for Managing Counterfeit Air Bags** from the list. **If you suspect that the airbag or inflator is counterfeit, do not continue this procedure.** Contact your DPSM for assistance.

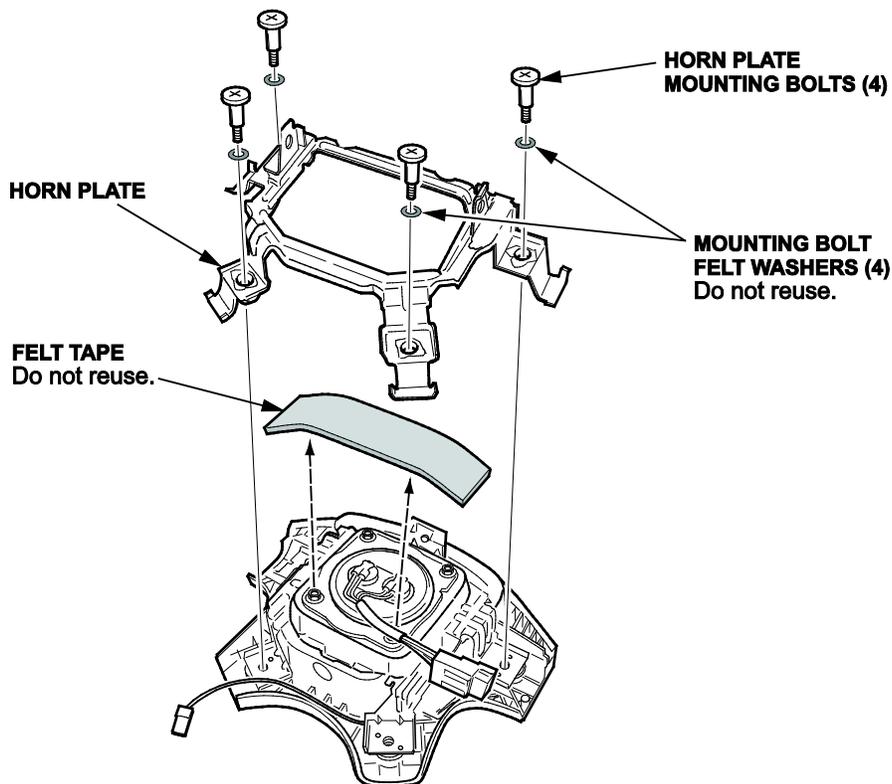
5. Remove the four horn plate mounting bolts, the mounting bolt felt washers, and the horn plate. The felt washers will not be reused.

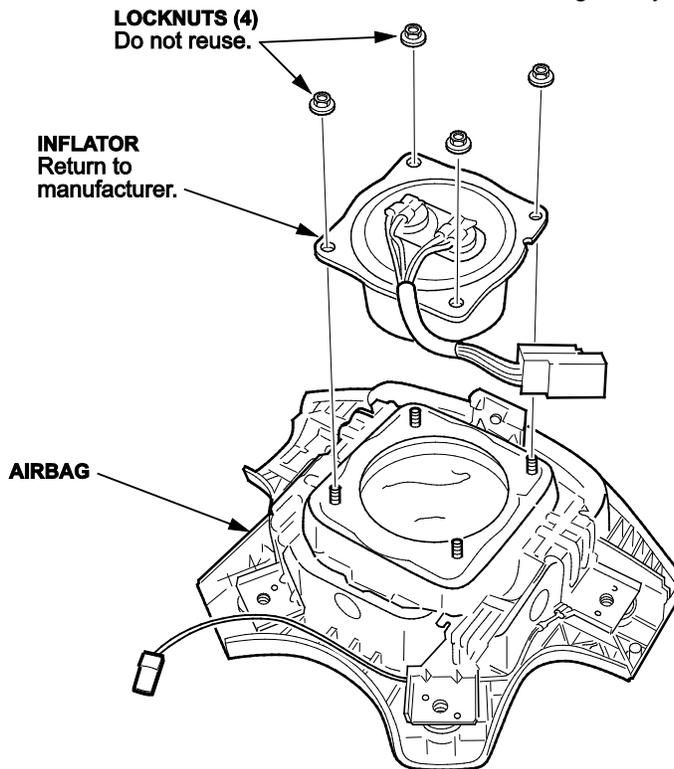
6. Remove and discard the felt tape covering the lower two inflator locknuts.
7. Using needle-nose vise grips or a 3/8 in. 6-point socket, remove the four locknuts from the inflator. The locknuts will not be reused.

NOTE: Do not remove the inflator from the airbag until you complete step 8.

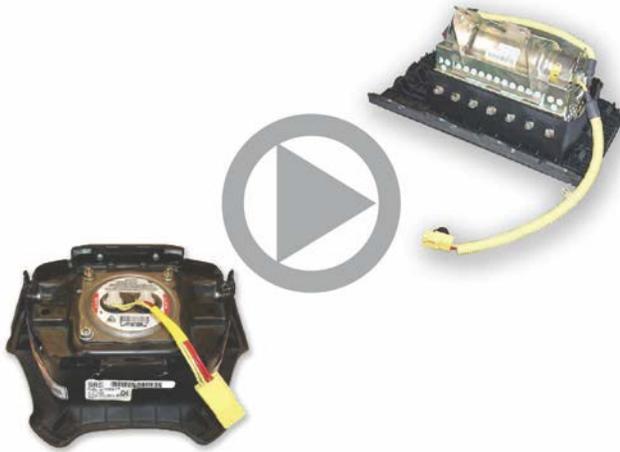
Click on the image below for a short video about the different variations of the driver's and front passenger's replacement inflators involved with the recalls related to replacing Takata inflators. While both the driver's and front passenger's inflators are shown in the video, this is informational only. Replace inflators only as directed by the iN VIN status inquiry.

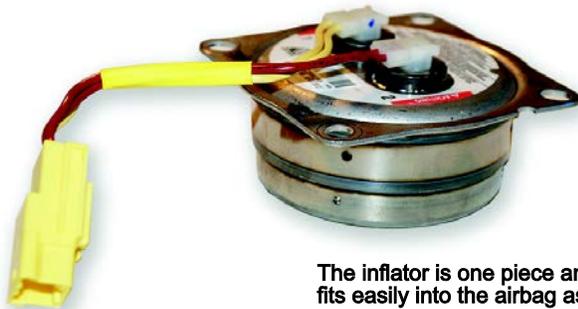
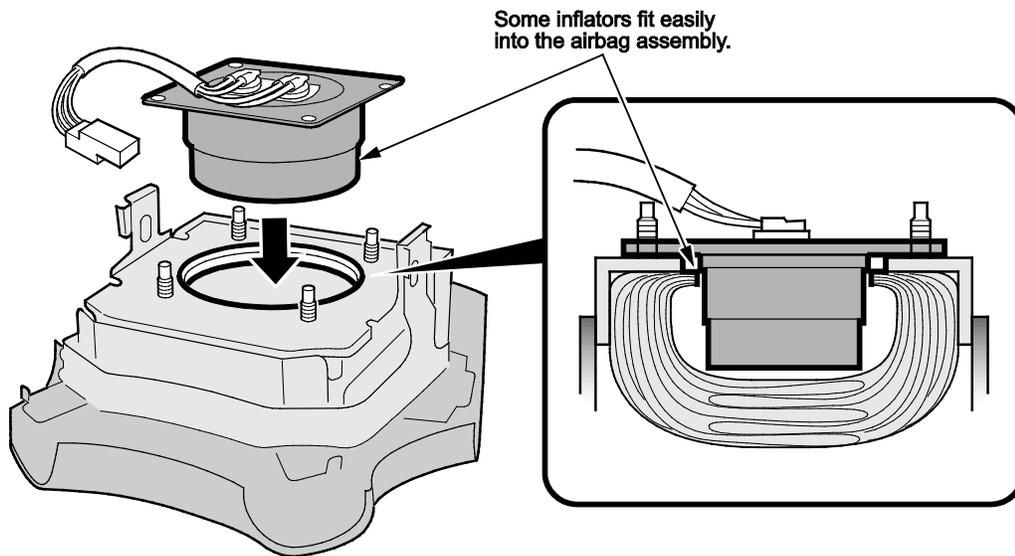
04770-S5A-305

Refer to **Driver's Inflator Type 1** in the video.

The inflator is one piece and fits easily into the airbag assembly.

- Insert the inflator into the opening.

NOTE: Make sure the inflator wires toward the bottom of the airbag. If you install the inflator incorrectly, you may not be able to reconnect the SRS airbag harness.

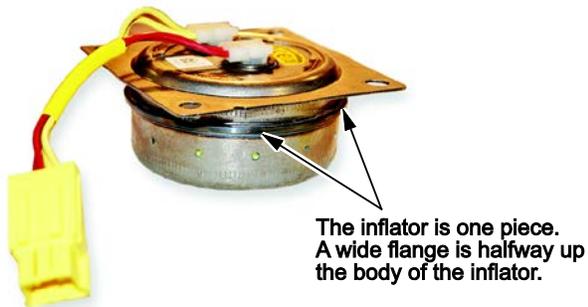
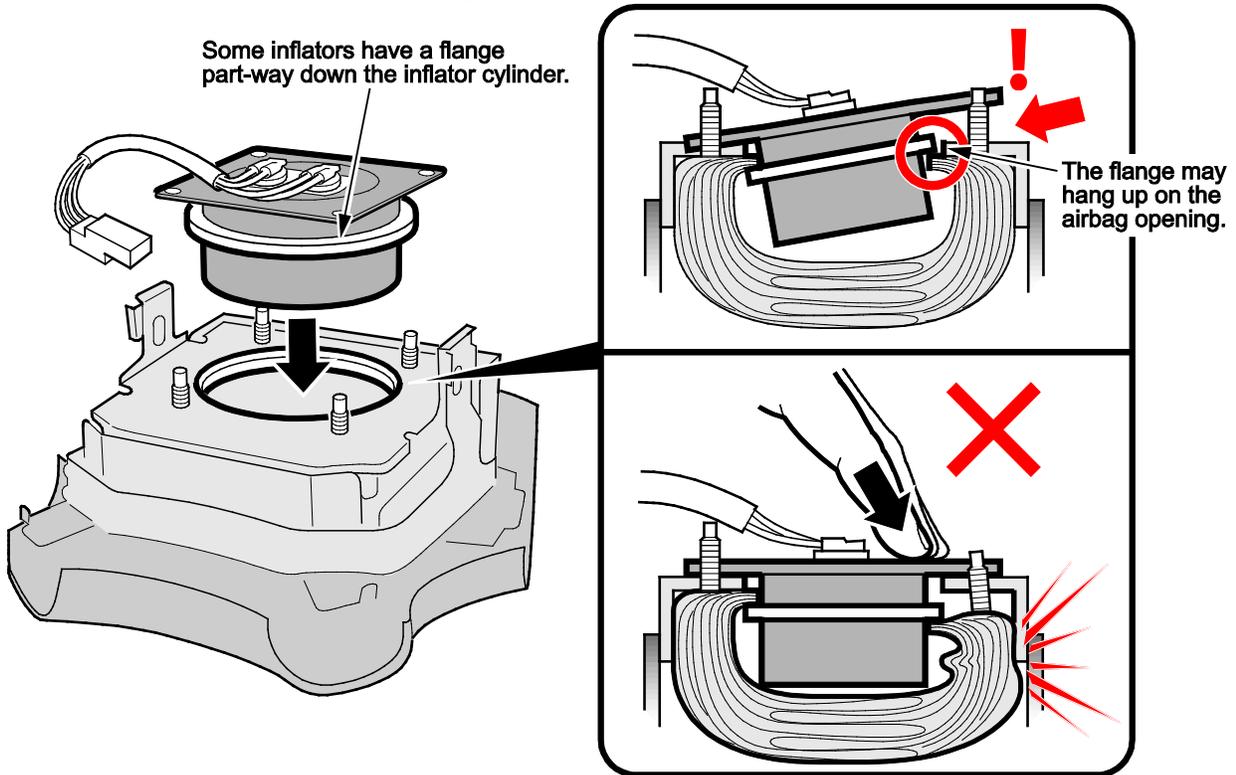
04770-S5A-405

Refer to **Driver's Inflator Type 2** in the video.

- Insert the airbag inflator into the opening. Do not force it into the airbag module.

NOTE: Make sure the inflator wires toward the bottom of the airbag. If you install the inflator incorrectly, you may not be able to reconnect the SRS airbag harness.

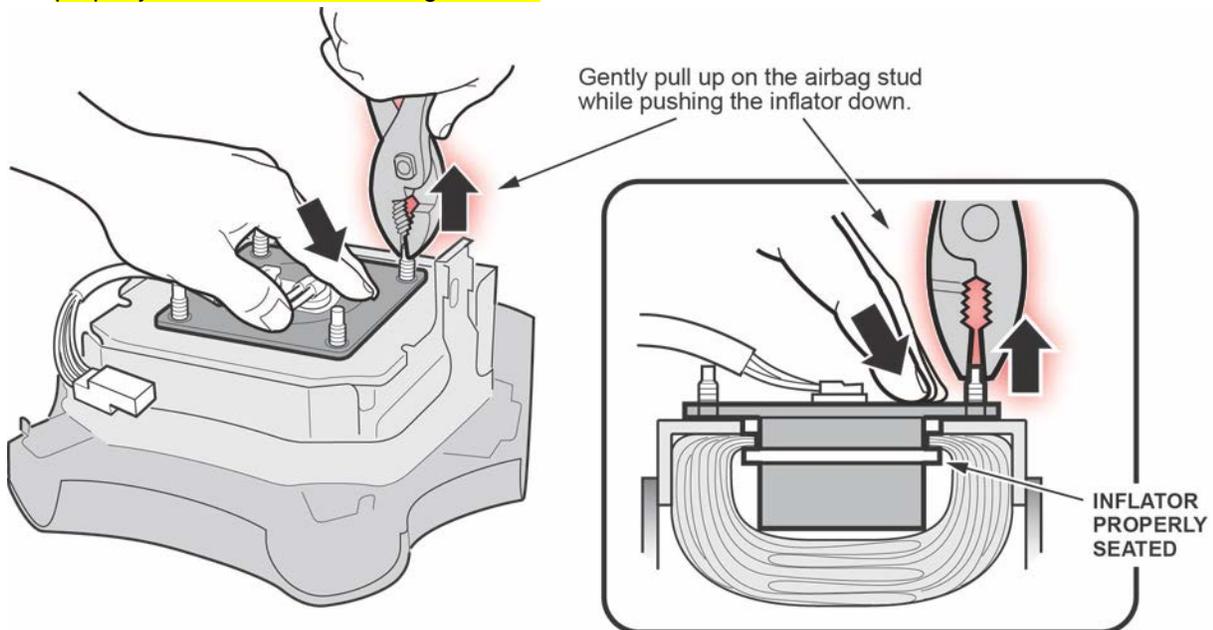
- Using a pair of pliers, gently pull up on each stud up while pushing the inflator module down until the airbag is properly seated within the airbag module.

11. Install and torque the new locknuts to **3.9 N·m (2.8 lb-ft, 34 lb-in)**.
12. Cover the lower two inflator locknuts with new felt tape.
13. Reinstall the horn plate with new felt washers on its mounting bolts. Torque the mounting bolts to **3.4 N·m (2.5 lb-ft, 30 lb-in)**, then make sure the horn plate moves freely.
14. Reinstall the driver's airbag using new Torx bolts and torque the bolts to **9.8 N·m (7.2 lb-ft)**.
15. Give your warranty clerk the inflator serial number and part number that you wrote down in step 2. For the warranty claim to be paid, the **replacement inflator part number that you received** must be on the warranty claim and your warranty clerk must enter the serial number in the Diagnostic Trouble Codes field.

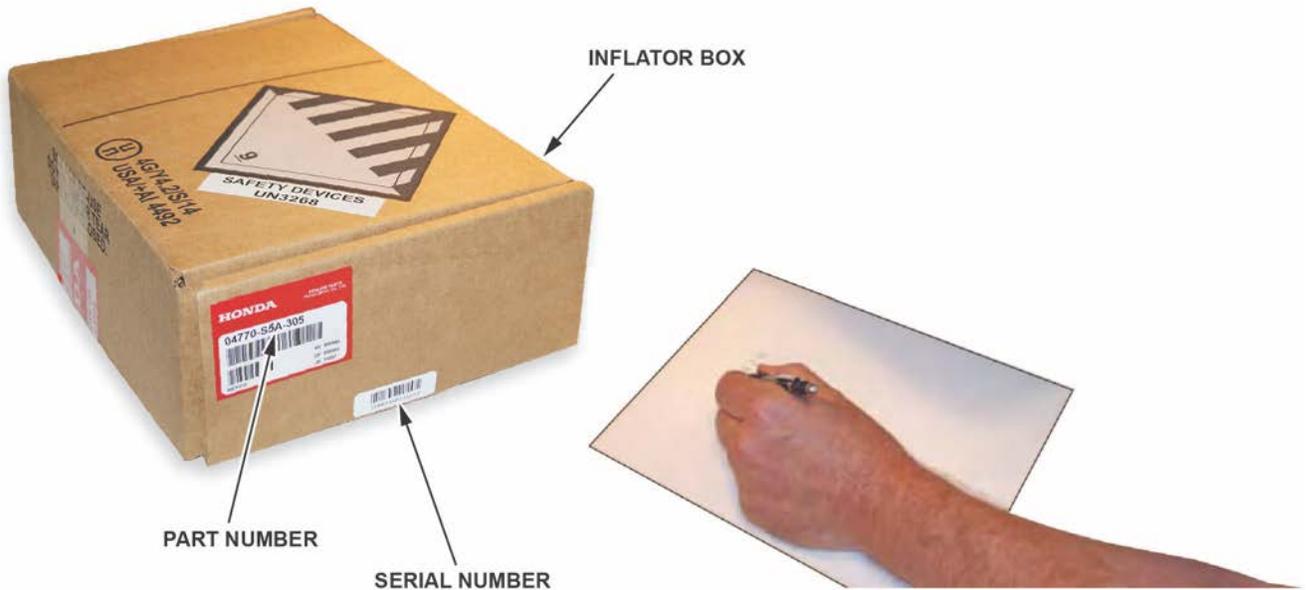
1. Remove the driver's airbag.
 2. Write down the serial number and part number located on the right side of the new inflator's box. For the warranty claim to be paid, the **replacement inflator part number that you received** must be on the warranty claim and your warranty clerk must enter the serial number in the Diagnostic Trouble Codes field.

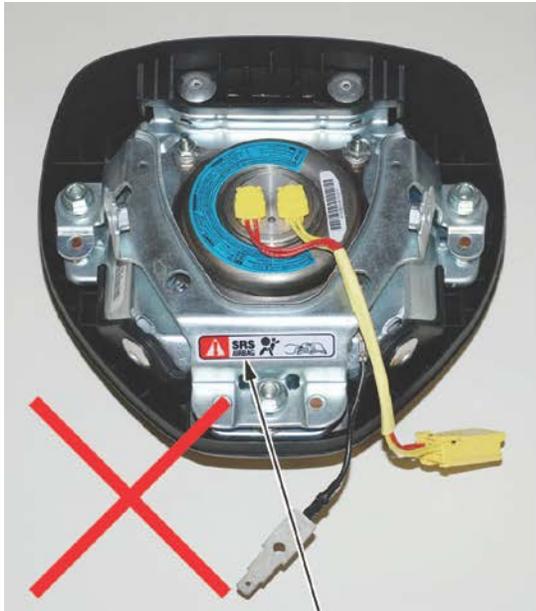
NON-STANDARD SAFETY LABEL

4. Visually inspect the airbag and the inflator for any unusual writing or markings.

- If there is nothing unusual about the airbag or the inflator, go to step 5.
- If there is unusual markings, like an incorrect label or a model year written in marker, the airbag and inflator may not be the correct airbag and/or inflator for the vehicle or it may be a counterfeit part. For more information about counterfeit airbags, you can refer to safercar.gov, enter keywords **MANAGING COUNTERFEIT**, and select Recommended Dealer Guidance for Managing Counterfeit Air Bags from the list. **If you suspect that the airbag or inflator is counterfeit, do not continue this procedure.** Contact your DPSM for assistance.

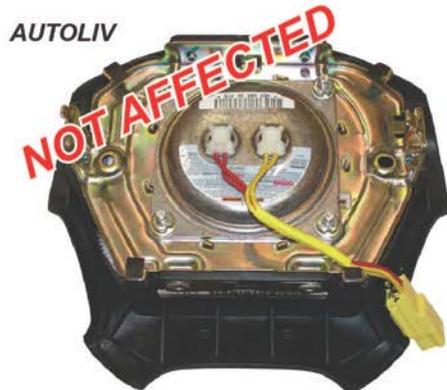
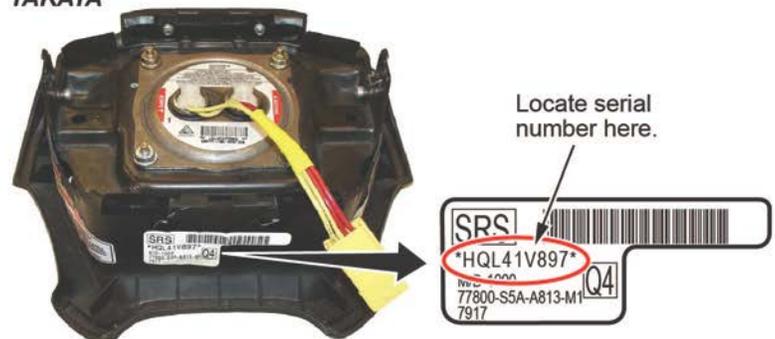
5. **Civic only** - Determine if the airbag is made by Autoliv or Takata by comparing the inflators to those in the images below.

NOTE: The Autoliv serial number label is different from the Takata label; the Autoliv has 11 characters, the Takata has 9.

AUTOLIV

TAKATA

- If the airbag is made by Autoliv, the airbag is OK. Reinstall the Autoliv airbag. If you already received a replacement inflator, return the unopened kit to American Honda.
- If the airbag is made by Takata, go to step 6.

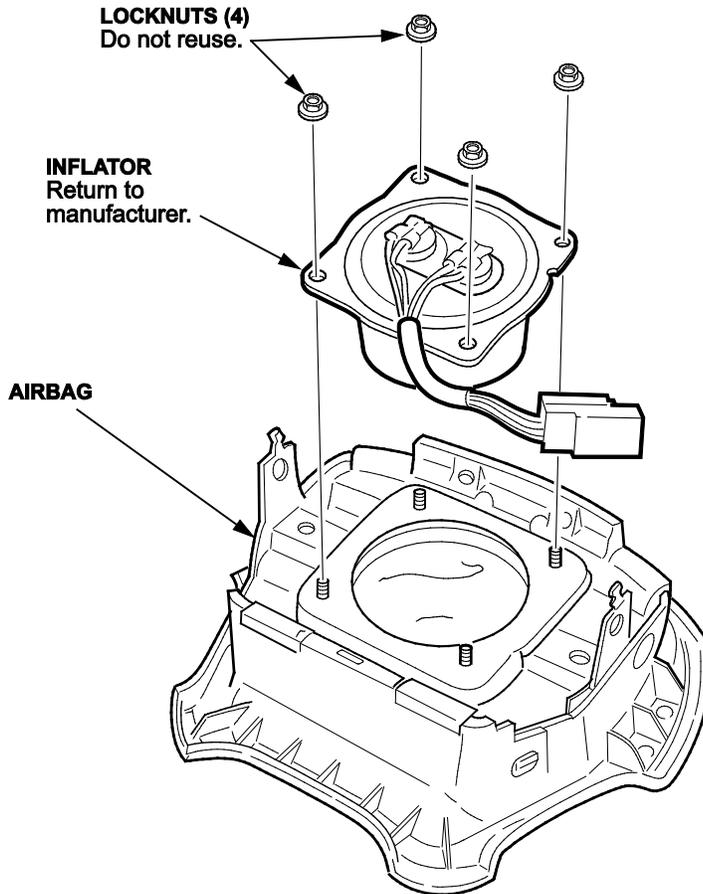
- Using needle-nose vise grips or a 3/8 in. 6-point socket, remove the four locknuts from the inflator. The locknuts will not be reused.

NOTE: Do not remove the inflator from the airbag until you complete step 7.

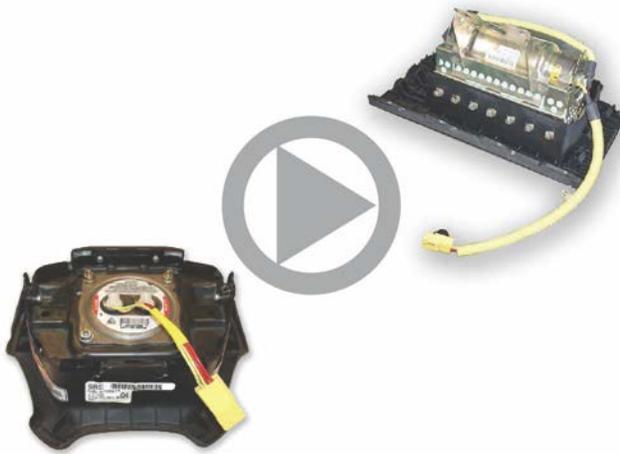
Click on the image below for a short video about the different variations of the driver's and front passenger's replacement inflators involved with the recalls related to replacing Takata inflators. While both the driver's and front passenger's inflators are shown in the video, this is informational only. Replace inflators only as directed by the iN VIN status inquiry.

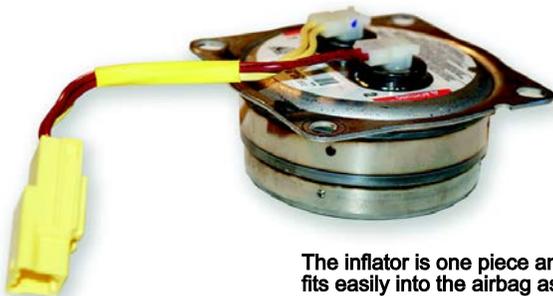
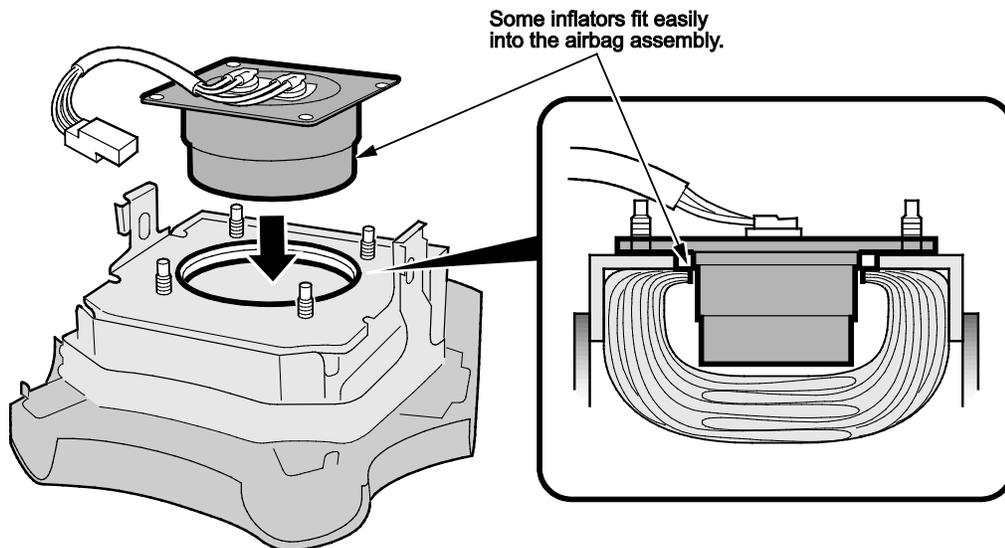
04770-S5A-305

Refer to **Driver's Inflator Type 1** in the video.

The inflator is one piece and fits easily into the airbag assembly.

- Insert the inflator into the opening.

NOTE: Make sure the inflator wires toward the bottom of the airbag. If you install the inflator incorrectly, you may not be able to reconnect the SRS airbag harness.

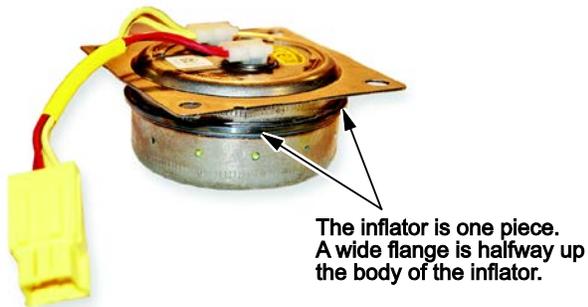
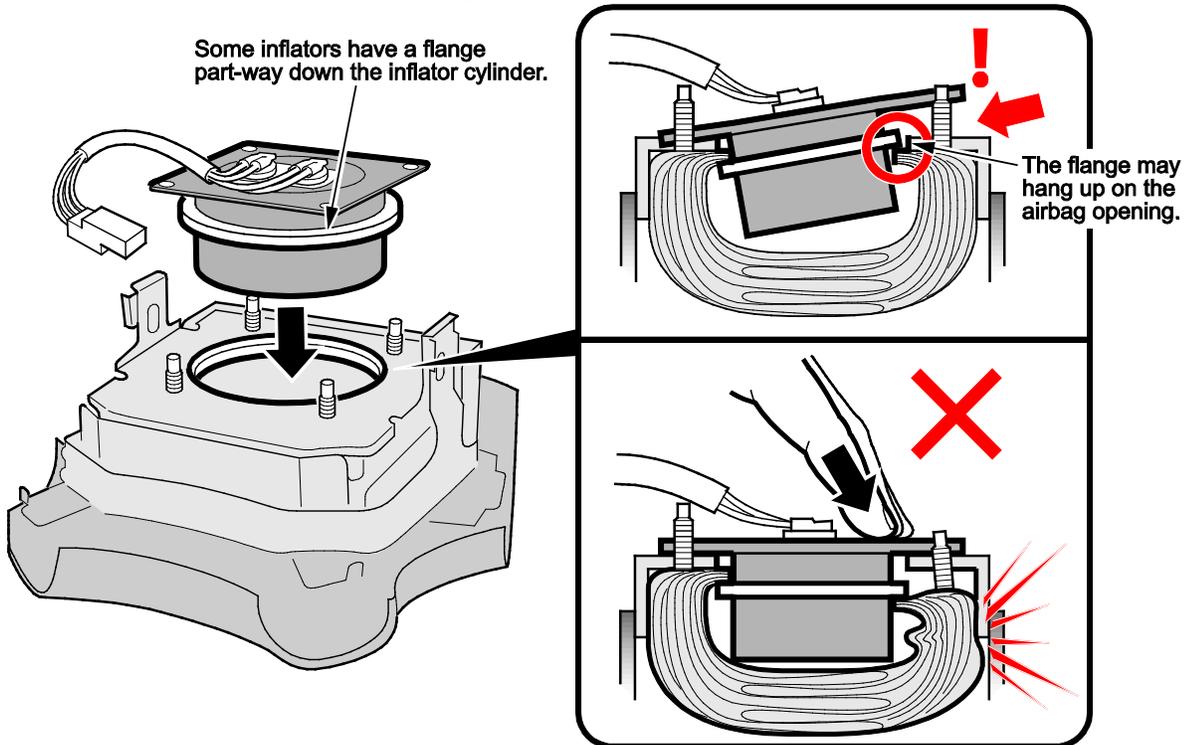
04770-S5A-405

Refer to **Driver's Inflator Type 2** in the video.

- Insert the airbag inflator into the opening. Do not force it into the airbag module.

NOTE: Make sure the inflator wires toward the bottom of the airbag. If you install the inflator incorrectly, you may not be able to reconnect the SRS airbag harness.

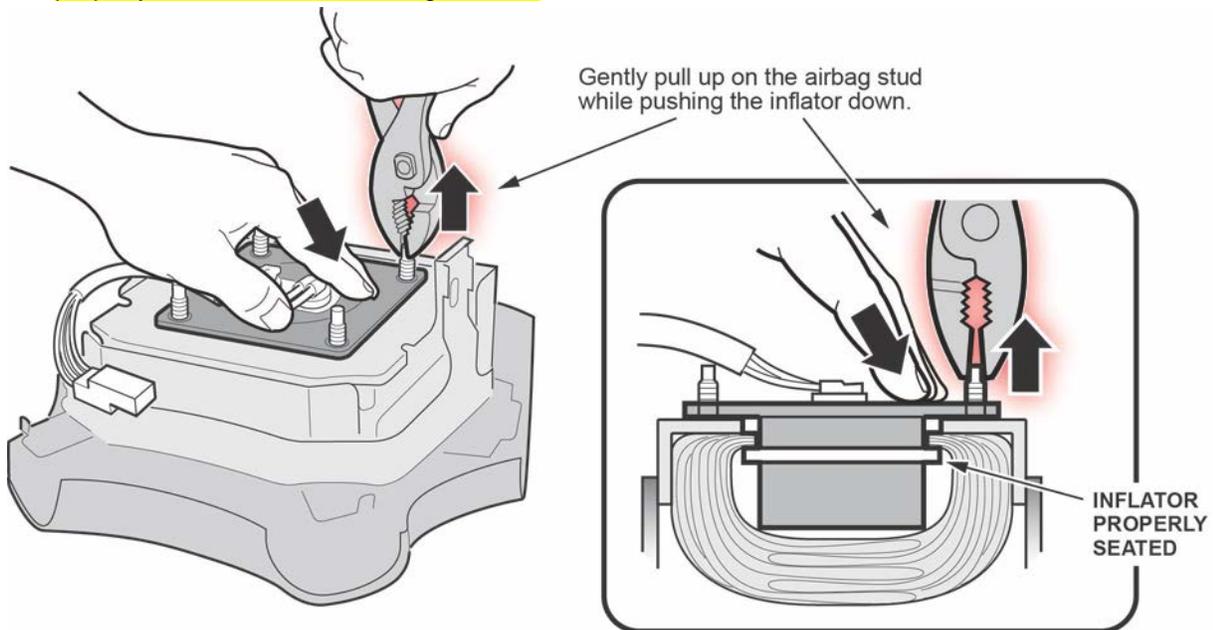
- Using a pair of pliers, gently pull up on each stud up while pushing the inflator module down until the airbag is properly seated within the airbag module.

10. Install and torque the new locknuts to **3.9 N·m (2.8 lb-ft, 34 lb-in)**.
11. Reinstall the driver's airbag using new Torx bolts and torque the bolts to **9.8 N·m (7.2 lb-ft)**.
12. Give your warranty clerk the inflator serial number and part number that you wrote down in step 2. For the warranty claim to be paid, the **replacement inflator part number that you received** must be on the warranty claim and your warranty clerk must enter the serial number in the Diagnostic Trouble Codes field.
