TSB150060

New Crankcase Breather Tube Hose Clamps for Part Option BR9277

- ISL G CM2180

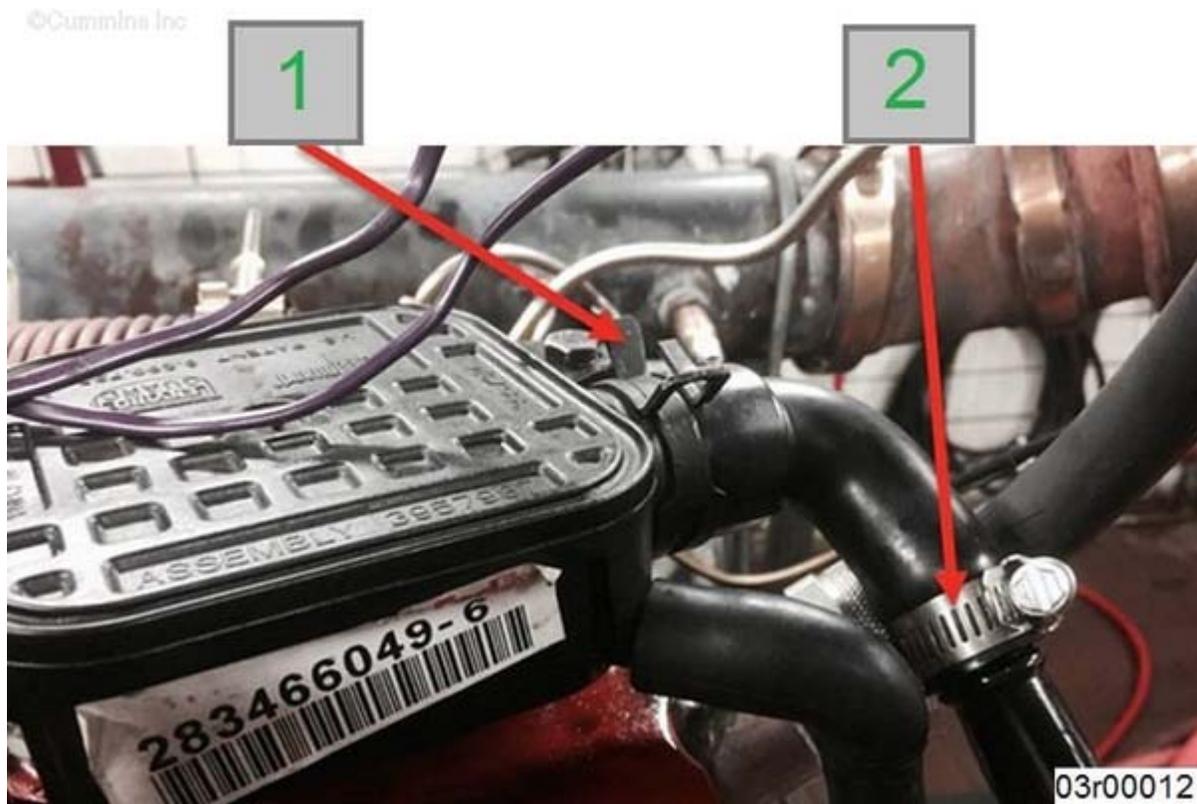
Figure 1, Number 1 Left: Spring Hose Clamp, Part Number 3925089. Number 2 Right: Worm Hose Clamp, Part Number 43828.

A spring loaded hose clamp, Part Number 3925089, has been released for the connection from the crankcase breather assembly to molded elbow.

The worm gear hose clamp, Part Number 0043828, has been released for the connection from the molded elbow to crankcase breather tube.

Cummins Inc. recommends that the new hose clamps, Part Numbers 3925089 and 0043828, be installed on both ends of the ninety degree elbow of the crankcase breather tube to prevent the crankcase breather tube from possibly detaching during high crankcase pressure conditions.

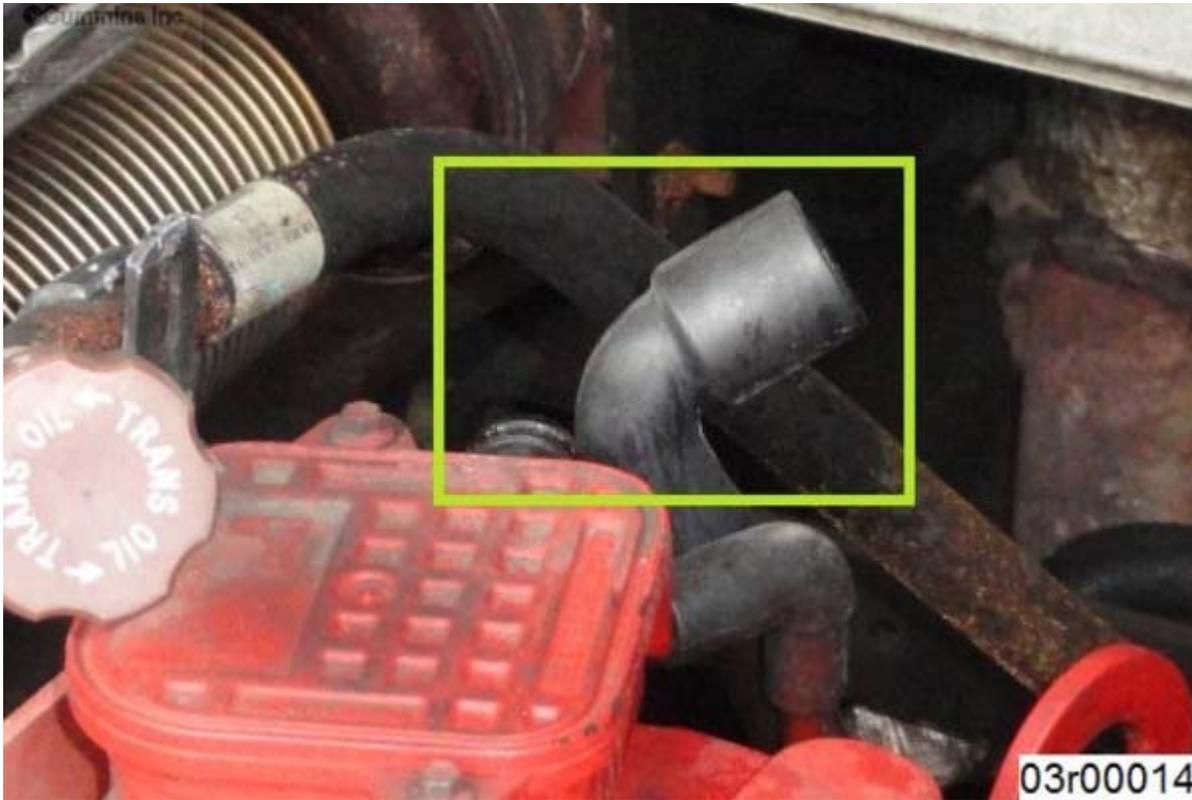
1. Remove molded elbow from the crankcase breather assembly by gently pulling.

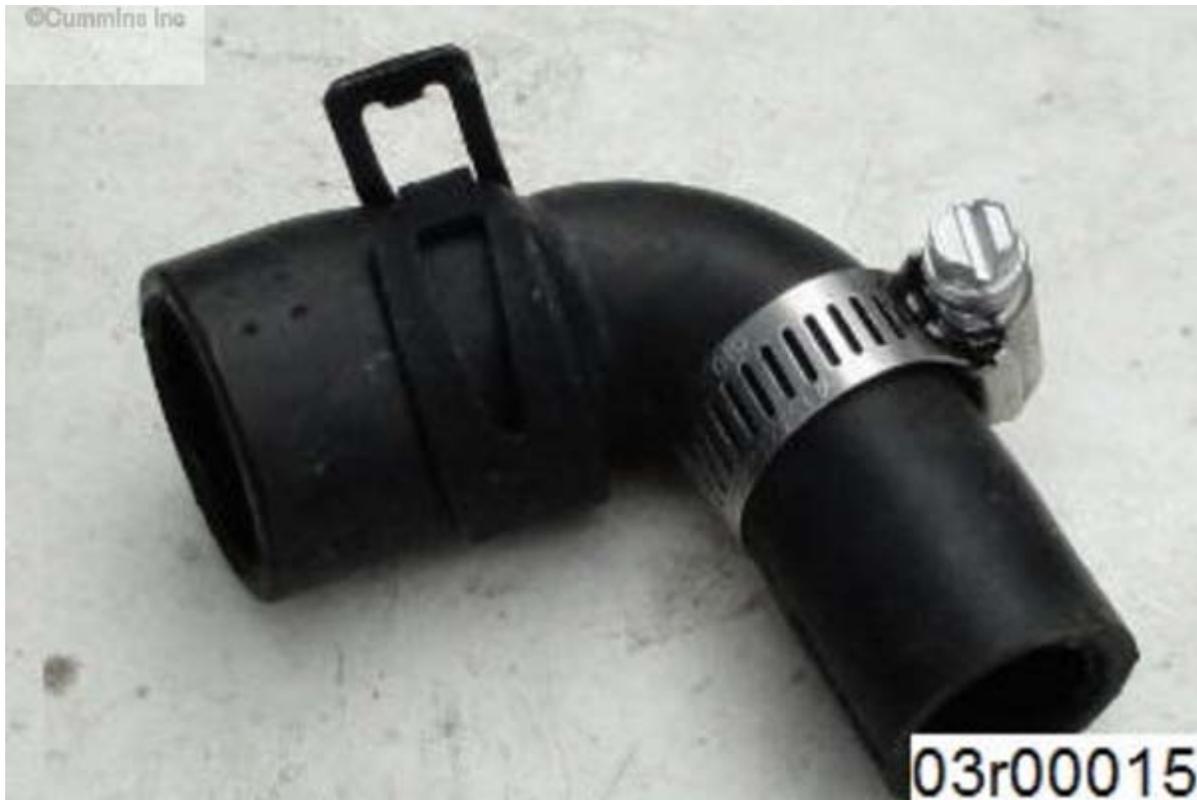
2. Remove molded elbow from crankcase breathe tube by gently twisting elbow while pulling.
3. Loosely install the hose clamps on the elbow.

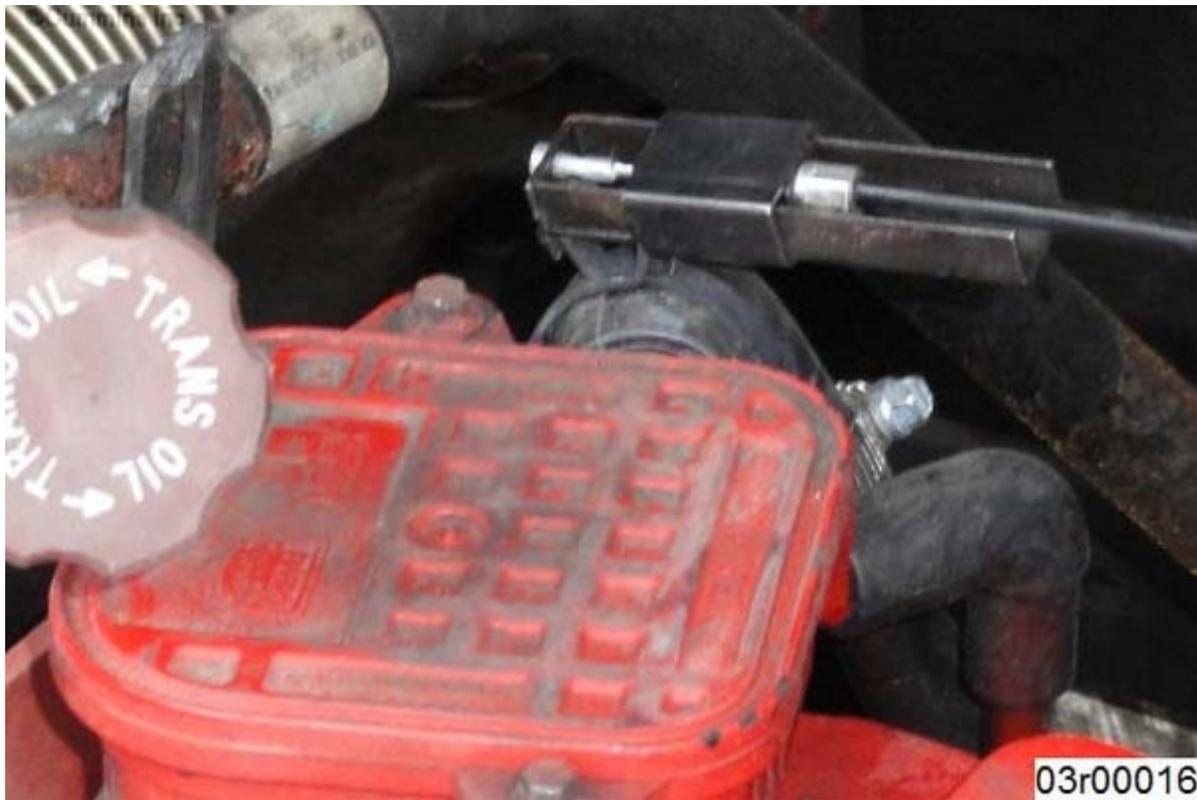
4. Install the elbow by pushing it onto crankcase breather tube, then onto crankcase breather assembly.
5. Move spring loaded hose clamp over the barb on the breather assembly.

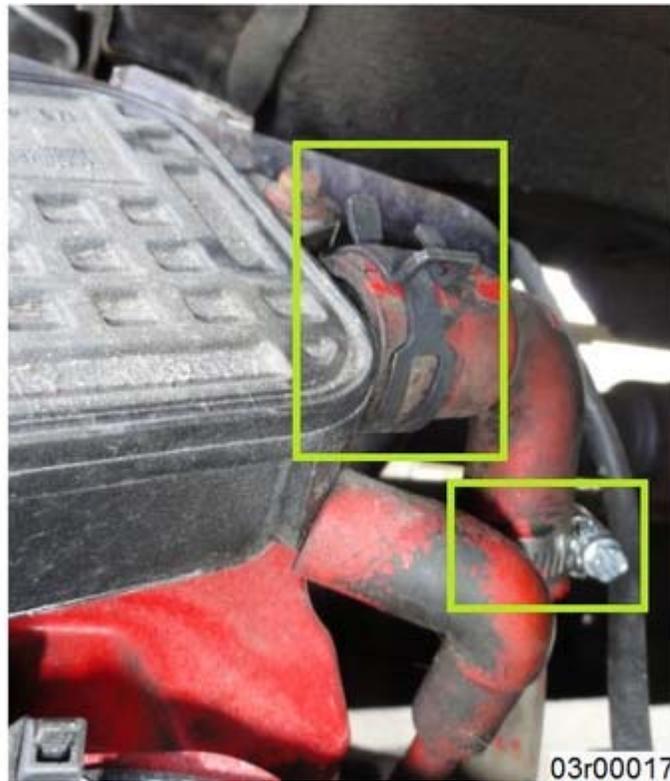
6. Move worm gear hose clamp over barb on crankcase breather tube. Tighten capscrew.

Torque Value: to 1.5 N•m [13 in-lb]
