Safety Notice

Affected Models	MV800 units with T14MV trailer, see attached list for serial numbers
Attention	Dealership Owners, Managers, Parts and Service Managers
Description	Please see the attached customer notice.
Parts Required	N/A
Estimated Repair Time	30 minutes
Compensation	parts/labor/mileage
Dealership Notes	<p>URGENT: Please perform this update as soon as possible in the interest of safety. Ditch Witch requests that you update all machines in your area by January 31, 2016.</p> <p>A notification will be mailed to owners of affected models in one week. A list of units in your area is included. Please note "What You Should Do" section of the attached customer notice. If you have any questions, contact the Trenchless Product Support Group.</p>

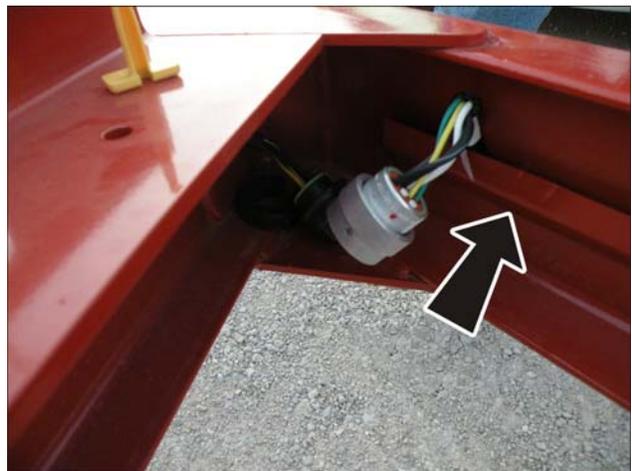
inmv800001s.jpg

1. Pry harness bar (shown) up enough to remove harness and disconnect trailer harness (215-0018) from tongue harness (215-0030).

IMPORTANT: Remove ring and washer (not shown) from trailer harness to fit through hole in trailer footboard.

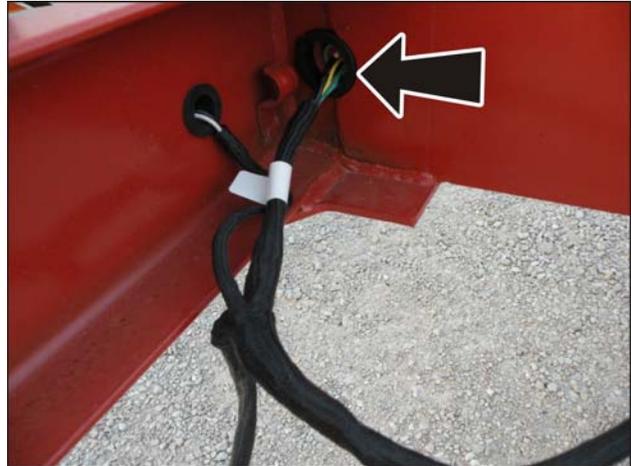
inmv800002s.jpg

2. Remove rubber grommet from hole in trailer footboard (shown).

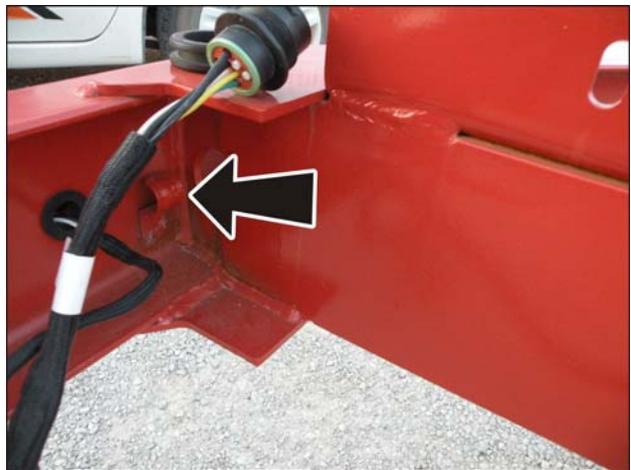
inmv800003s.jpg

3. Remove harness from clip (shown) and pull harness through hole in trailer footboard.

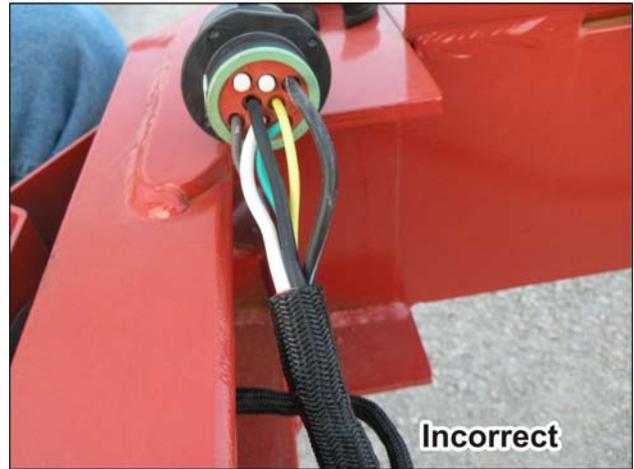
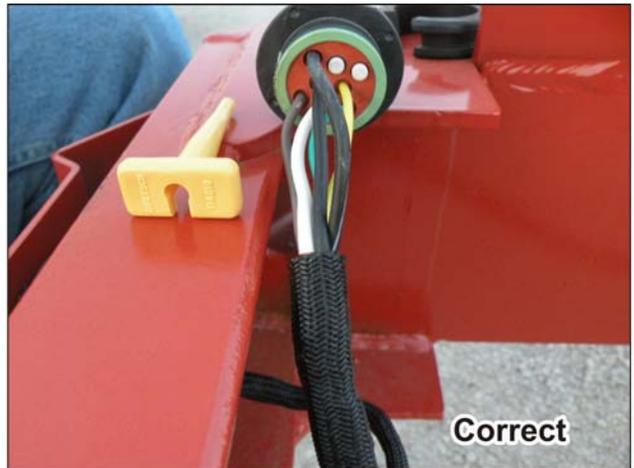
inmv800004s.jpg

4. Use yellow tool (259-439) to move black/white wire from pin F to pin H (shown).

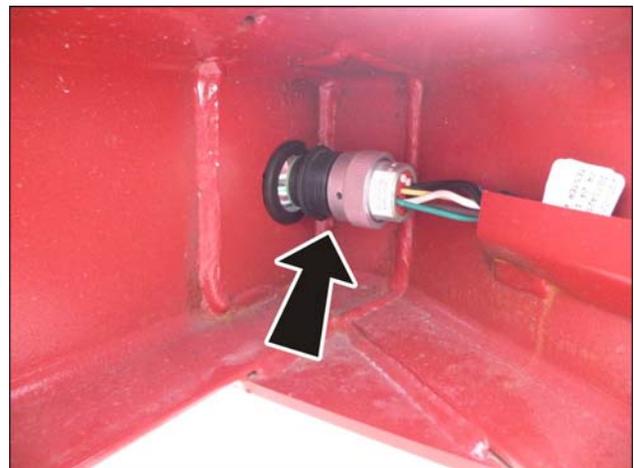
inmv800006s.jpg

5. Route trailer harness back through hole in trailer footboard.
6. Reconnect trailer harness to tongue harness (shown).
7. Secure harness into harness clip and harness bar and reinsert grommet.
8. Test to ensure proper function.
