**July 28, 2015**

02193 Version 2

## Noncompliance Recall: HR-V Emission Label

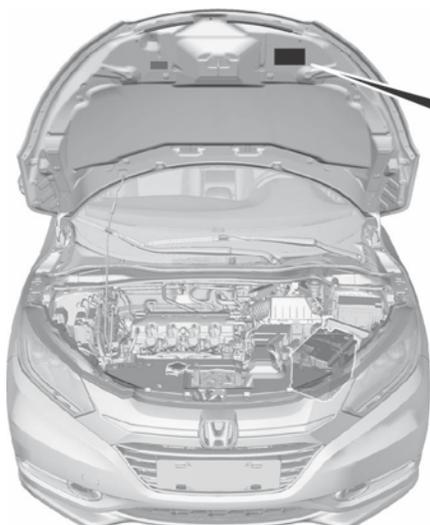
1. Open the hood and make sure the emission label is present at the location shown.

- Using alcohol and a clean shop towel, clean the hood area where the emission label is placed. Allow the area to dry.
- Peel off the backing from the emission label, and apply it to the hood. Press the label firmly to make sure it sticks. The vehicle is OK. Return the vehicle to the customer.

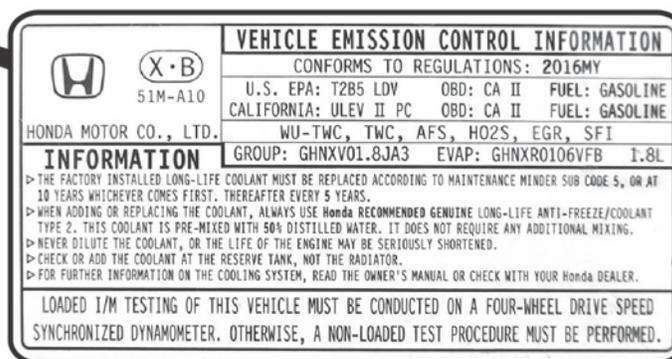
2. Inspect the emission label to make sure **2016** is the model year listed as shown.

51M-A10	<b>VEHICLE EMISSION CONTROL INFORMATION</b>	
	CONFORMS TO REGULATIONS: <b>2016MY</b>	
HONDA MOTOR CO., LTD.	U.S. EPA: T2B5 LDV	OBD: CA I FUEL: GASOLINE
	CALIFORNIA: ULEV II PC	OBD: CA II FUEL: GASOLINE
	WU-TWC, TWC, AFS, HO2S, EGR, SFI	
<b>INFORMATION</b>	GROUP: GHNXV01.8JA3	EVAP: GHNXR0106VFB 1.8L
▷ THE FACTORY INSTALLED LONG-LIFE COOLANT MUST BE REPLACED ACCORDING TO MAINTENANCE MINDER SUB CODE 5, OR AT 10 YEARS WHICHEVER COMES FIRST. THEREAFTER EVERY 5 YEARS.		
▷ WHEN ADDING OR REPLACING THE COOLANT, ALWAYS USE Honda RECOMMENDED GENUINE LONG-LIFE ANTI-FREEZE/COOLANT TYPE 2. THIS COOLANT IS PRE-MIXED WITH 50% DISTILLED WATER. IT DOES NOT REQUIRE ANY ADDITIONAL MIXING.		
▷ NEVER DILUTE THE COOLANT, OR THE LIFE OF THE ENGINE MAY BE SERIOUSLY SHORTENED.		
▷ CHECK OR ADD THE COOLANT AT THE RESERVE TANK, NOT THE RADIATOR.		
▷ FOR FURTHER INFORMATION ON THE COOLING SYSTEM, READ THE OWNER'S MANUAL OR CHECK WITH YOUR Honda DEALER.

- If the correct model year is listed, the vehicle is OK. Return the vehicle to the customer.
- If the wrong model year is listed, replace it with the correct one.
  - Remove the original label and use 3M adhesive remover to clean any remaining adhesive residue.
  - Using alcohol and a clean shop towel, clean the hood area where the emission label is placed. Allow the area to dry.
  - Peel off the backing from the emission label, and apply it to the hood. Press the label firmly to make sure it sticks. The vehicle is OK. Return the vehicle to the customer.
