SUBJECT: Campaign #133 – Vehicle Certification Label

INSTRUCTION TO PERFORM CAMPAIGN #133

Certain 2012 through 2016 model year Winnebago Era®.

NHTSA Safety Recall 15V-490

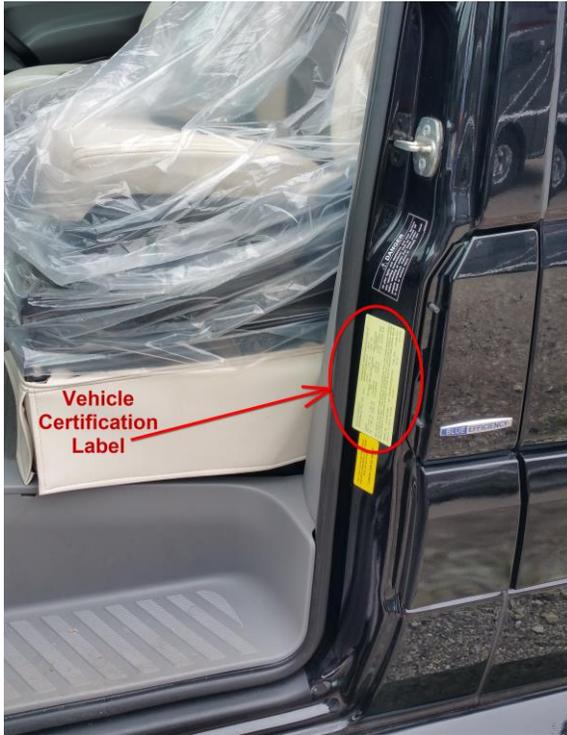
C

1. Cover the existing Vehicle Certification Label on the driver's door jamb with the corrected label included with this Campaign as shown in Photo C.

Install Label
