ATB 51811-01884 Version 12

Safety Recall: Front Passenger's Airbag Inflator Can Be Over-Pressurized

Supersedes 14-040, dated August 14, 2015 to revise the information highlighted in **yellow**

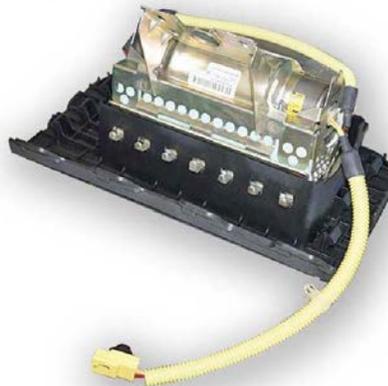
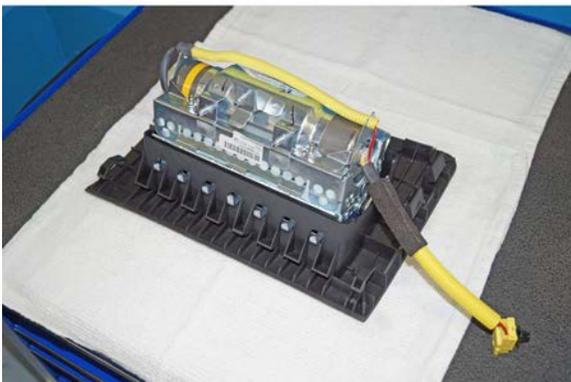
4. Place the airbag face-down on a clean shop towel as shown.

- The orientation of the airbag is critical because if the inflator is installed incorrectly, the harness will be too short when you reinstall the airbag.
- The brackets between the various models are similar but may differ from the example shown in the procedure.

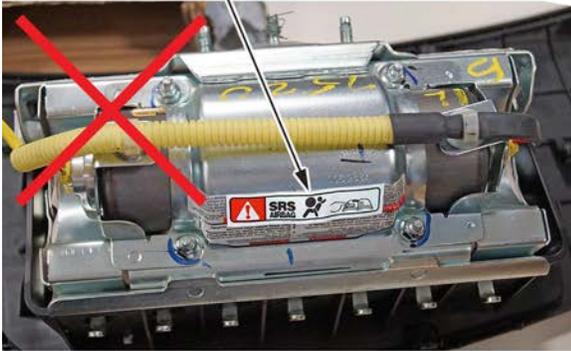
NON-STANDARD SAFETY LABEL

- If there is nothing unusual about the airbag or the inflator, go to step 6.
- If there are any unusual markings, like an incorrect label or a model year written in marker, the airbag and inflator may not be the correct airbag and/or inflator for the vehicle or it may be a counterfeit part. For more information about counterfeit airbags, you can refer to safercar.gov, enter keywords **MANAGING COUNTERFEIT**, and select **Recommended Dealer Guidance for Managing Counterfeit Air Bags** from the list. **If you suspect that the airbag or inflator is counterfeit, do not continue this procedure.** Contact your DPSM for assistance.

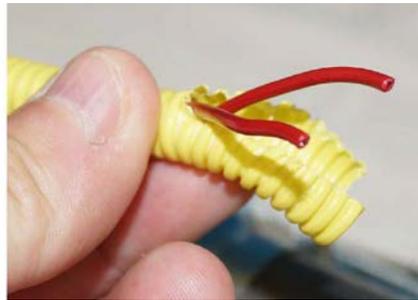
- Cut about 2 inches of the corrugated tube, then pull out the two red wires.

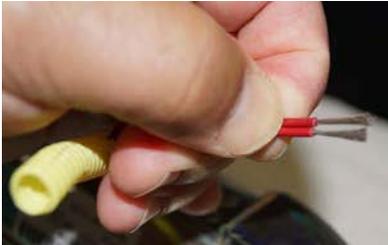
- Strip away about 1 inch of the wire insulation, then twist the wires together.

- Tape the twisted ends with electrical tape.

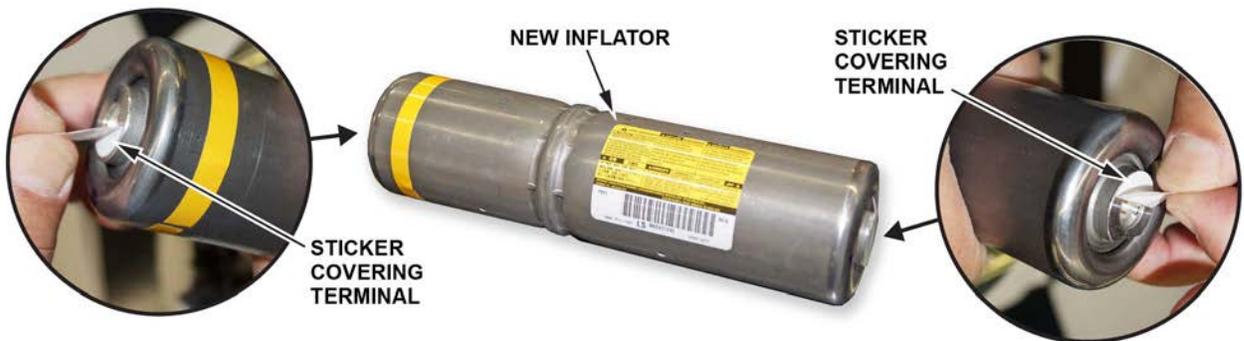
15. Remove the stickers covering the terminals on both sides of the new inflator.

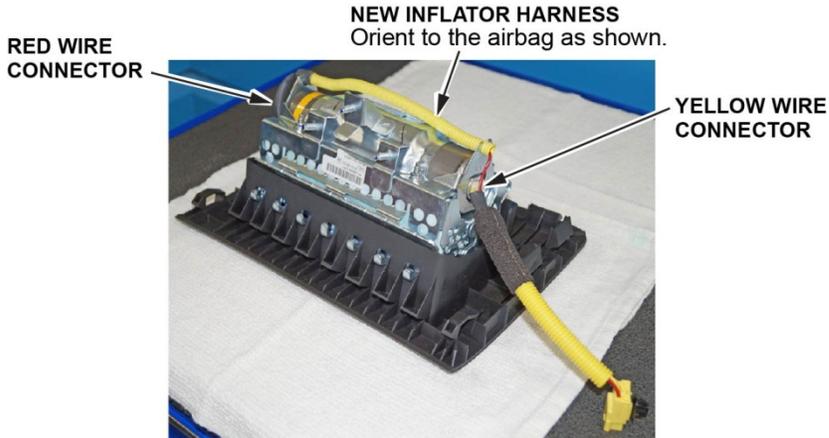
- Make sure the airbag and harness are aligned as shown.

- **Make sure you have the orientation correct as shown below.** If you connect the harness incorrectly, the harness cannot be removed, and you will not be able to reinstall the airbag because the harness will be too short.
- On the replacement inflators with plastic collars, connect the red wire connector to the connector with the red dot.
- On the replacement inflators without plastic collars, connect the red wire connector to the connector nearest the yellow band.

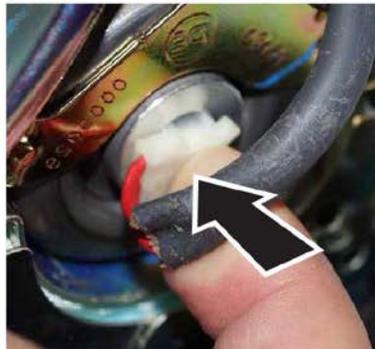
② Press the connector into place until it clicks.

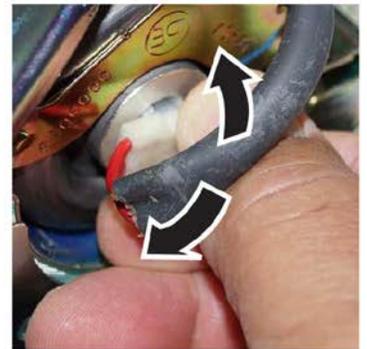
③ Wiggle the connector to make sure it's secure.

- After you hear each connector click, wiggle it to make sure it is secure.
NOTE: If the connector is not properly aligned, it will come out.
