AMERICAN EMERGENCY VEHICLES
165 AMERICAN WAY
JEFFERSON, NC 28640
P: 800-374-9749 F: 336-982-9826

IMPORTANT SAFETY RECALL

Subject: ASA/Voyager VCMS140I Rear Observation Camera NHTSA Recall Number: 15E050

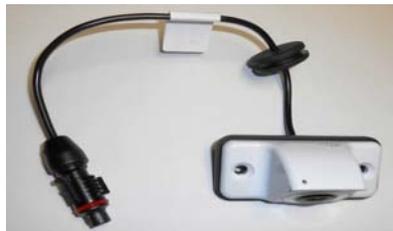
ASA VCMS140I Rear Observation Camera Serial Number Identification

Remove both anchor screws from the camera base mount and remove the camera from the vehicle until the white tag affixed to the cable is exposed. The unit Serial Number is the 14 digits at the bottom of the tag. If SN matches one of the 54 listed below it must be replaced.

Please verify the camera Serial Number (instructions included with this letter) then contact ASA at 1-877-384-4400 to report the SN. If unit is part of the Recall request a return authorization number to secure your free replacement VCMS140I rear observation camera(s).
