SUBJECT: Safety Recall R46 - Front Suspension Track Bar Frame Bracket Update

R46 FRONT SUSPENSION TRACK BAR FRAME BRACKET OVERVIEW

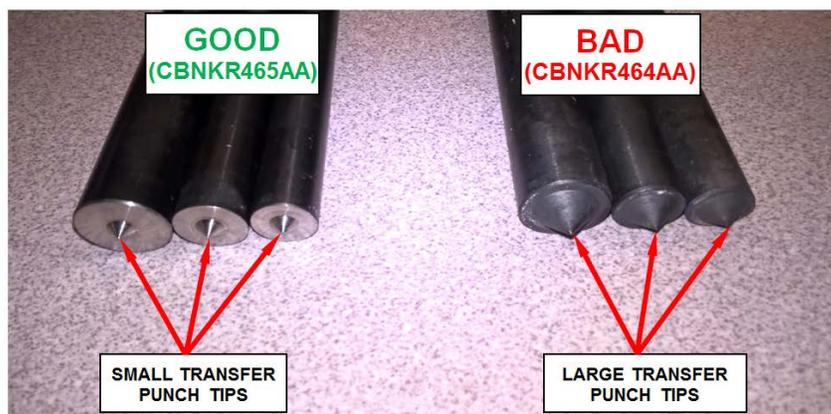
- The replacement transfer punches in **CBNKR465AA** kit are correct and should be used for all involved vehicle repairs. Transfer punches contained in this kit will have green dot paint on the transfer punch shank to indicate it is a good transfer punch.

Below is an image of the transfer punches, also displayed in the **Dealer Service Instructions**

- **CBNKR464AA Track Bar Reinforcement Bracket Installation Kit** contains drill bits and transfer punches. The transfer punches supplied in this kit have tips that are not to design specifications. Please dispose of the transfer punches in kit CBNKR464AA. Be sure to keep the drill bits to perform the recall.
