SAFETY RECALL DSC and ELG

FRONT PASSENGER AIRBAG INFLATOR MODULE

CERTAIN 2002 – 2010 MODEL YEAR SC 430

Updated 03-01-2016

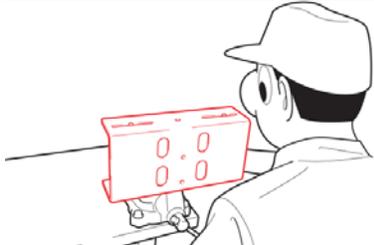
<p>ALWAYS keep as much of your body as possible in front of the bracket when working on the airbag assembly.</p>

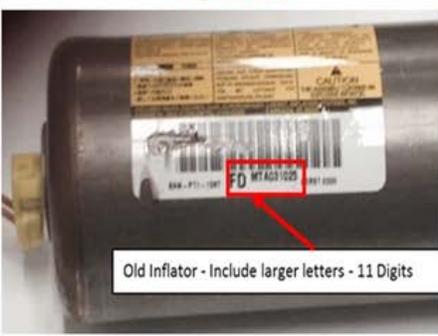
Original Inflator

Old Inflator - Include larger letters - 11 Digits

How to Identify the Inflator serial code on the Original and Replacement Inflator can?

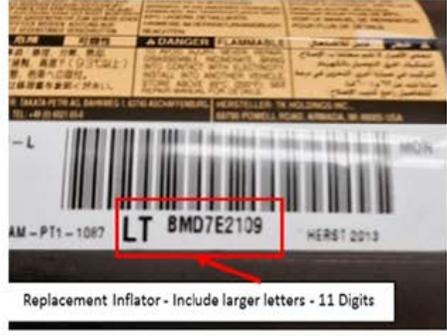
The first two characters of the **Replacement Inflator Serial code** will be either 'LT' or 'LR'.

Replacement Inflator - Include larger letters - 11 Digits

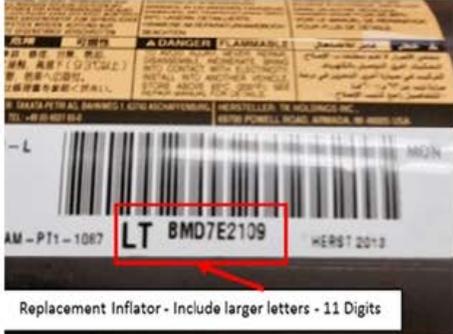
Replacement Inflator - Include larger letters - 11 Digits

How to Identify the Inflator serial code on the Original and Replacement Inflator can?
