MACK TRUCKS, INC.
PO BOX 26115
GREENSBORO, NC 27402-6115

**IMPORTANT SAFETY RECALL SC0401
NHTSA RECALL # 16V-156**

Mack Trucks, Inc. has decided that a defect, which relates to motor vehicle safety, exists in certain 2016 and 2017 Mack Titan model trucks manufactured from February 25, 2015 through February 12, 2016 with a 2 piece steering shaft.

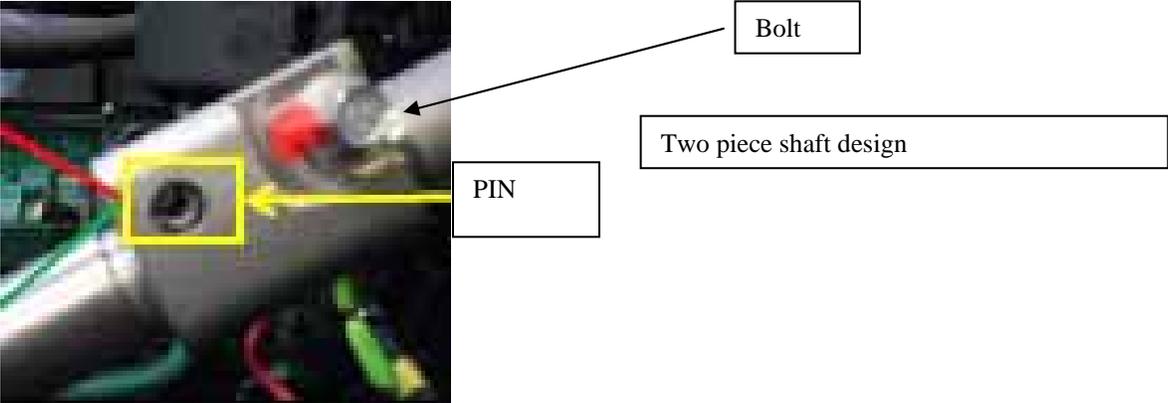
Picture to be able to identify a two-piece shaft design

Open the hood and look at the steering shaft. The shaft is a two-piece design if it has the junction block in the picture.

The bolt connecting the upper steering shaft to the lower steering shaft at the junction block may not properly secure the upper steering shaft.
