MODEL
2015MY
Sorento (XMa)

NUMBER
106

TECHNICAL SERVICE BULLETIN

SUBJECT: PAINT PEELING OFF DOOR PANELS (SA166)

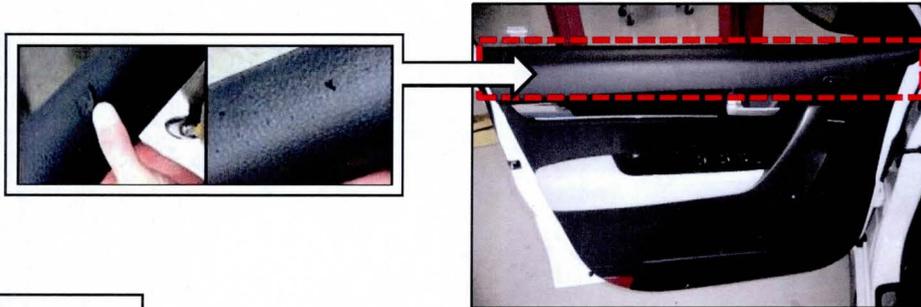
This bulletin provides information related to an inspection of the door panels on some 2015MY Sorento (XMa) vehicles, produced from April 21, 2014 through May 2, 2014, which may exhibit paint peeling, flaking or bubbling from the upper surfaces of the door panels (see images below). All four doors should be inspected (excluding rear doors with the sunshade option) and, if necessary, all affected door panels should be replaced with Techline approval and per the applicable procedure on KGIS. Kia is requesting the completion of this Service Action on all affected vehicles in dealer stock, prior to delivery. Before conducting the procedure, verify the vehicle is included in the list of affected VINs.

If defective panels are found, a photo needs to be submitted to Techline for approval before replacement occurs. All replaced door panels will be returned to WPRC for inspection. The paint must be peeling, as shown above, and not rubbed down to the minimum surface. Any claims showing excessively rubbed down panels may be subject to chargeback.

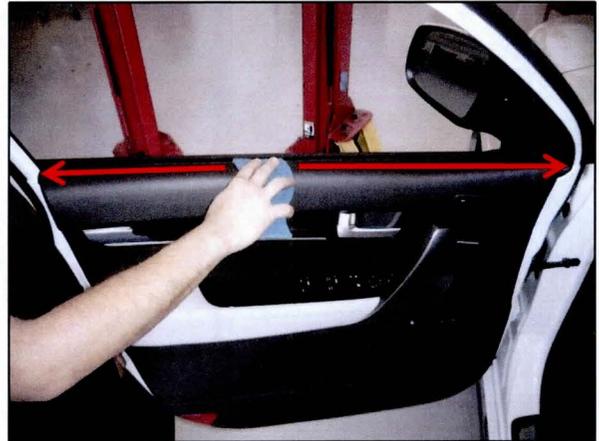
1. Use a non-scratch scouring pad to rub the upper horizontal surface of each door panel using light to medium pressure. Proceed across the entire surface in 2" to 3" sections at a time and avoid using long strokes.

Once finished, inspect the surface of the panel for signs of peeling or bubbling paint. If no damage is present, proceed to step 2. If damage is present, proceed to step 4.

4. Replace the affected door panel per the applicable procedure on KGIS.

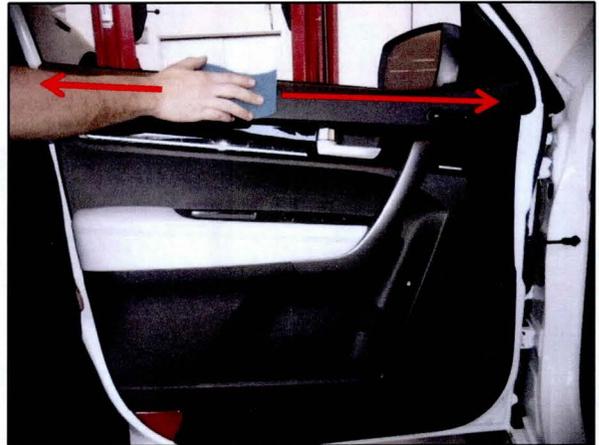
2. Use a non-scratch scouring pad to rub the upper vertical surface of each door panel using light to medium pressure. Proceed across the entire surface in 2" to 3" sections at a time and avoid using long strokes.

Once finished, inspect the surface of the panel for signs of peeling or bubbling paint. If no damage is present, proceed to step 3. If damage is present, proceed to step 4.

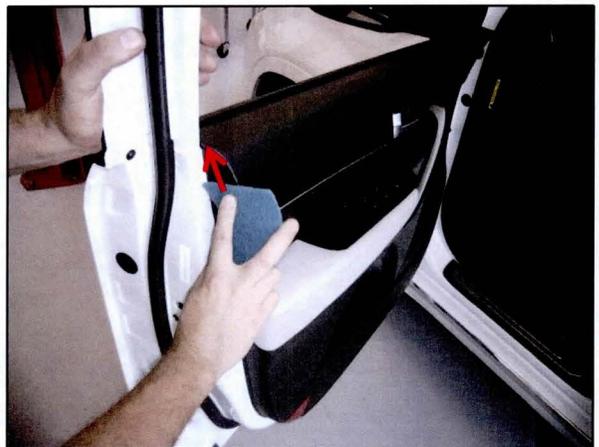
3. Use a non-scratch scouring pad to rub the rear edge of each door panel using light to medium pressure.

Once finished, inspect the surface of the panel for signs of peeling or bubbling paint. If no damage is present, no further action is required. If damage is present, proceed to step 4.
