**KIA MOTORS**  
*The Power to Surprise®*

MODEL  
2011-2013 Optima  
(TF & QF)

NUMBER  
PS235

SUBJECT: HORN CHIRP AND PARKING LAMPS INOP WHEN  
LOCKING DOORS WITH RKE FOB

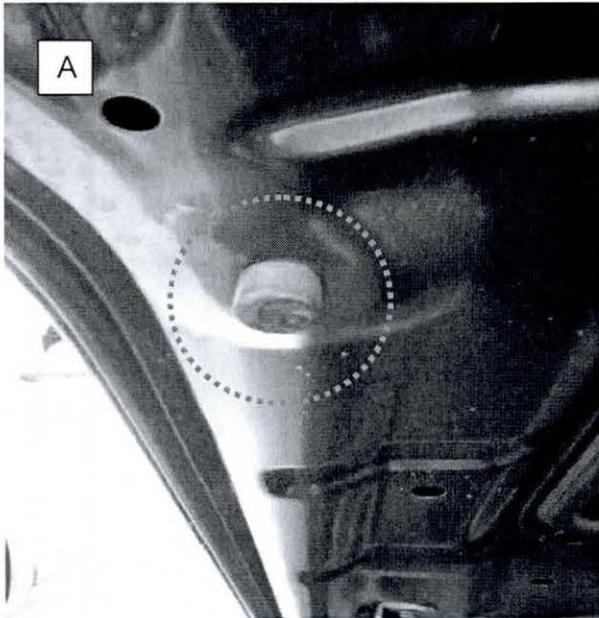
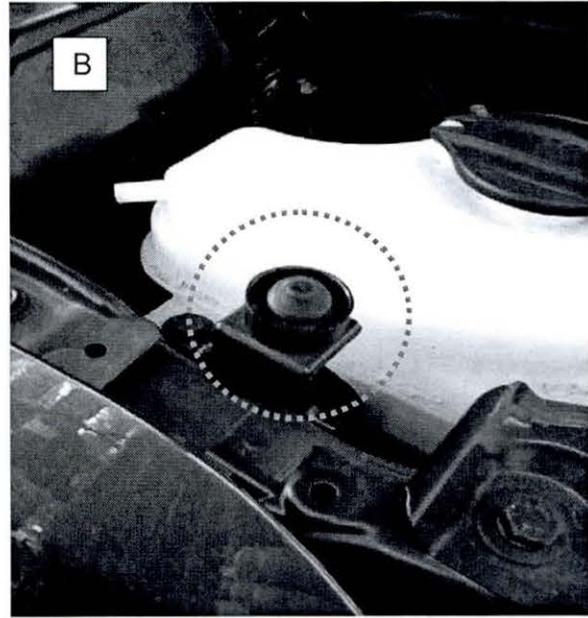
If you encounter a customer complaint relating to the vehicle not producing an audible tone, or horn chirp, and the parking lamps not flashing when locking the vehicle with the RKE fob, check to make sure the rubber hood stopper (A) is in place on the hood. The rubber stopper depresses the hood switch (B) and if not in place, may cause this condition, and may also prevent the alarm system from operating correctly.
