Revised August 2016

Dealer Service Instructions for:

Safety Recall R46 / NHTSA 15V-541 Front Suspension Track Bar Frame Bracket

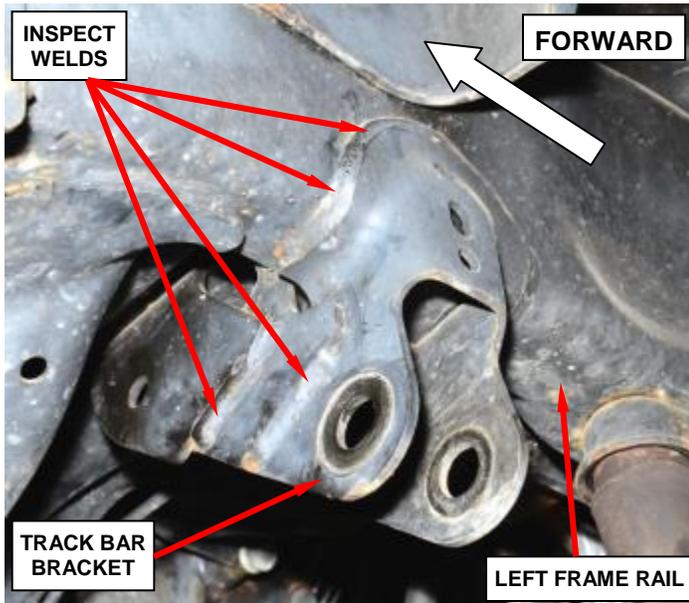
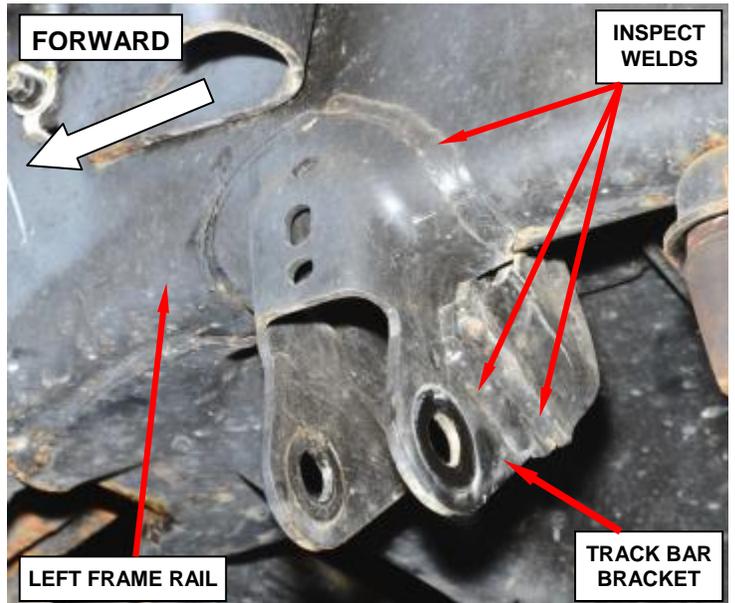
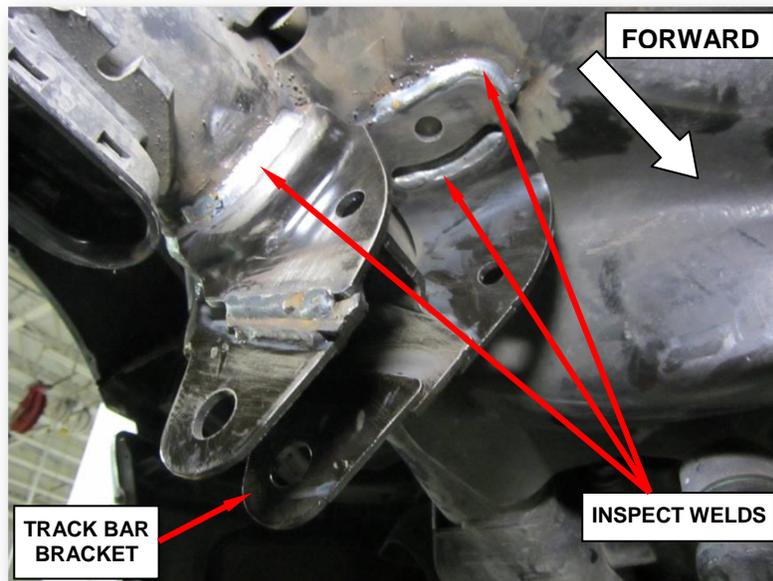
**Figure 1 – Suspect Weld Locations on Front and Back Side of Track Bar Bracket
(Track Bar Removed for Photographic Purposes Only)**

- If there are no cracked weld(s), fractured weld(s) and/or the bracket separation from the left frame rail, continue with the appropriate **Front Suspension Track Bar Reinforcement Bracket Installation section**.
- If the front suspension track bar bracket is found to have cracked weld(s), fractured welds and/or the bracket is separated from the frame, use the following procedure:
 - a. Using a digital camera, photograph the track bar bracket and the surrounding area. Images should at minimum, mirror the three images shown in Figure 1. Make sure all the pictures are clear and in focus.

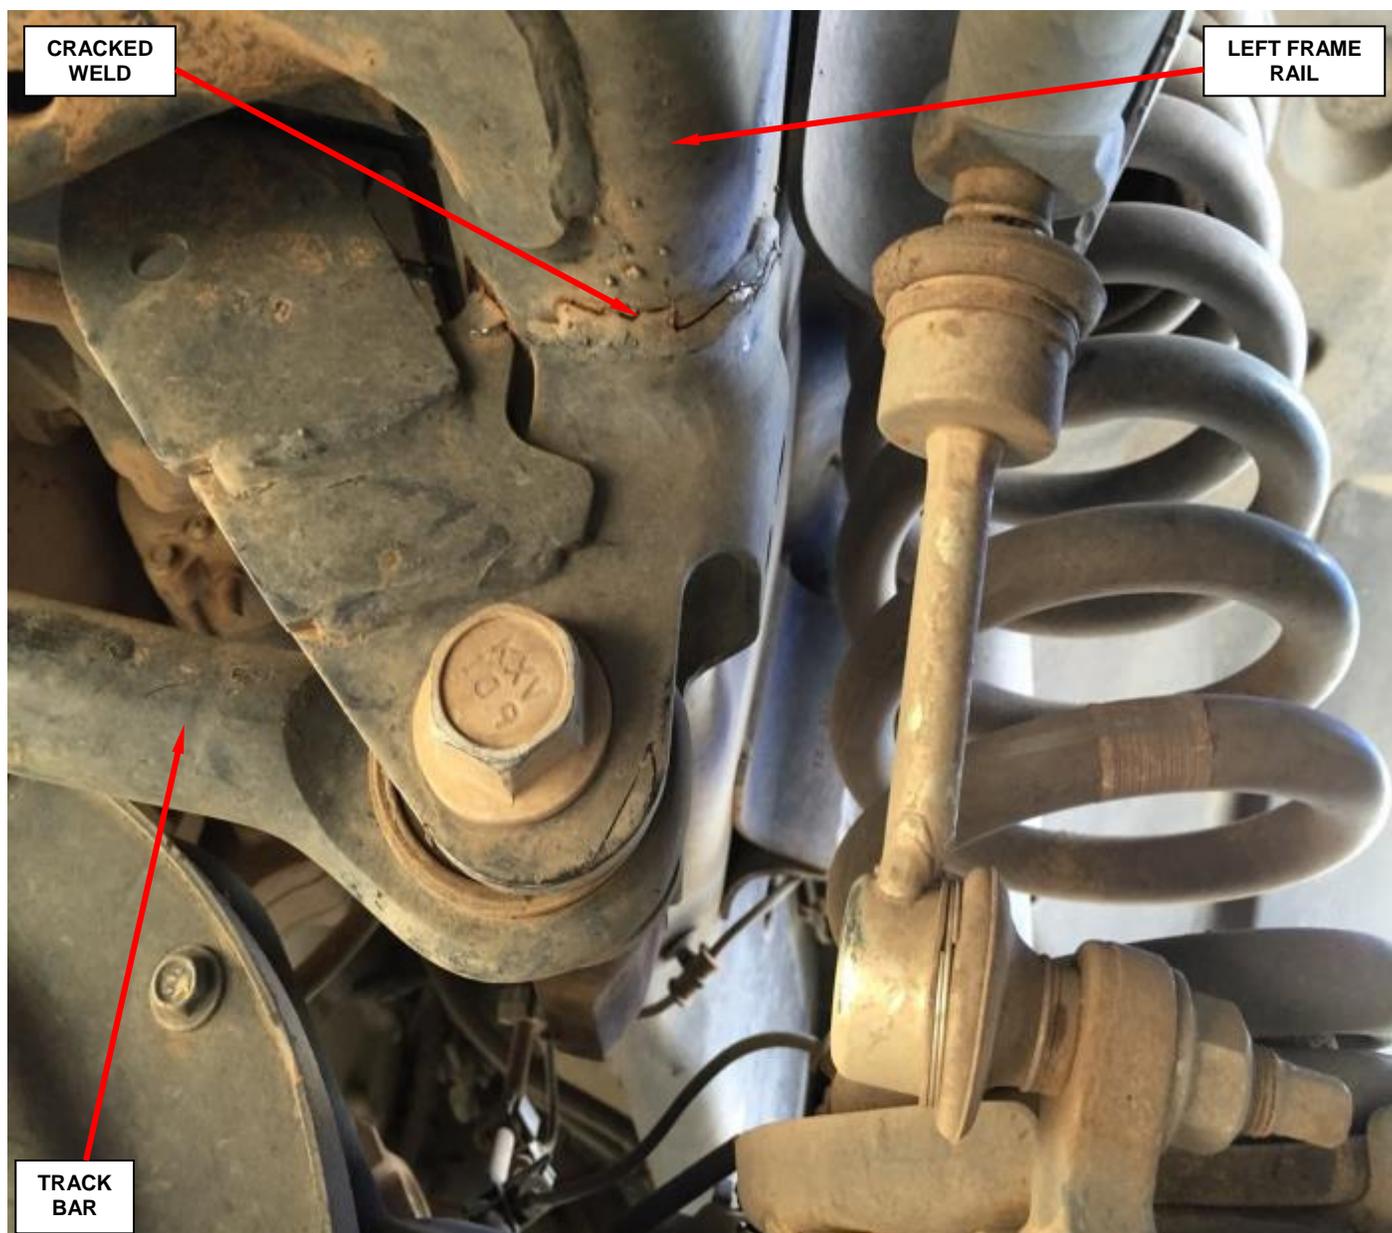
Figure 2 – Example of a Cracked Track Bar Bracket Weld

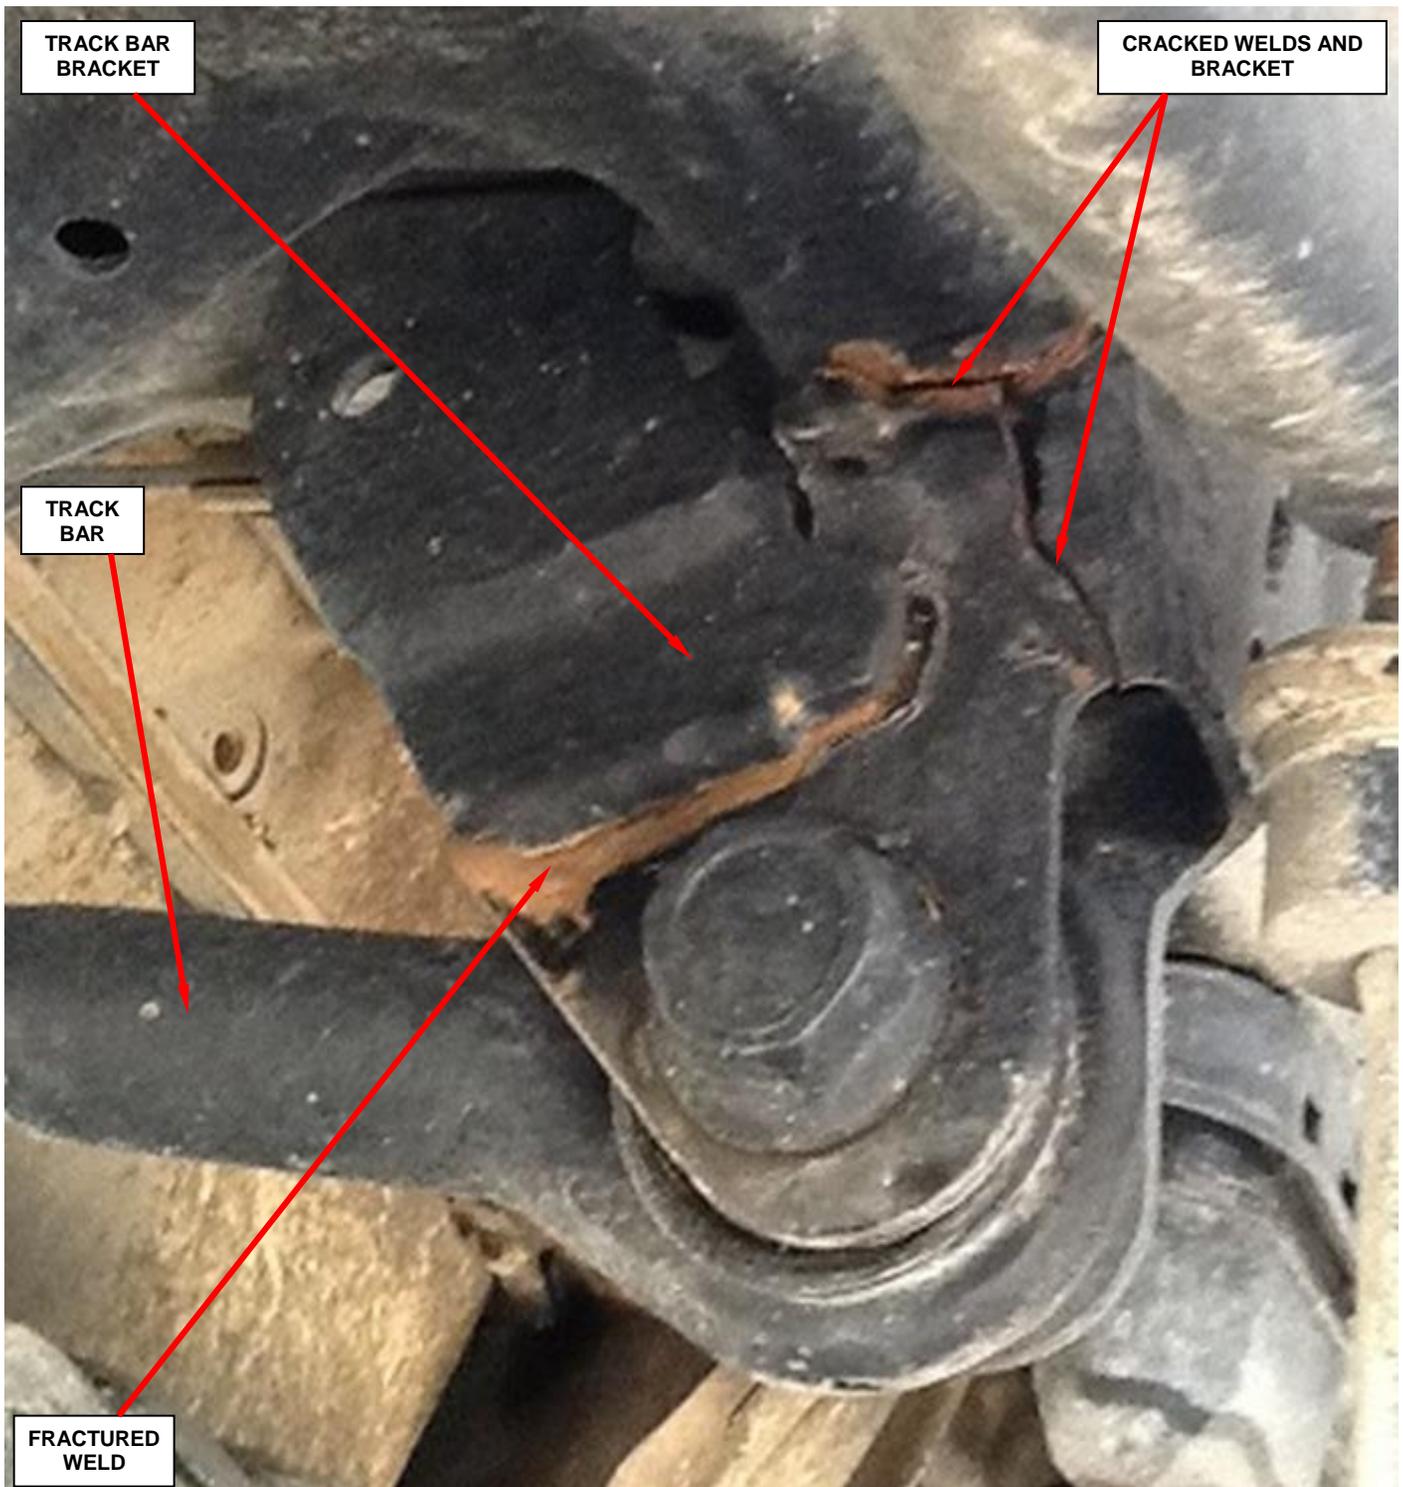
Figure 3 – Example of a Fractured Weld at Track Bar Bracket

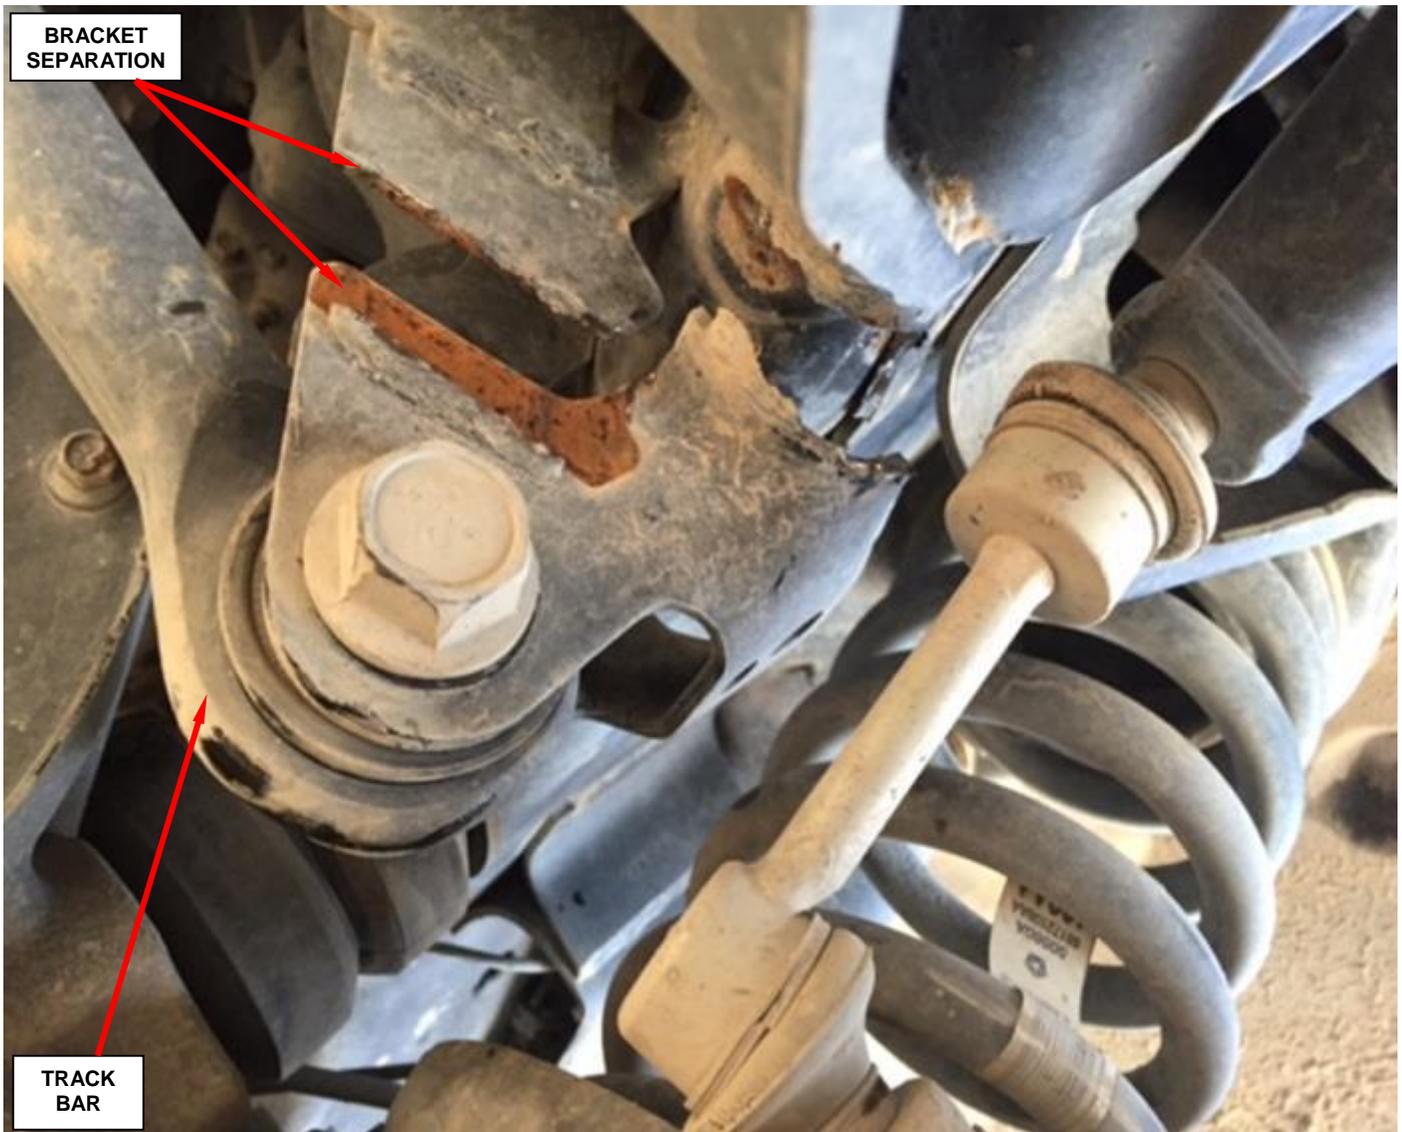
Figure 4 – Example of Track Bar Bracket Separated from the Left Frame Rail

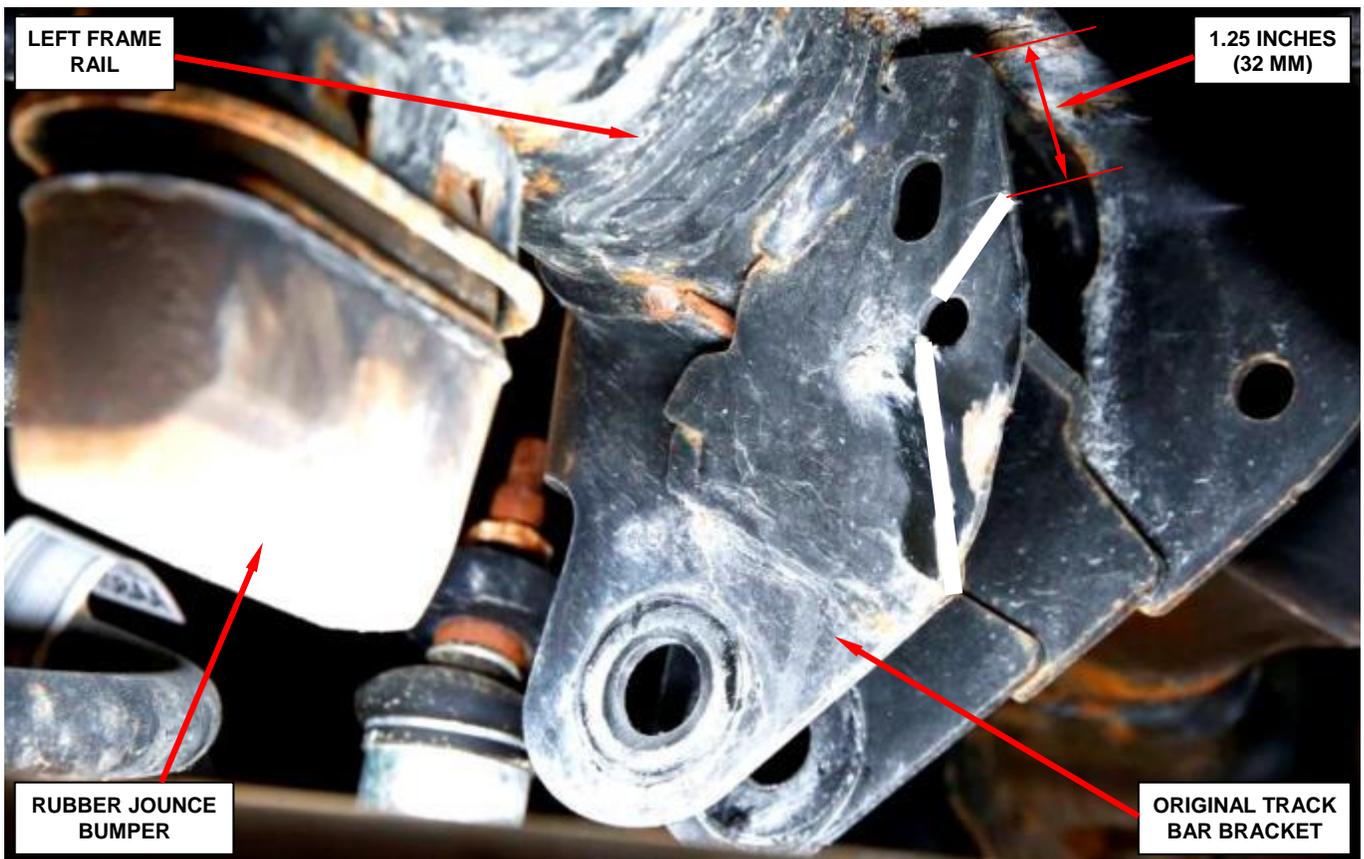
Figure 7 – Mark Frame and Cut Bracket with a Cut-Off Wheel

d. Using a cut-off wheel, cut the frame bracket along the lines made in Step 4a.

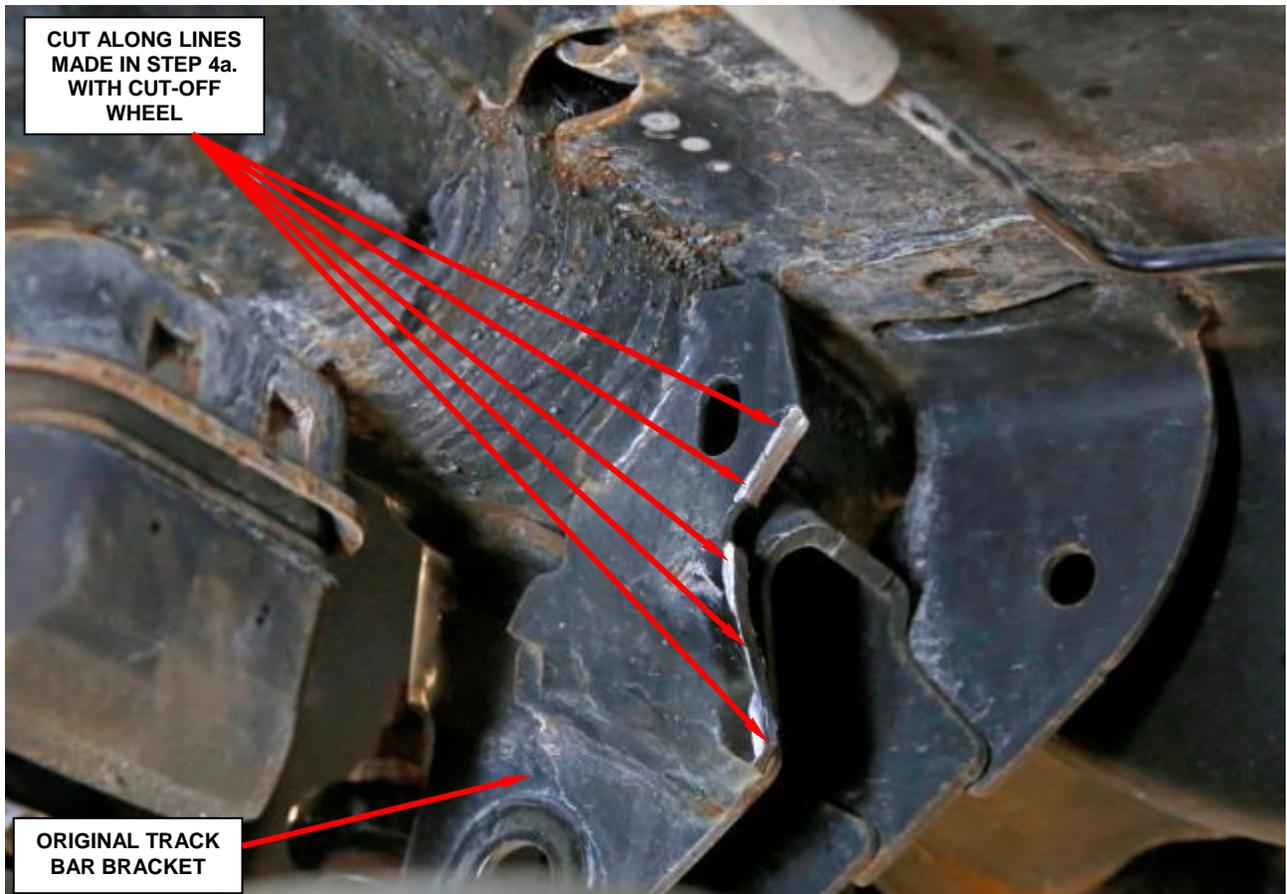
Figure 9 – Correctly Cut Track Bar Bracket

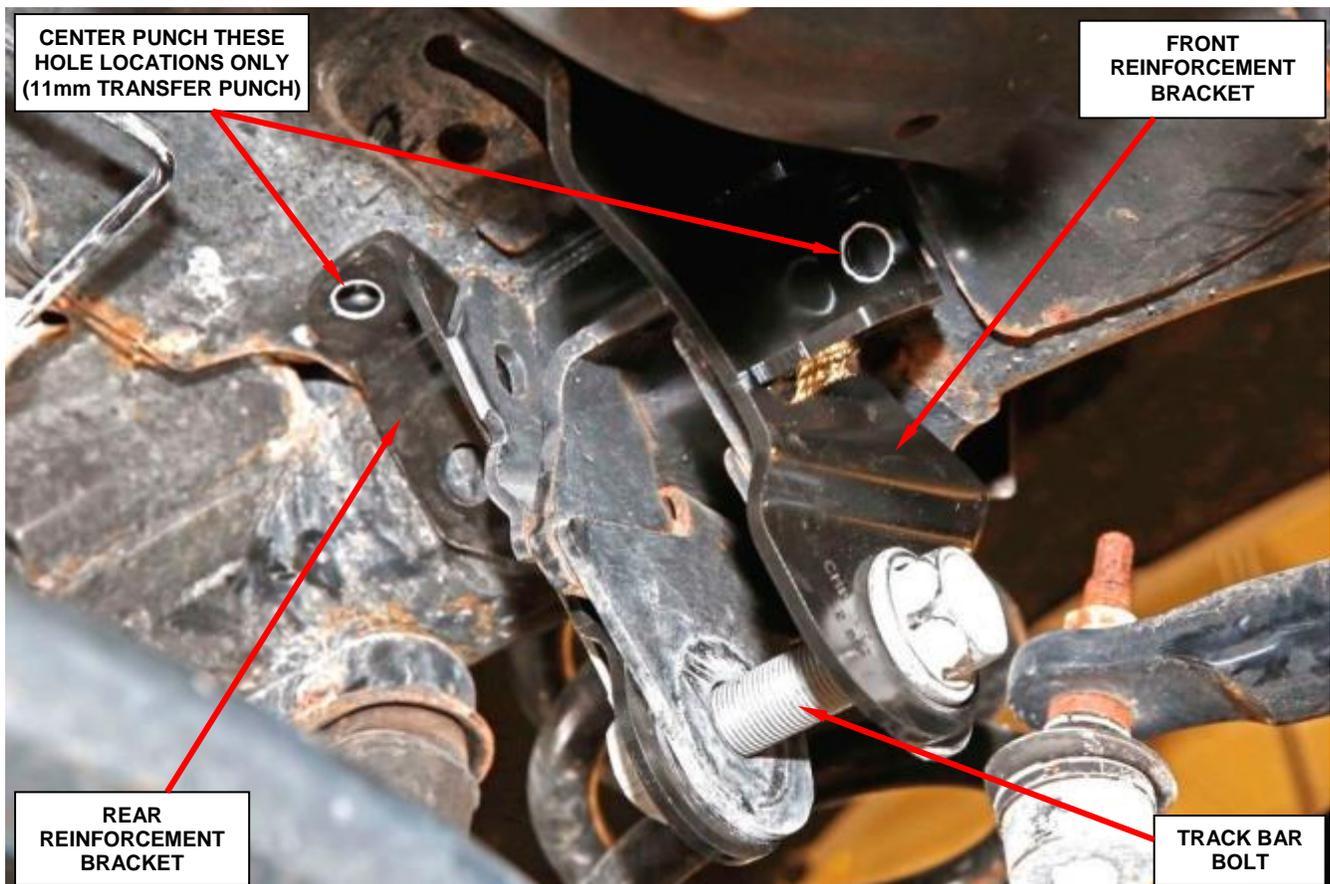
Figure 10 – Temporarily Install Track Bar Reinforcement Brackets

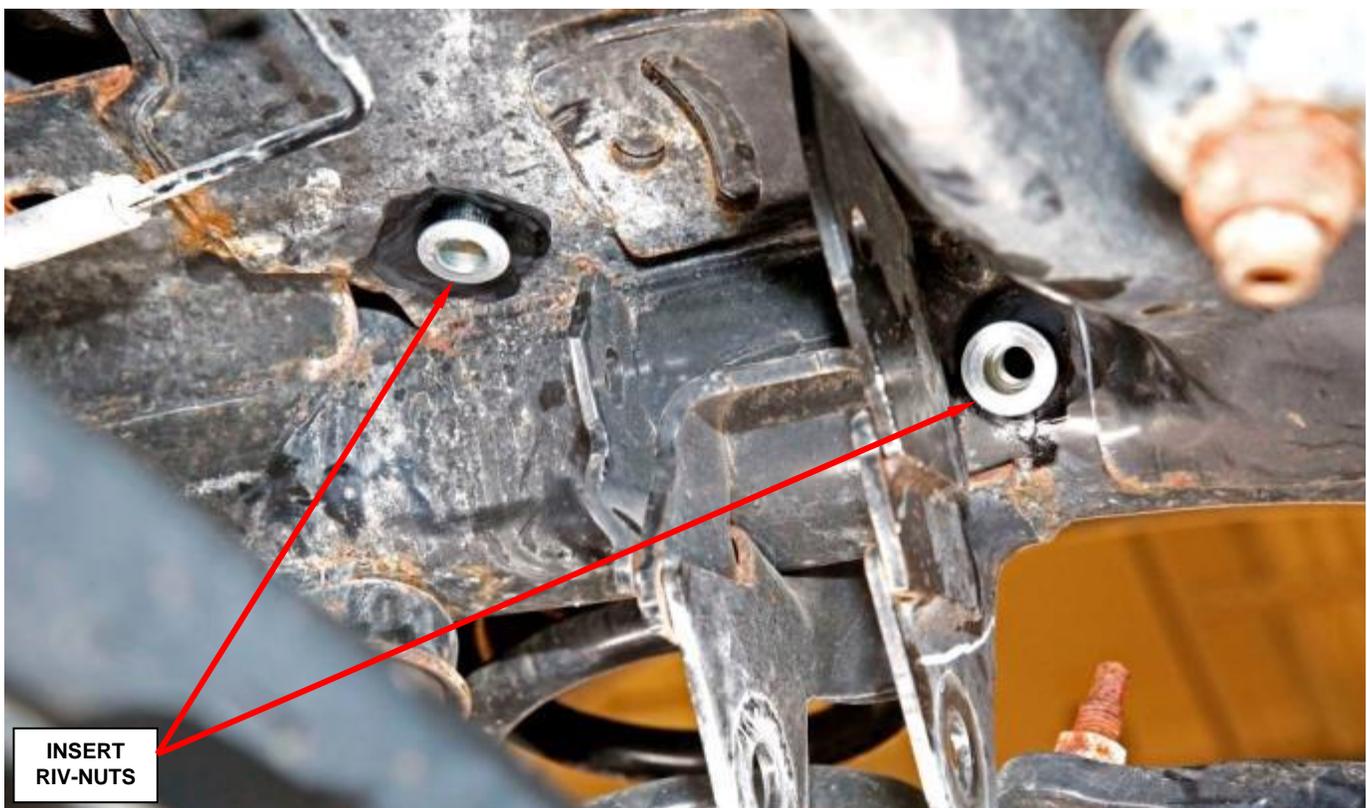
Figure 11 – Install Two Riv-Nuts

CAUTION: Make sure the riv-nut shoulder is flush against the frame surface.

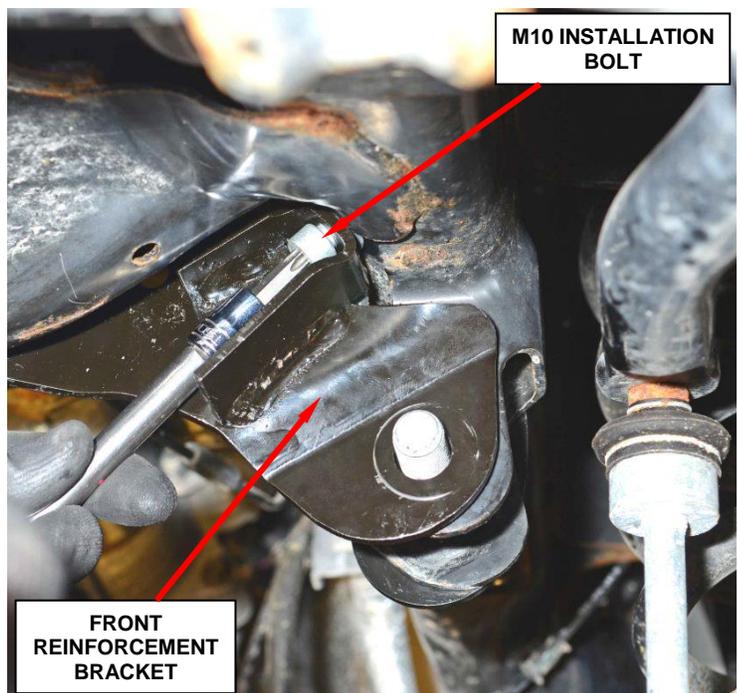
Figure 15 – Crimp Riv-Nut with M10 Installation Bolt

20. Push the front reinforcement up during the riv-nut crimping process. It is important for the bracket to make contact with the head of the riv-nut and the head of the riv-nut to properly seat against the frame surface during the crimping process.
21. Tighten the M10 installation bolt on the riv-nut to 27 ft. lbs. (37 N·m) to crimp the riv-nut (Figure 15).

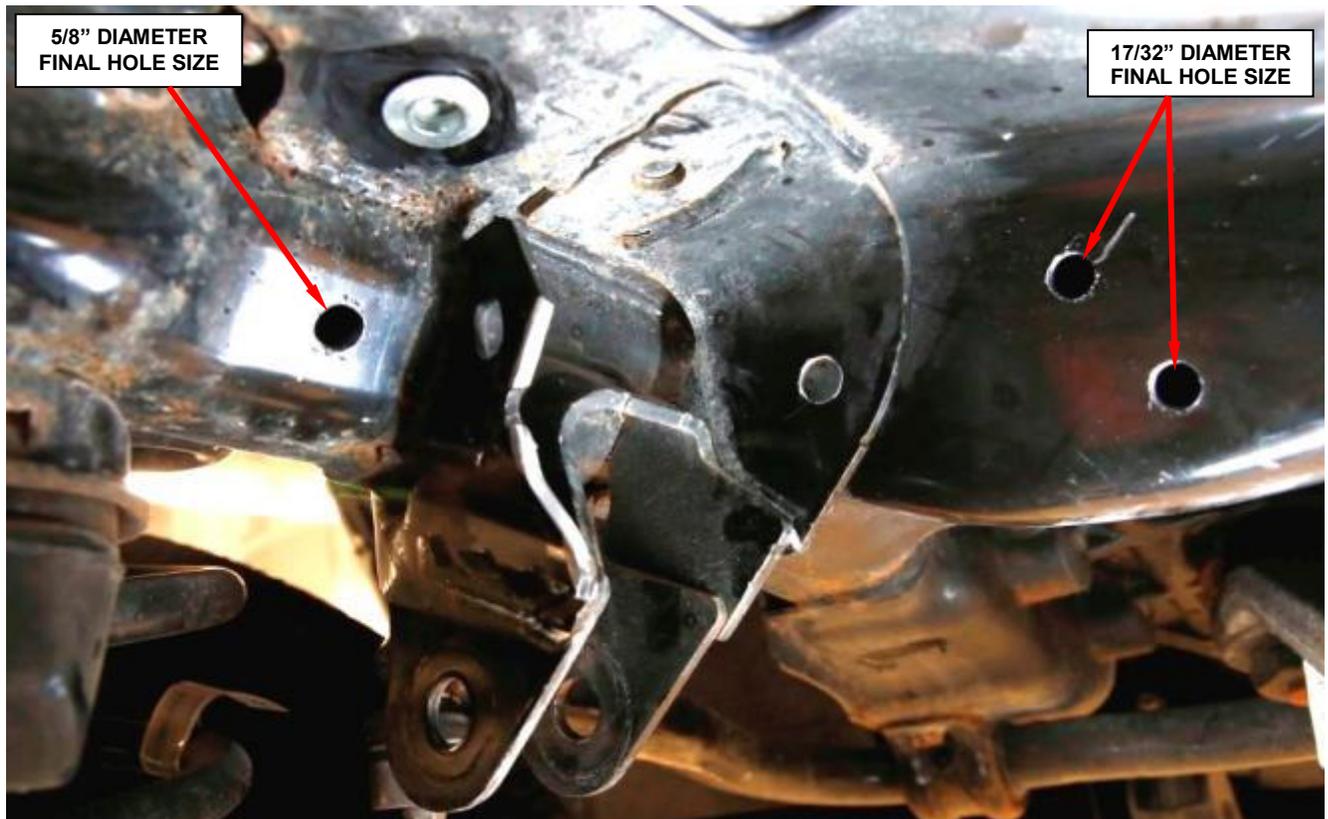
Figure 19 – Drill Three Holes in Frame at Center Punch Marks

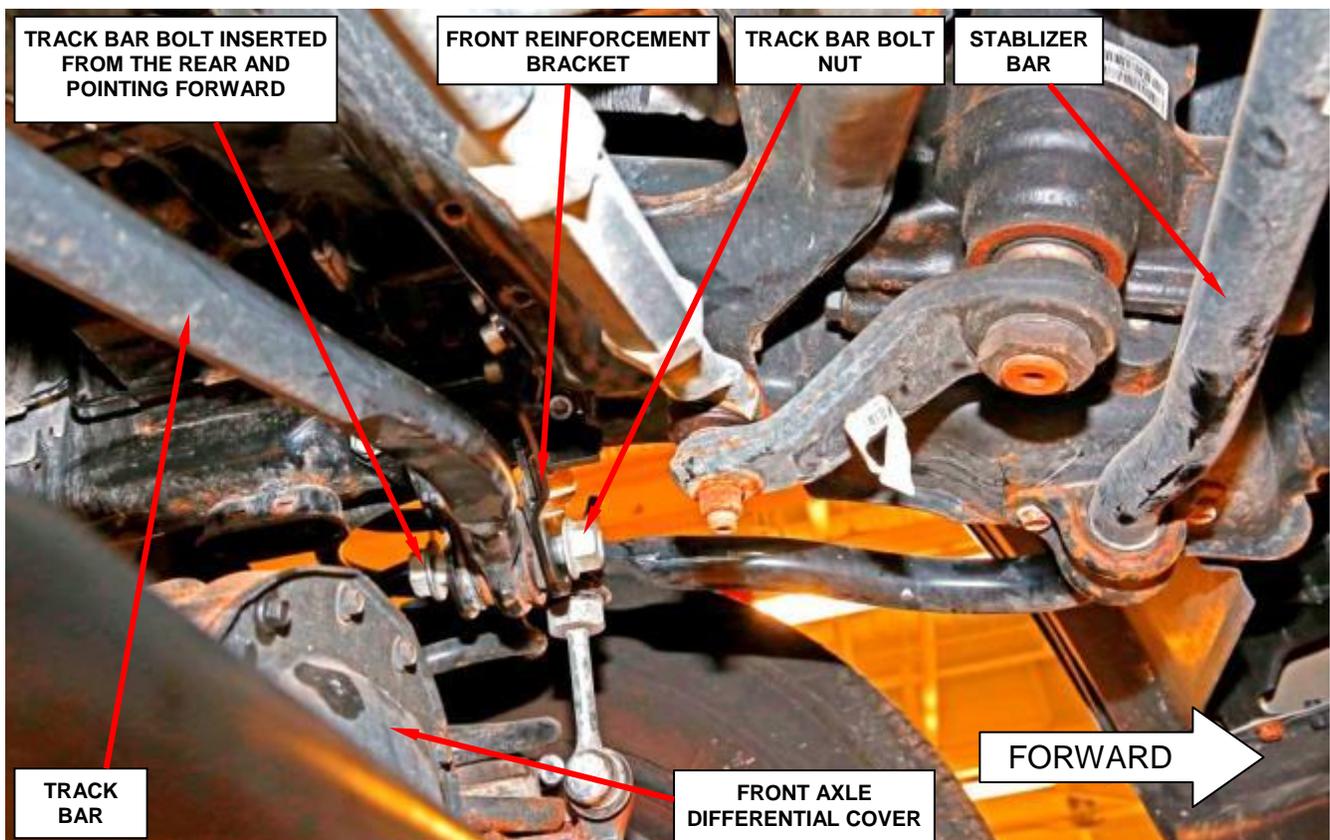
Figure 28 – Install Track Bar Bolt in Orientation Shown

CAUTION: If the track bar bolt is installed facing rearward, the suspension will hit the track bar bolt during suspension travel. Install the bolt through the rear reinforcement bracket first, with the nut going against the front reinforcement bracket (Figure 28).

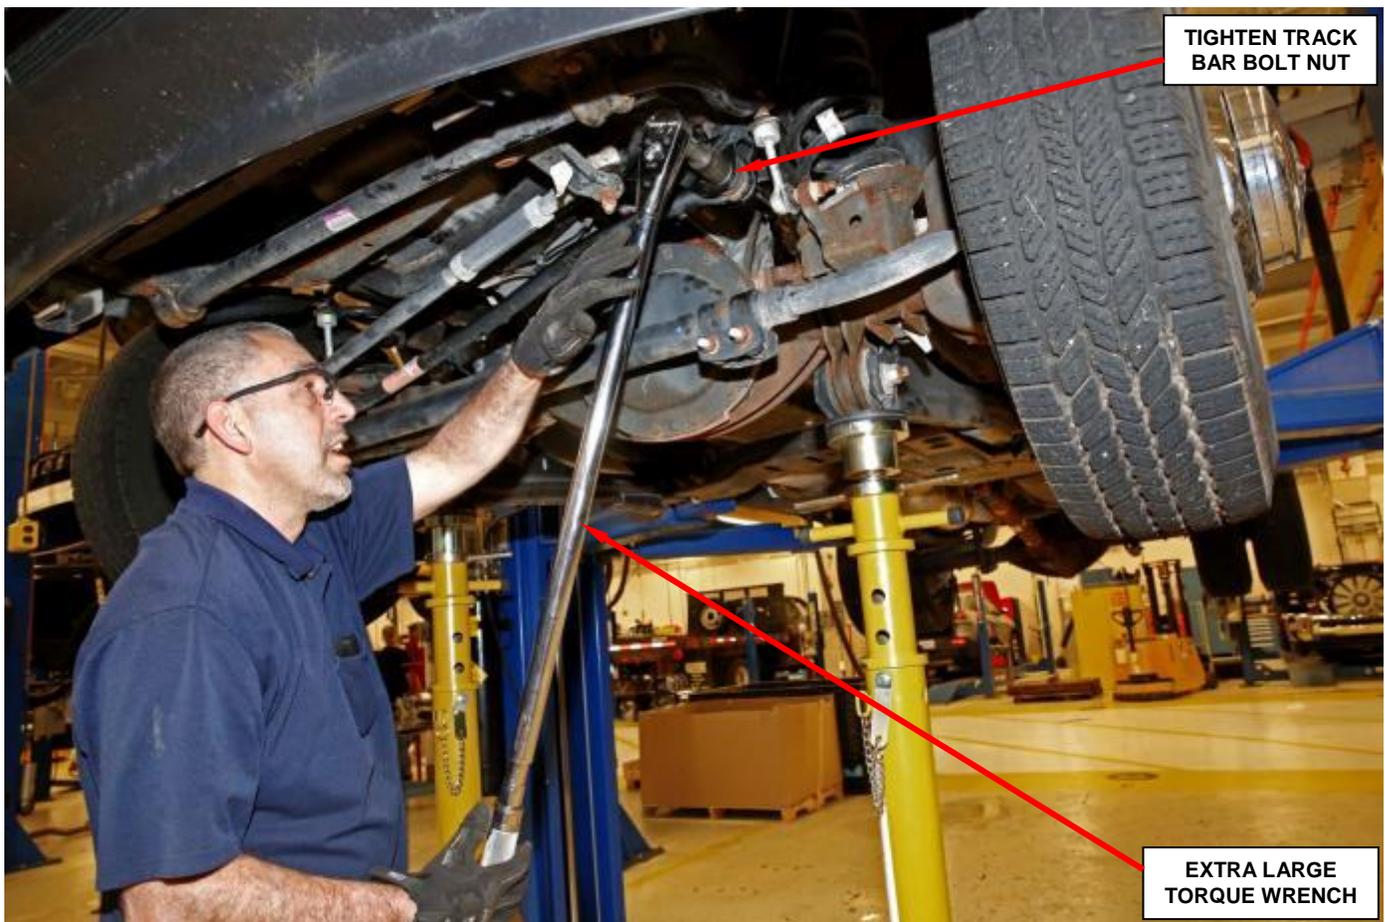
Figure 29 – Tighten Track Bar Bolt to 285 ft. lbs. (387 N·m)

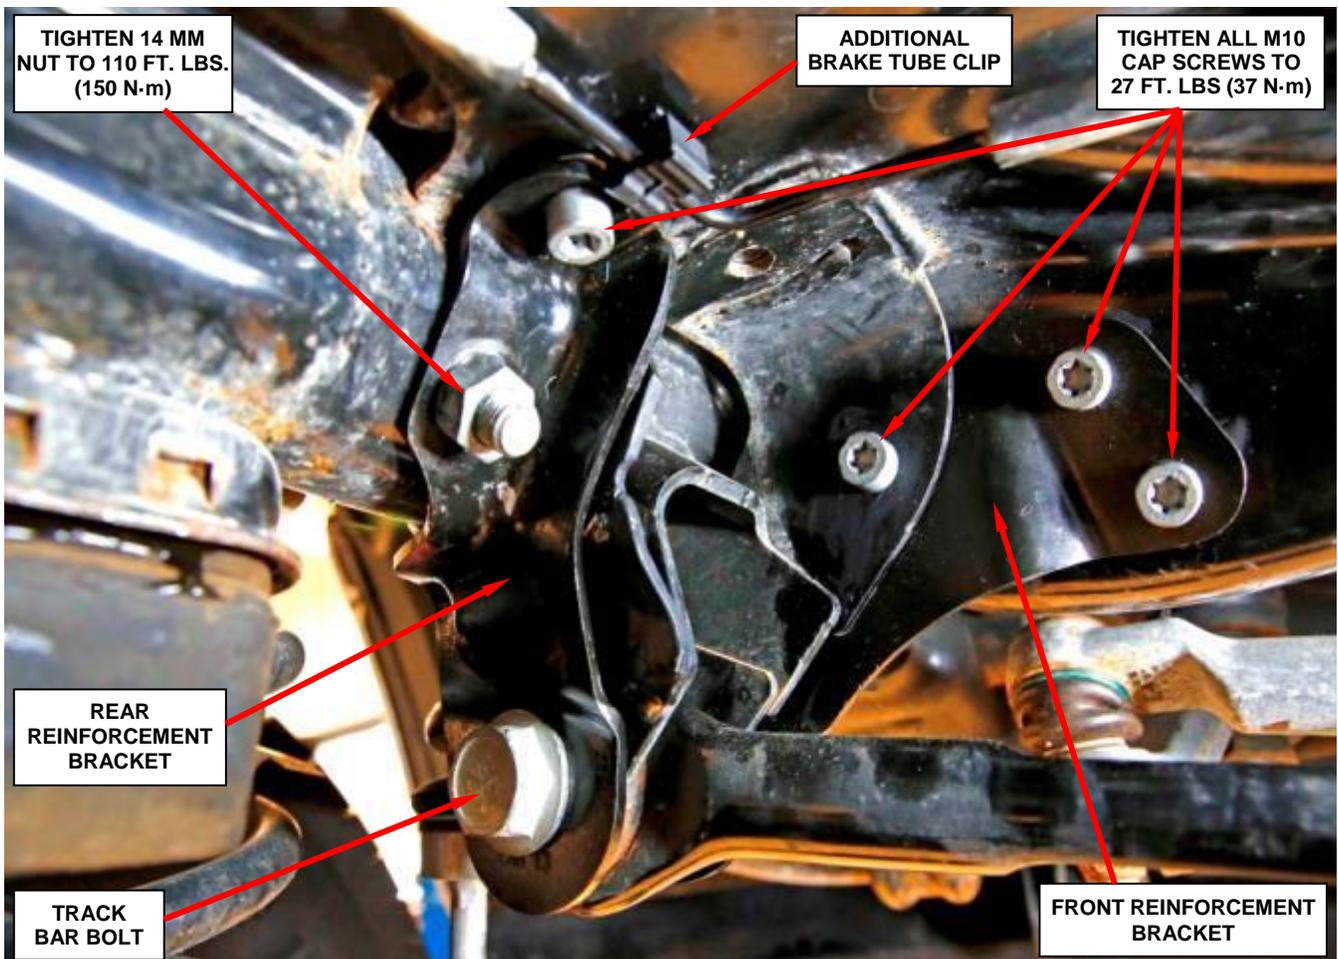
Figure 30 – Correctly Installed Reinforcement Brackets

67. Tighten all of the remaining reinforcement bracket M10 cap screws to 27 ft. lbs. (37 N·m) (Figure 30).

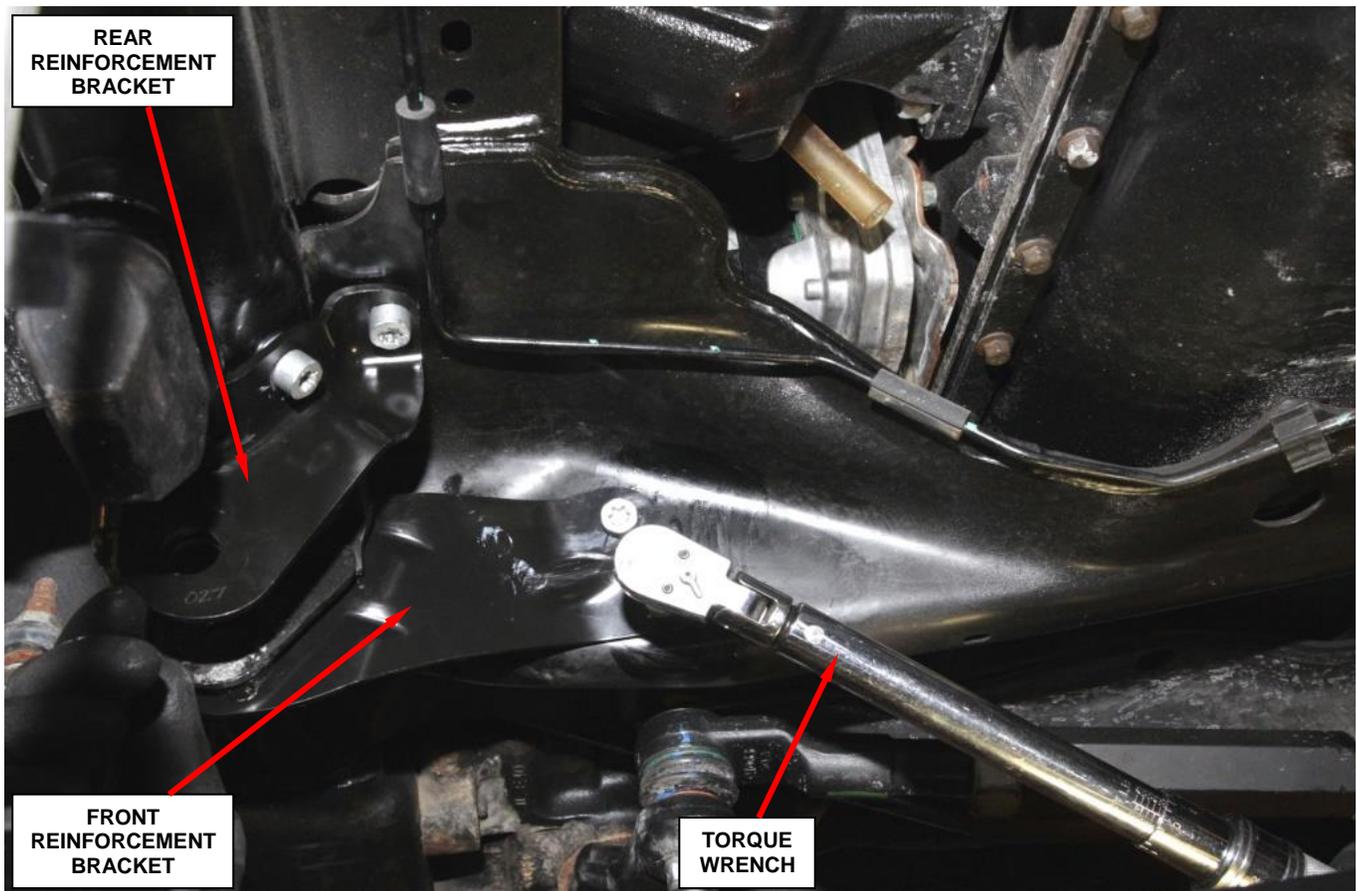
Figure 41 – Tighten All M10 Torx Head Cap Screws to 27 ft. lbs. (37 N·m) to Crimp Riv-Nuts

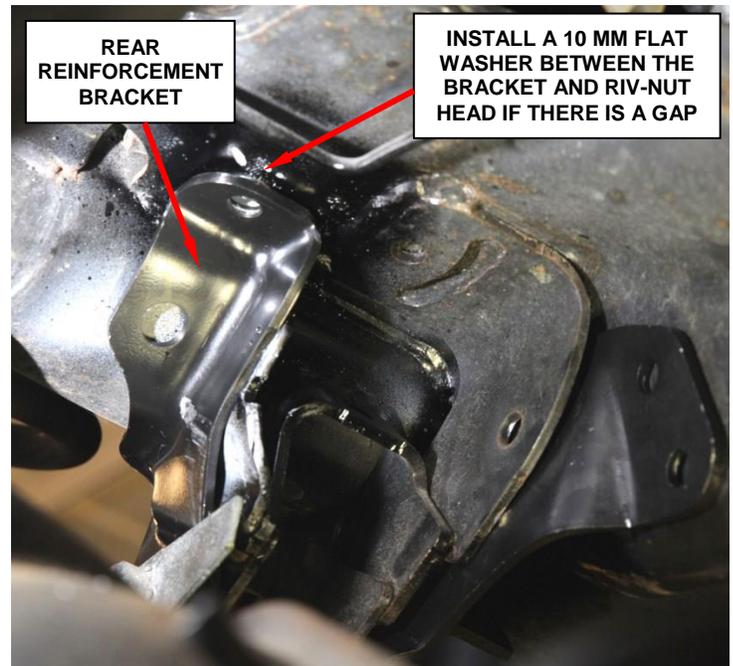
Figure 42 – Reinforcement Bracket Gap

CAUTION: If poor alignment occurs between the newly located M10 riv-nut and the front reinforcement bracket bolt hole and the M10 installation bolt cannot be installed, refer to Section E. – Bracket Hole Alignment.

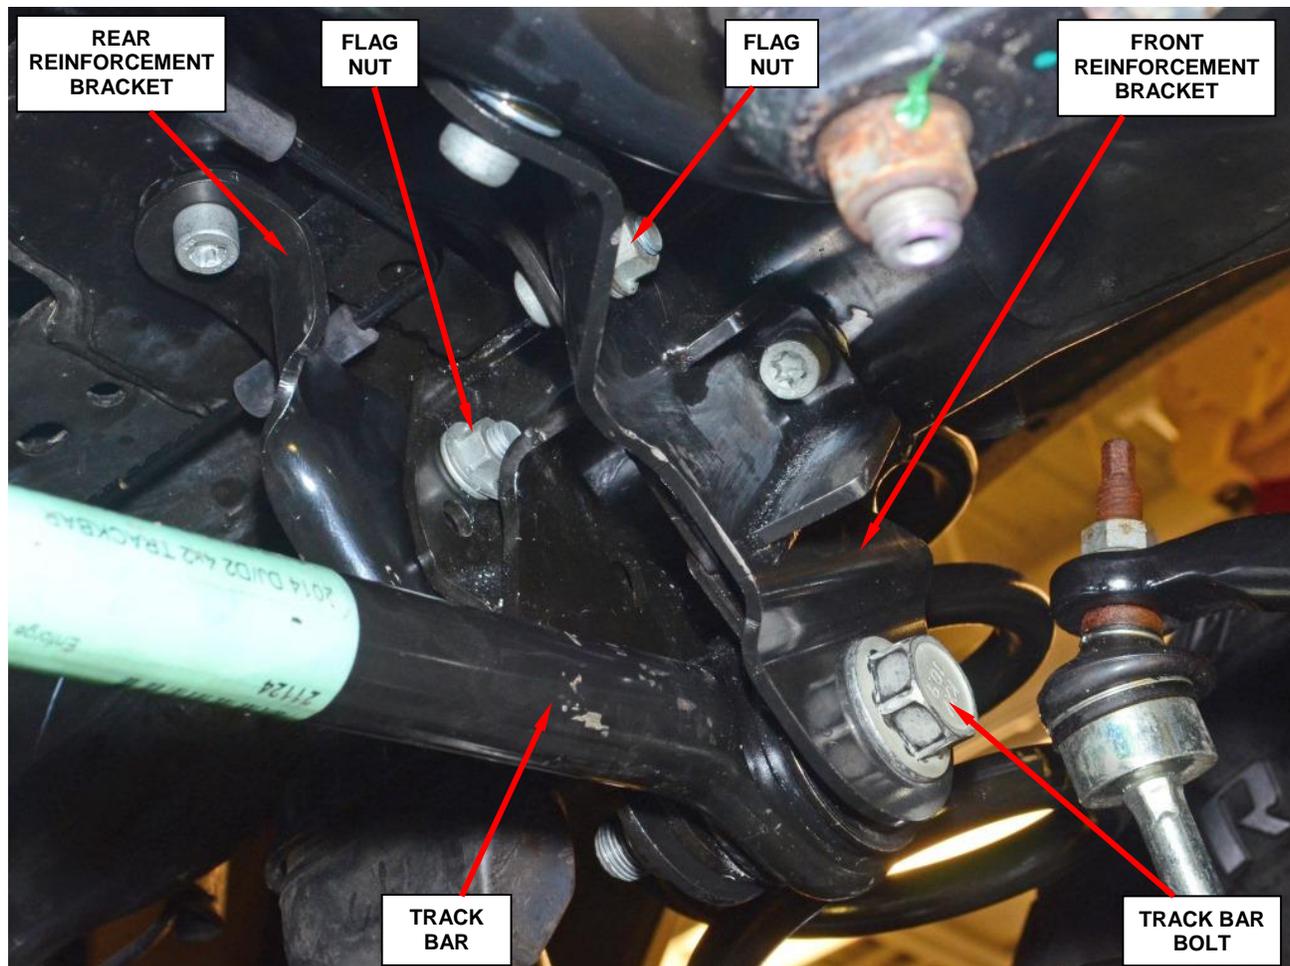
Figure 60 – Install New Track Bar Bolt and Nut / Tighten to 285 ft. lbs. (386 N·m)

NOTE: All M10 Torx head cap screws should be finger tight before tightening the track bar bolt.

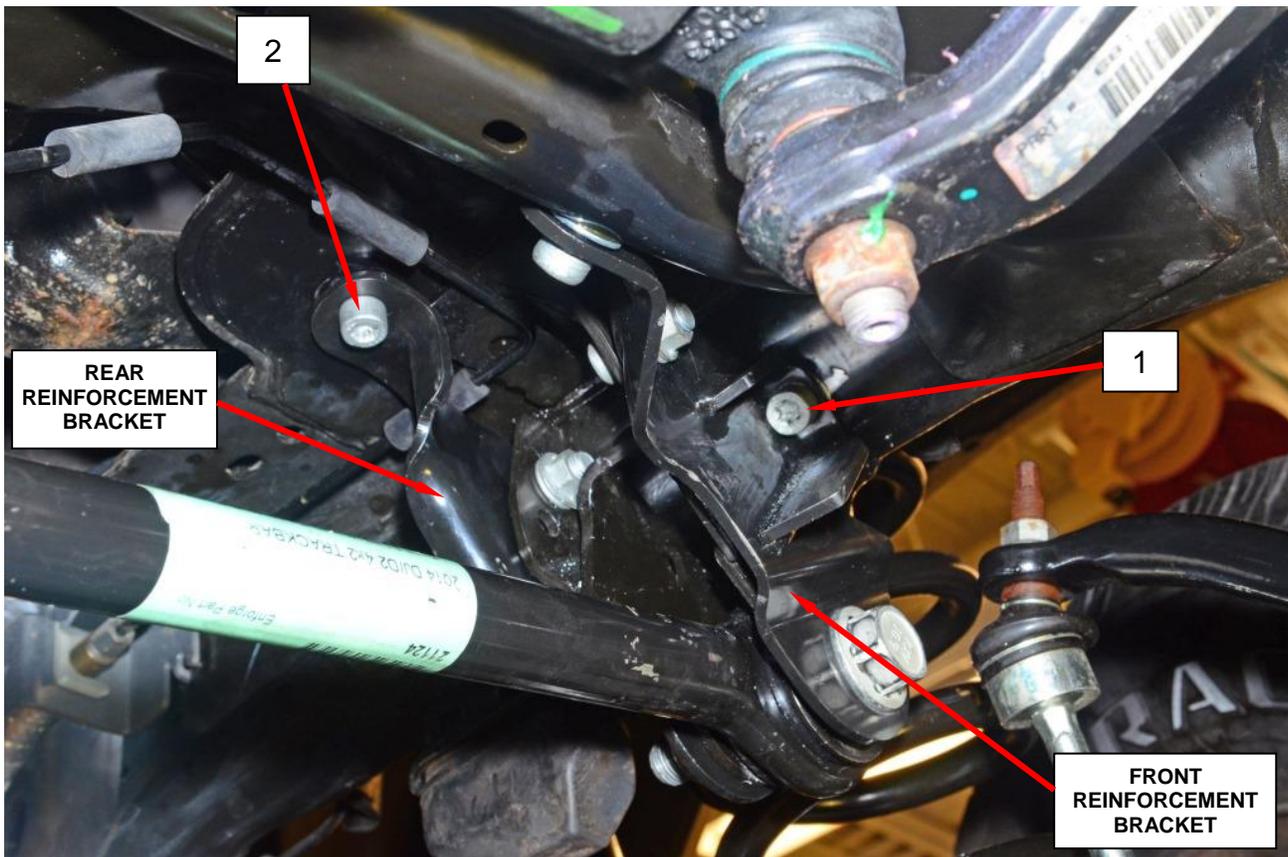
Figure 61 – Tighten the M10 Bolts in Proper Sequence

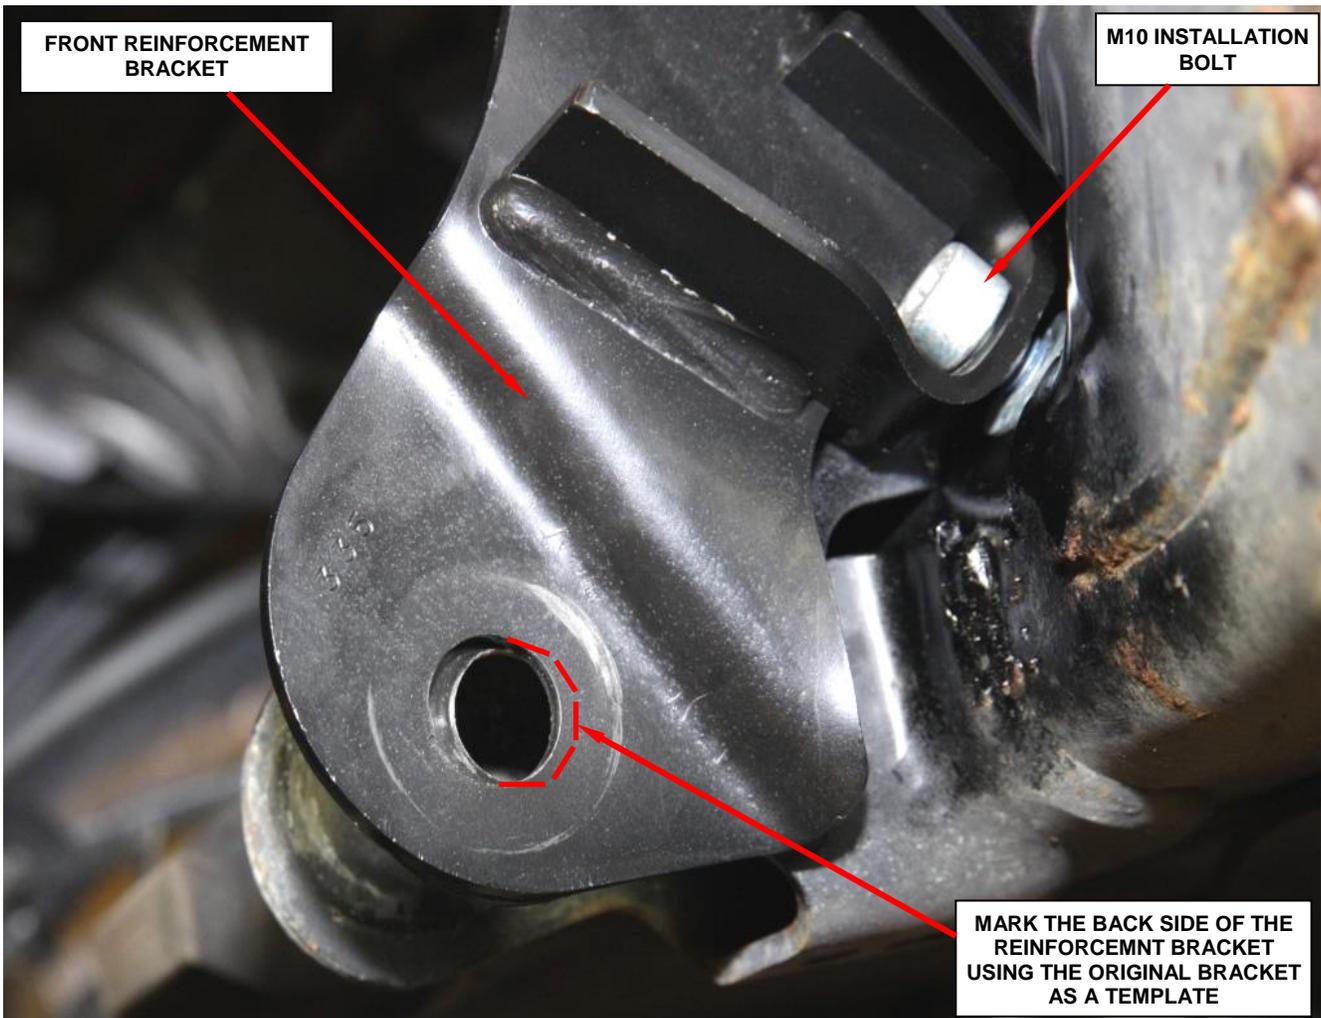
Figure 63 – Mark Backside of Reinforcement Bracket

1. Remove the track bar bolt.
2. Install the reinforcement bracket that has a hole alignment issue using the M10 installation bolt.
3. Mark the M18 hole on the reinforcement bracket for the track bar bolt (Figure 63).
