Revised August 2016

Dealer Service Instructions for:

Safety Recall R46 / NHTSA 15V-541 Front Suspension Track Bar Frame Bracket

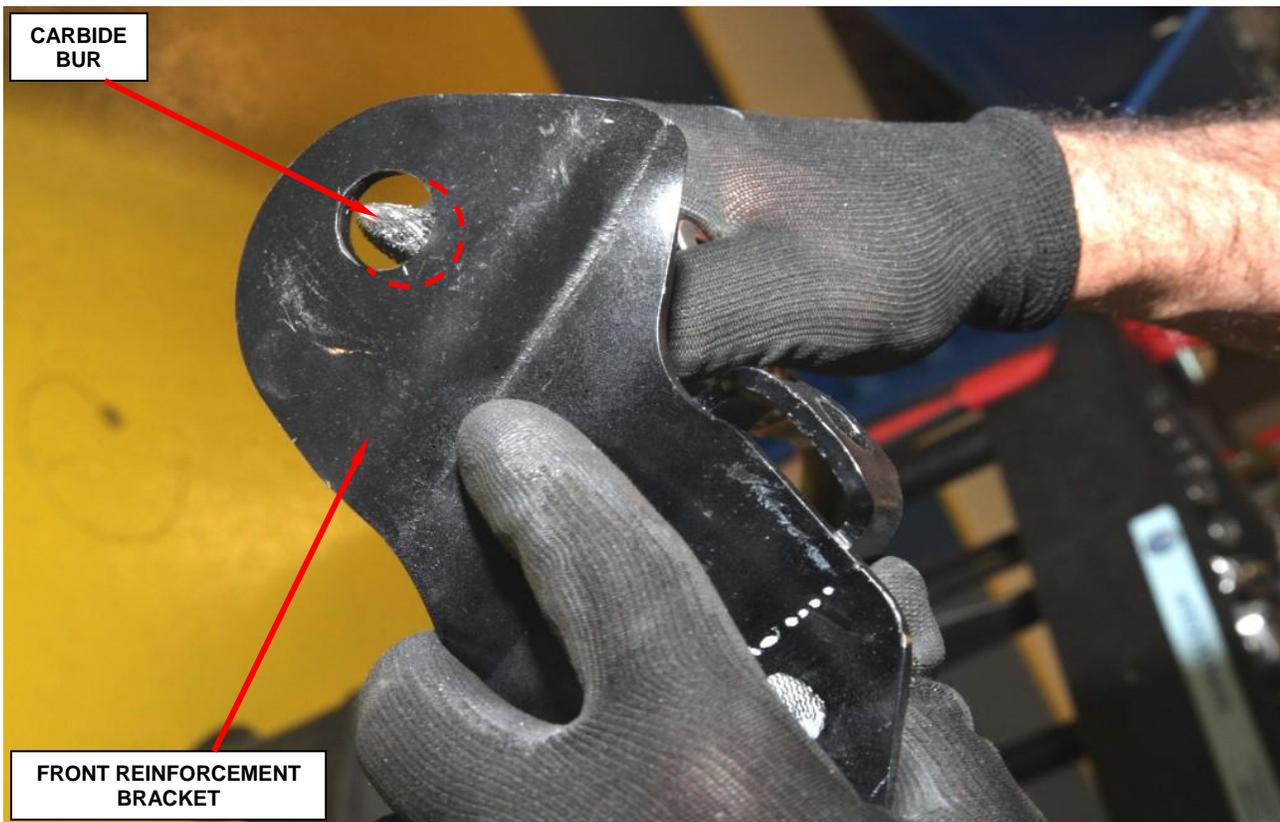
Figure 64 – Elongate Track Bar Bolt Hole as Marked in Step 3
