TECHNICAL INSTRUCTIONS
FOR
SAFETY RECALL G03
BRAKE FLUID RESERVOIR SENSOR CONNECTOR
CERTAIN 2016 MY HIGHLANDER

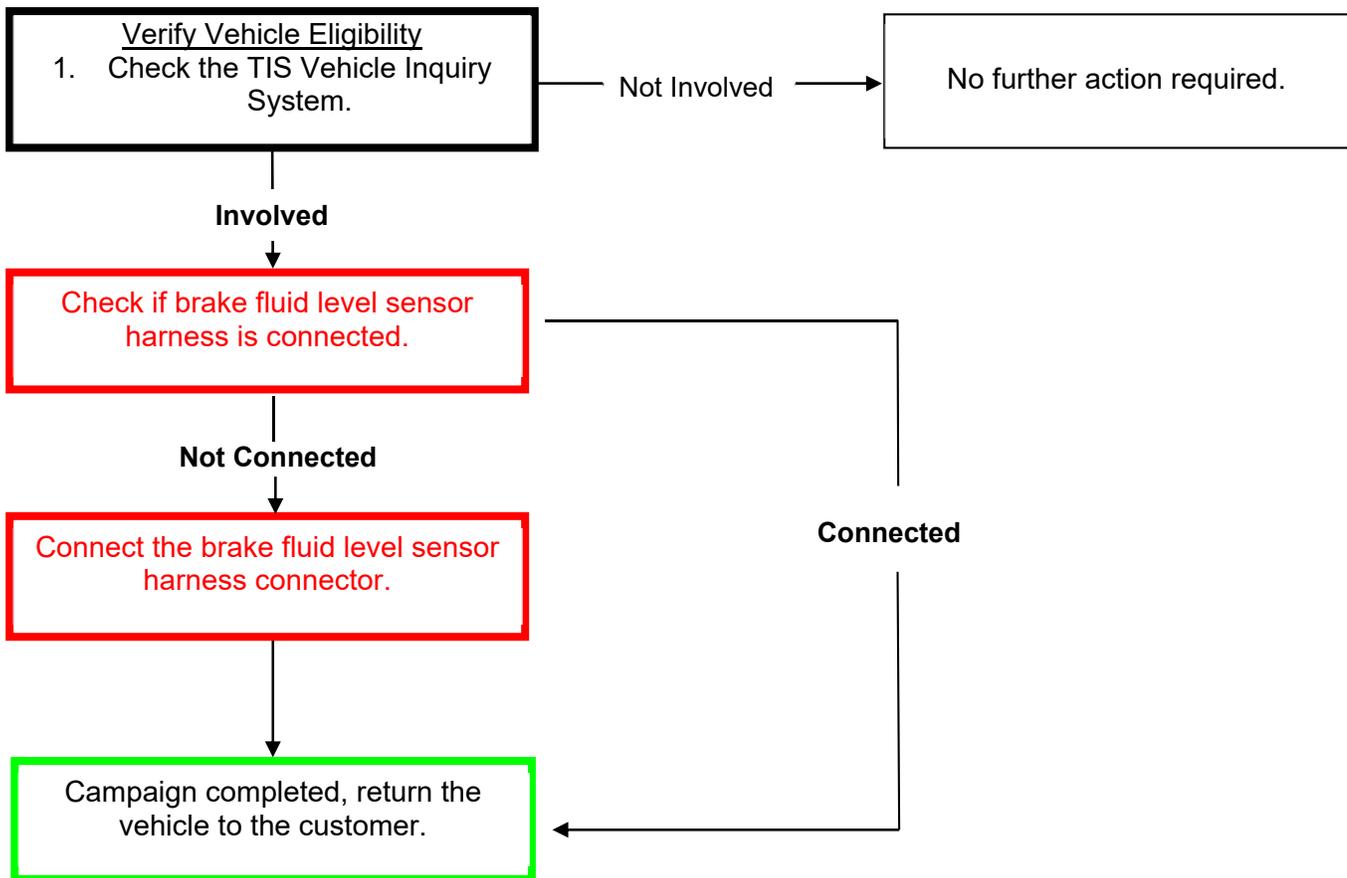
I. OPERATION FLOW CHART

The flow chart is for reference only. **DO NOT** use it in place of the full technical instructions. Follow **ALL** steps as outlined in the full technical instructions to confirm the campaign is completed correctly.

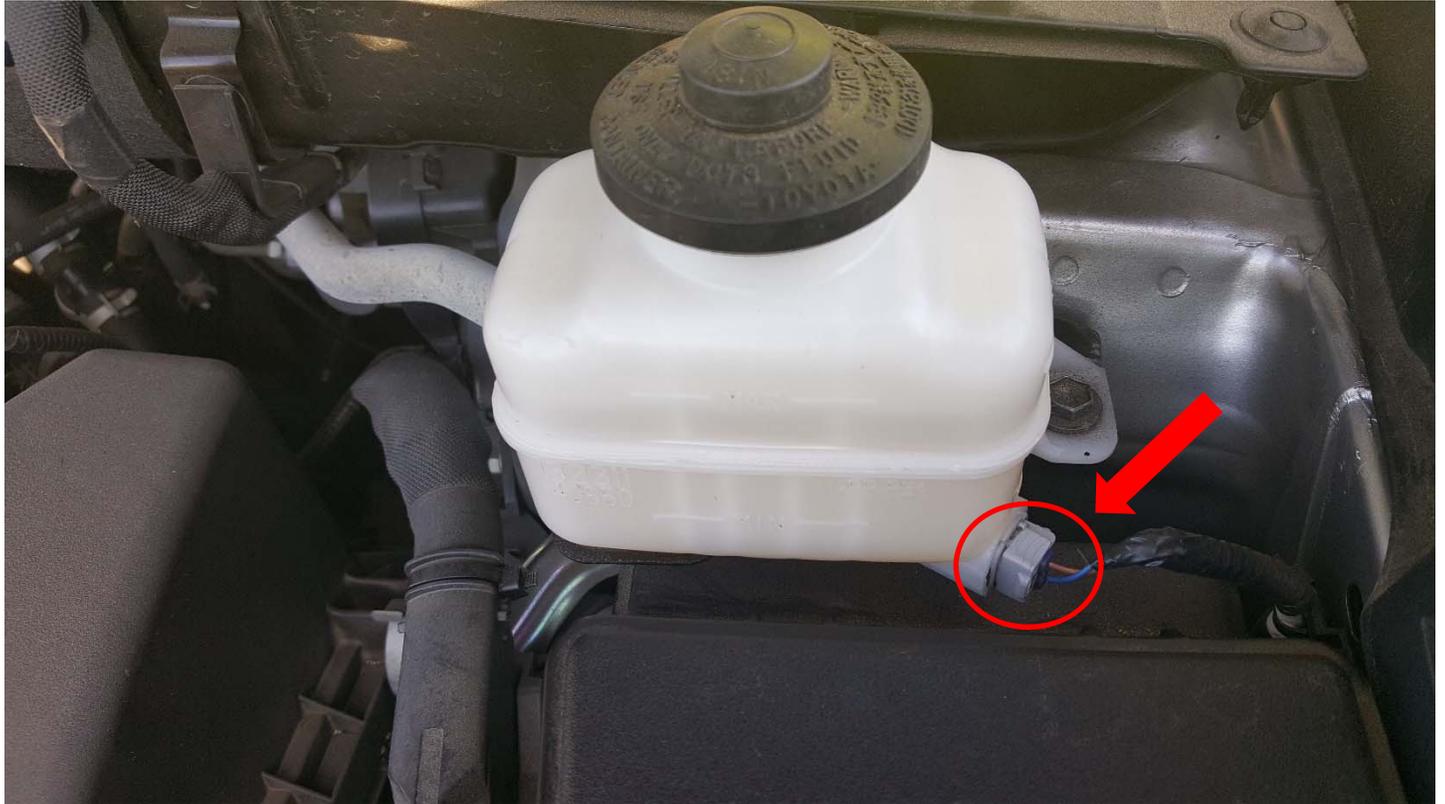
On the involved vehicles, there is a possibility that the wire harness which attaches to the brake fluid reservoir sensor was not connected during the vehicle assembly process. If this were to occur, the vehicle would not meet a federal safety standard provision requiring a warning light if there is a drop in the brake fluid level. If a warning light does not come on to indicate a drop in fluid level, this could increase the risk of a crash.

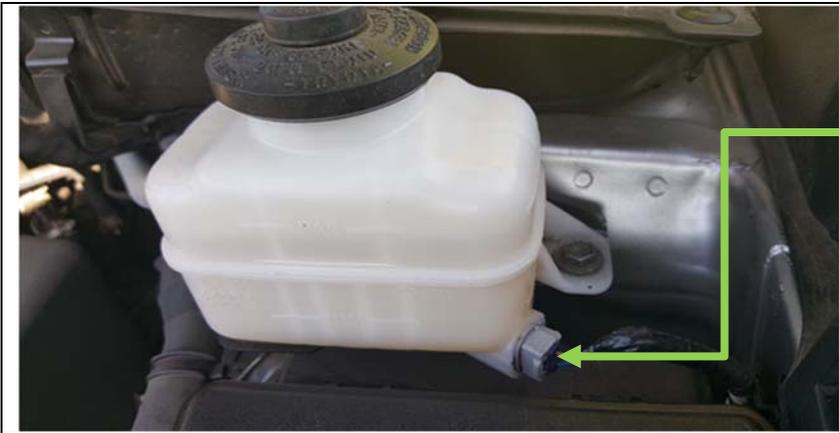
VI. BRAKE FLUID RESERVOIR SENSOR CONNECTOR INSPECTION

1. INSPECT THE BRAKE FLUID RESERVOIR SENSOR CONNECTOR

- a) Inspect the connector for secure attachment to the brake fluid reservoir.

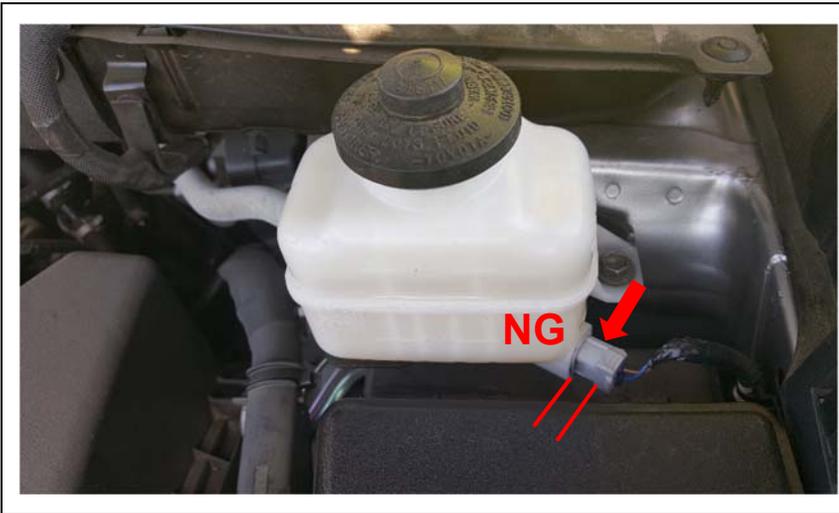
2.

Brake fluid reservoir sensor connector is **NOT** securely connected or completely disconnected.

Re-connect the connector to the brake fluid reservoir and confirm the connection.

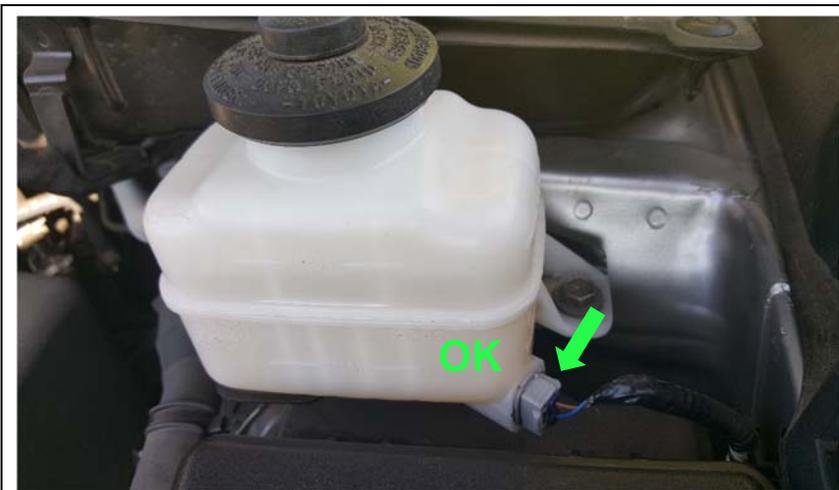
3.

Re-assure the brake fluid reservoir sensor connector has a secure connection with the brake reservoir.

- Ensure that the brake fluid level sensor harness is securely connected.
