V. ATTACHMENTS

PHOTOGRAPHS

DETERMINATION OF ORIGIN AND CAUSE

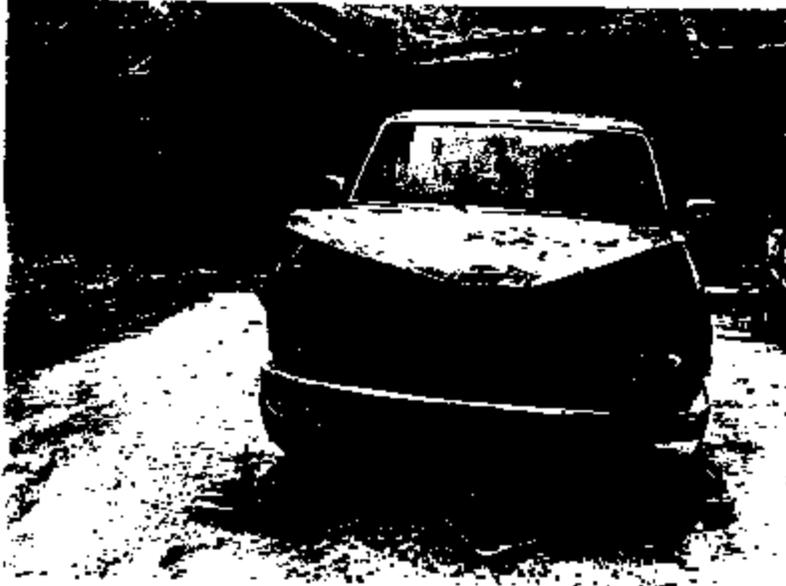
1. View of the front of the Ford vehicle.

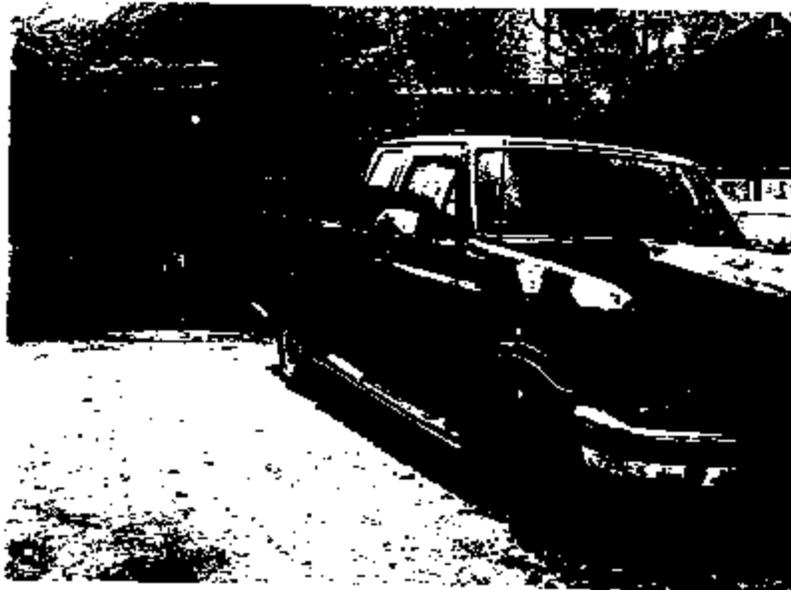
3. View of the right side of the Ford vehicle.

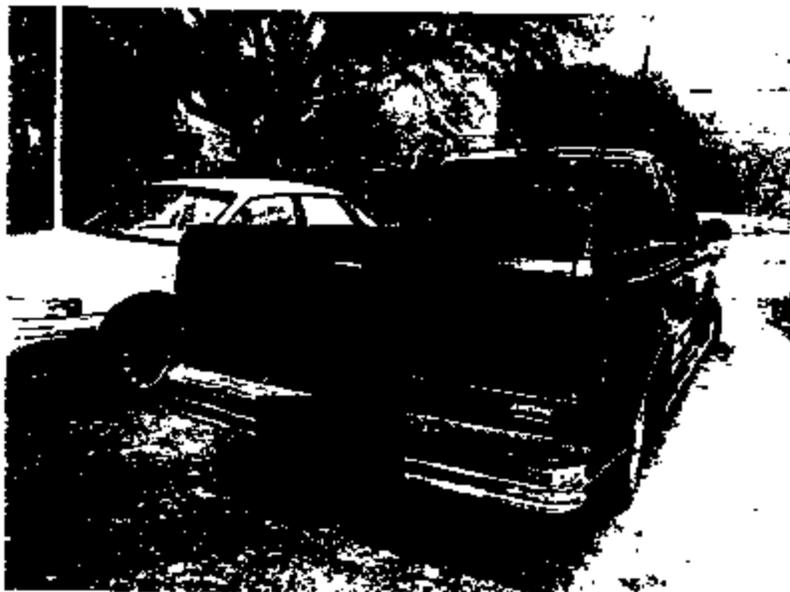
4. View of the rear of the Ford vehicle.

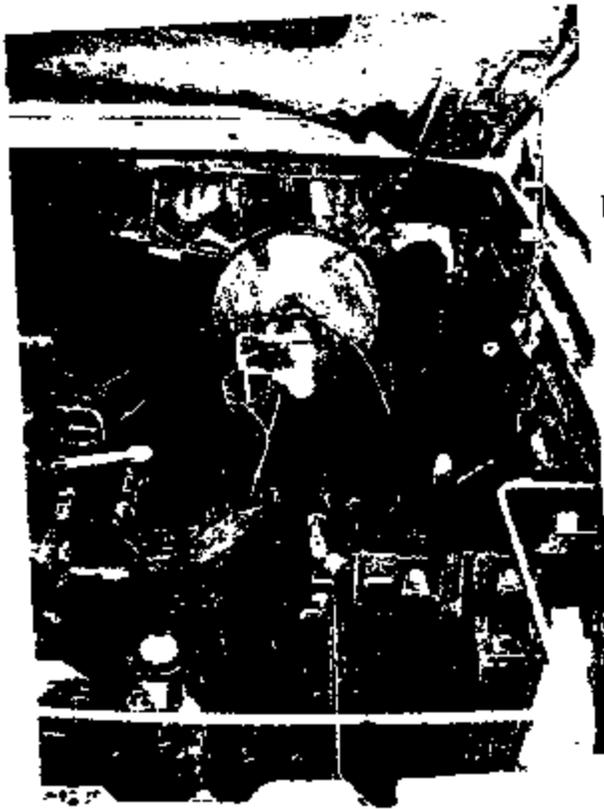
9. Overview of the engine compartment.

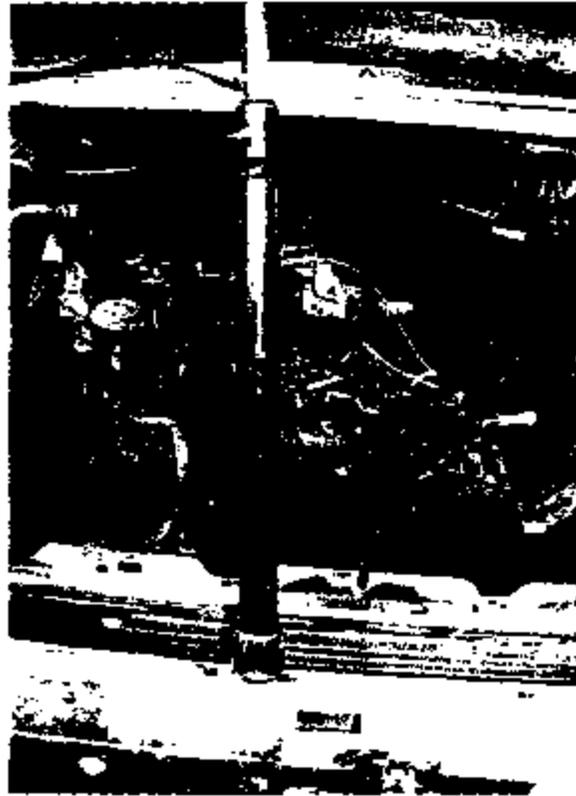
11. View of the center third of the engine compartment.

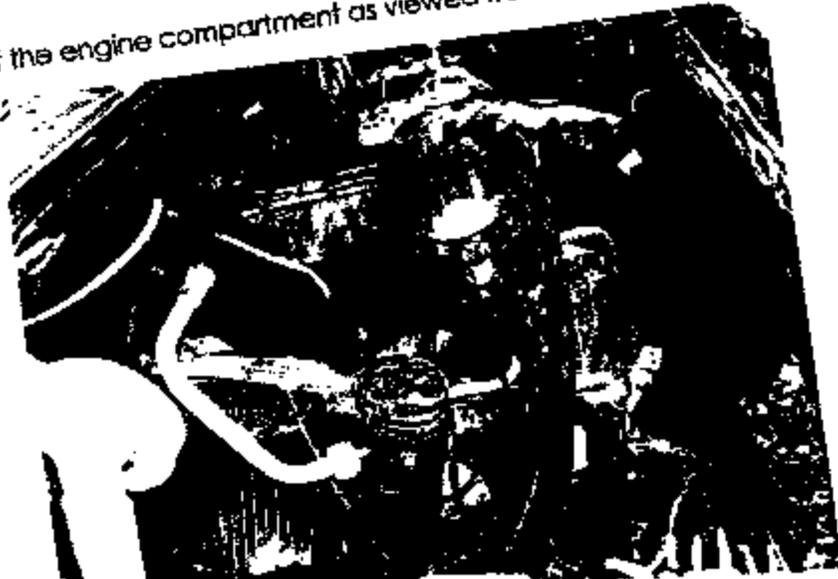
13. View of the engine compartment as viewed from the right.

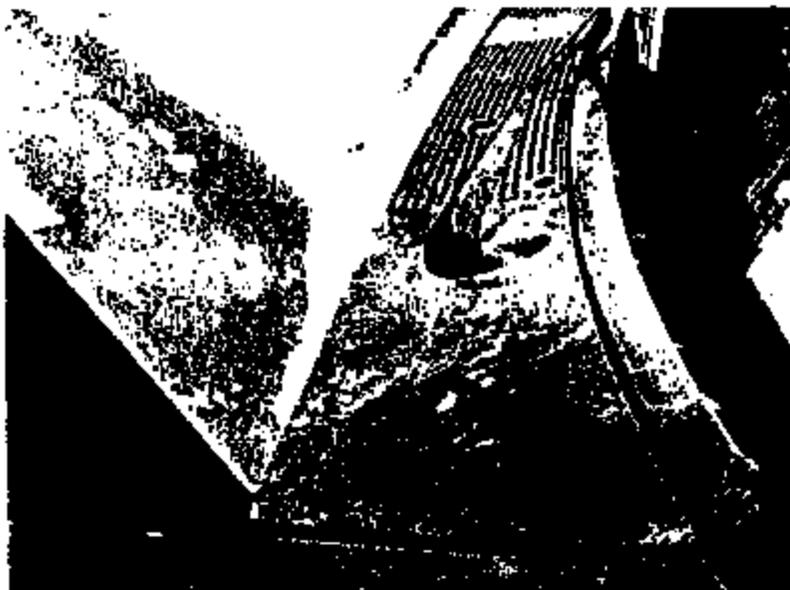
28. View of the consumed paint between the rear portion of the vehicle hood and the bottom front of the windshield.

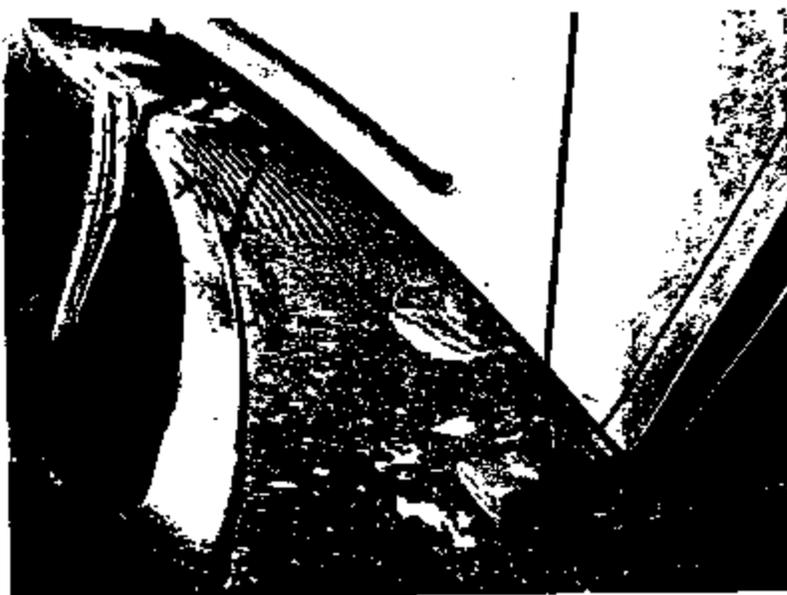
29. View of the still fully intact paint on the right side between the rear portion of the hood and the front of the windshield.

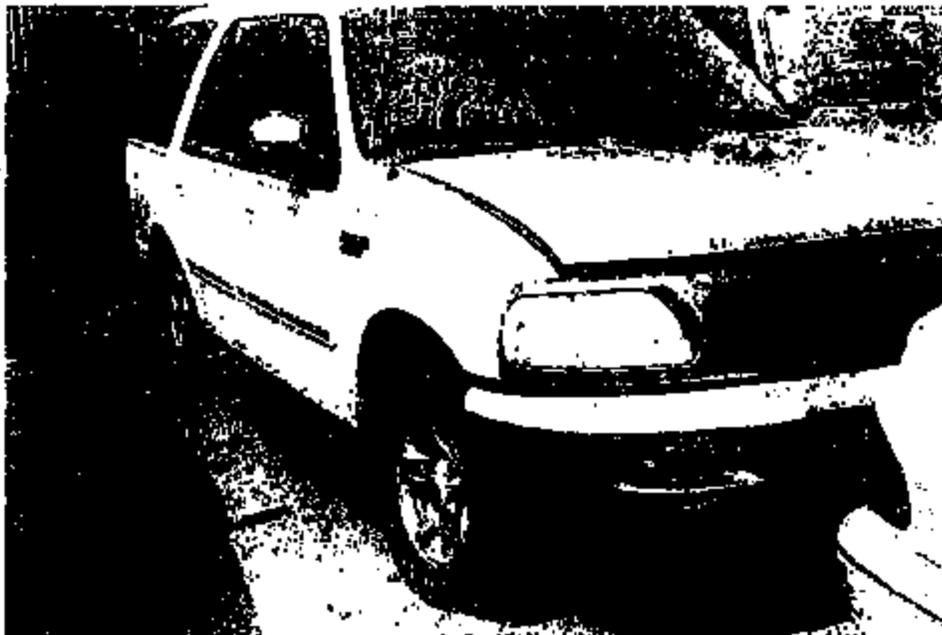
The Ford, Figures 1 through 3, was identified by the manufacturer's identification label, Figure 4. There were 70,593 miles on the odometer at the time of our inspection. On the exterior of the vehicle, the only damage seen, other than smoke residue all around the perimeter of the hood, was an area of burned paint and a hole melted through the aluminum hood. It was noteworthy that the fire had burned hot enough to melt the aluminum hood material, but had neither burned all the paint off the hood nor had melted the plastic material in the grill area. Figure 5 shows the underside of the hood.

Figure 1
Ford, viewed from the right front
